Subject: Notice of Violation No. R9-2014-0024, City of San Diego Construction Management Program, NPDES Order Nos. R9-2013-0001 and R9-2007-0001, Municipal Storm Water Permits

**NOTICE OF VIOLATION
No. R9-2014-0024**

Facility: Torrey Hills Unit 19
Inspection Date: 09/20/2013

Facility: Estates at Costa del Mar
Inspection Date: 1/7/2014

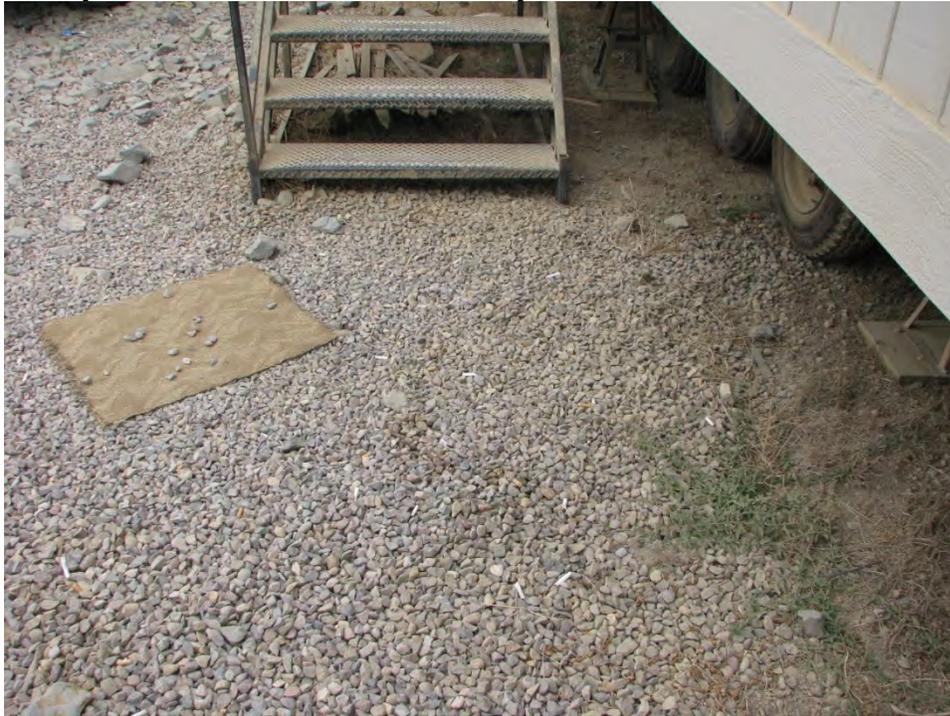
Figure 1. Trailer entrance; cigarette butts

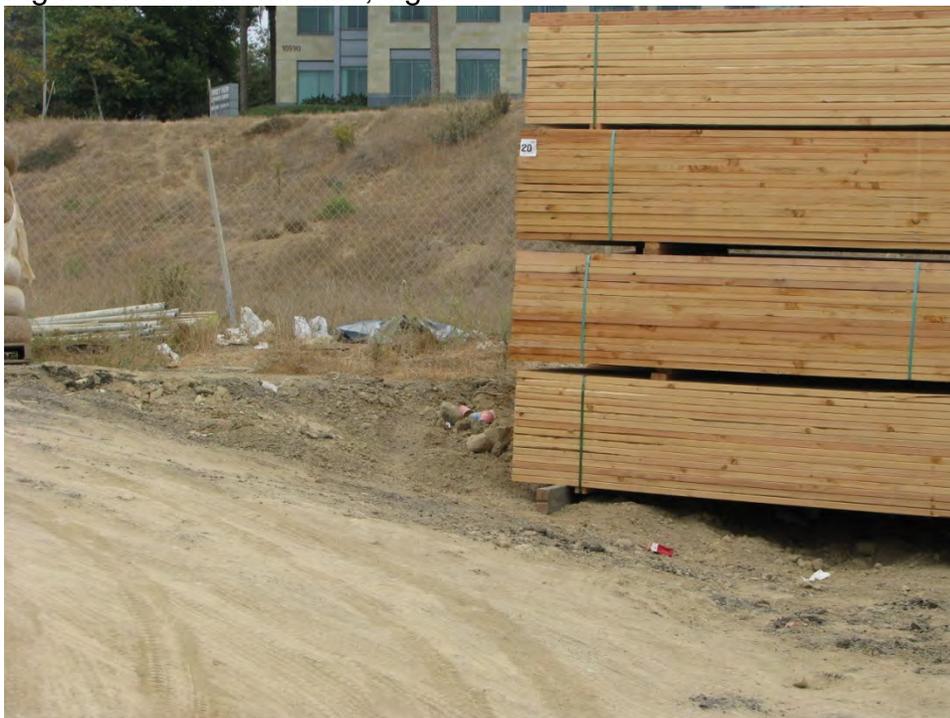
Figure 2. Near south entrance; trash area

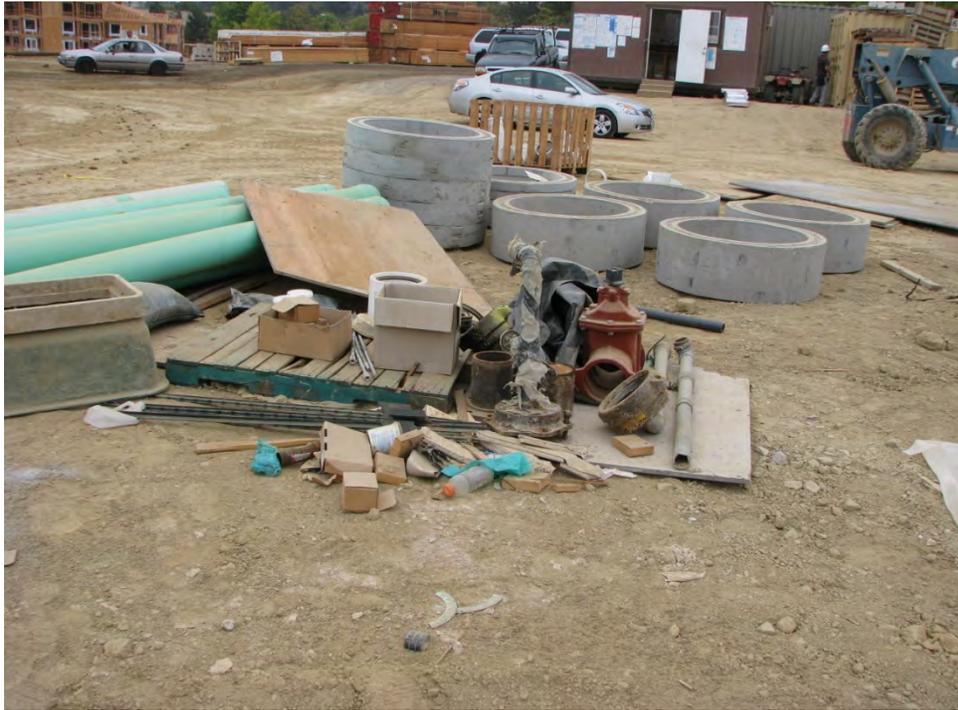
Figure 3. Site interior; construction debris

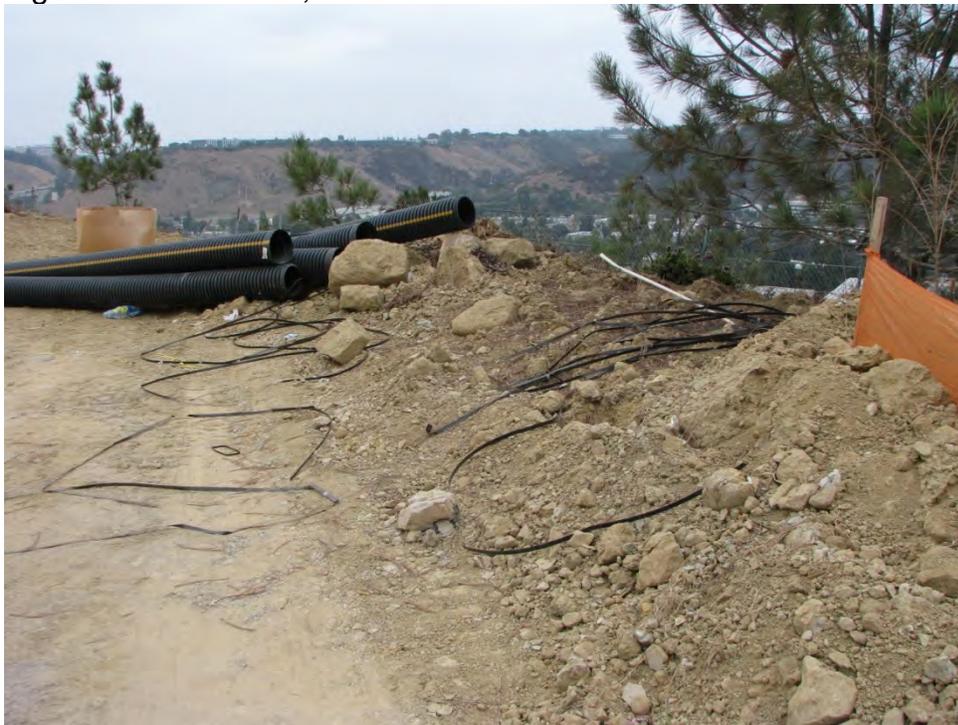
Figure 4. South west side; construction debris

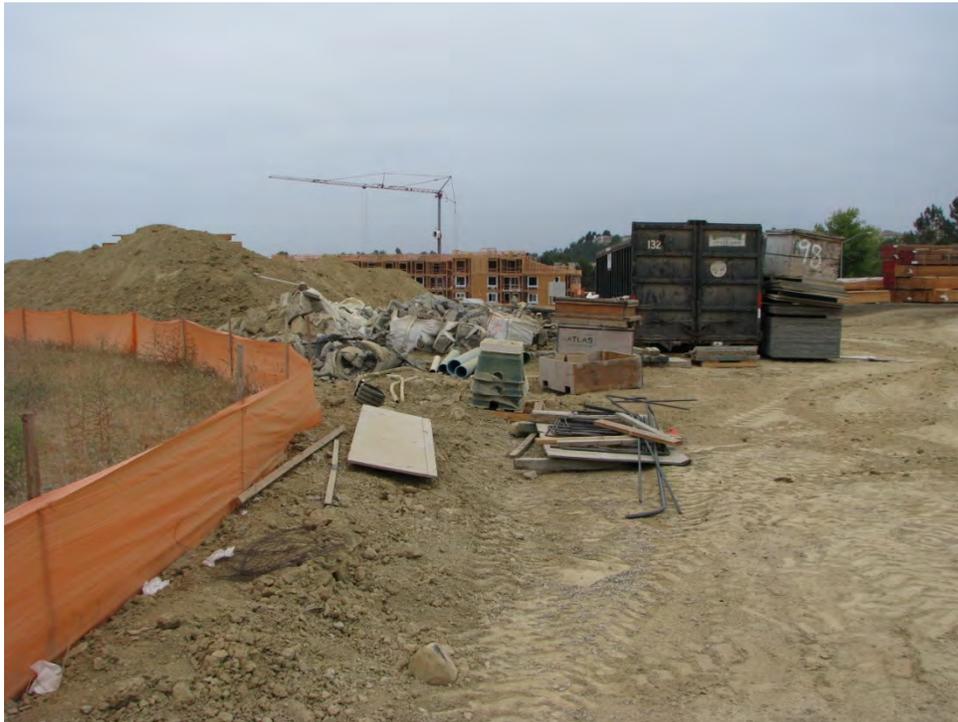
Figure 5. Site interior; construction debris

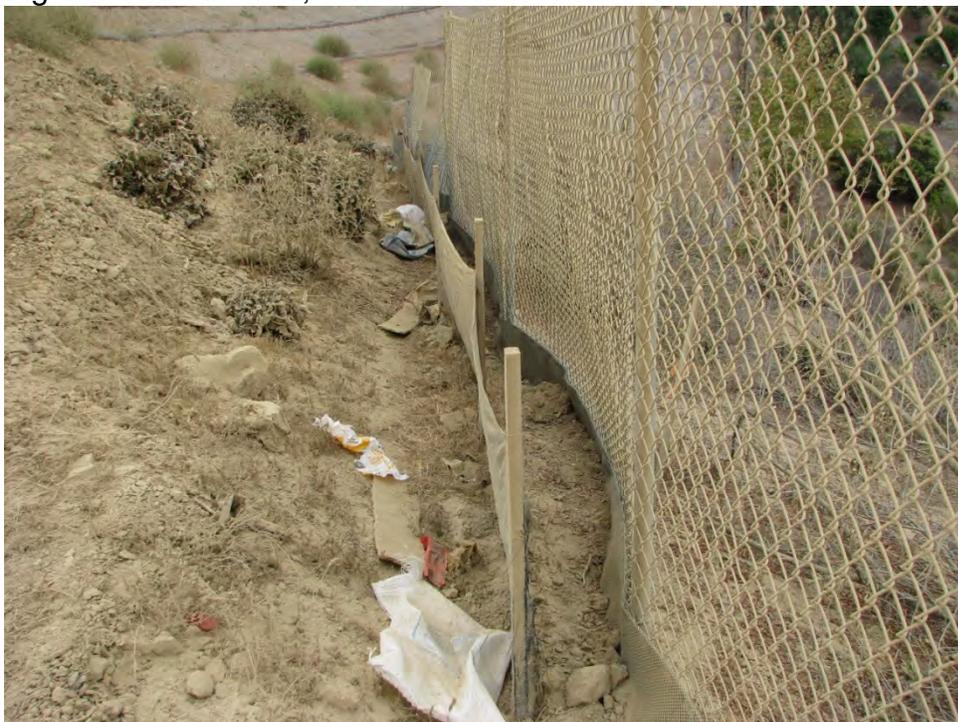
Figure 6. West perimeter; trash

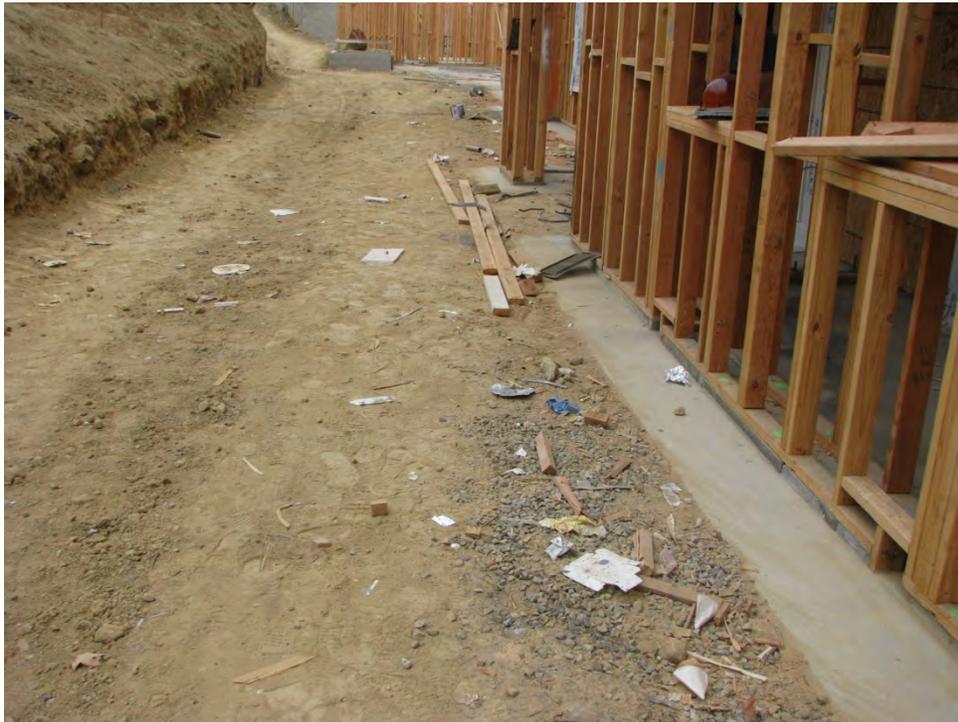
Figure 7. Site interior; trash

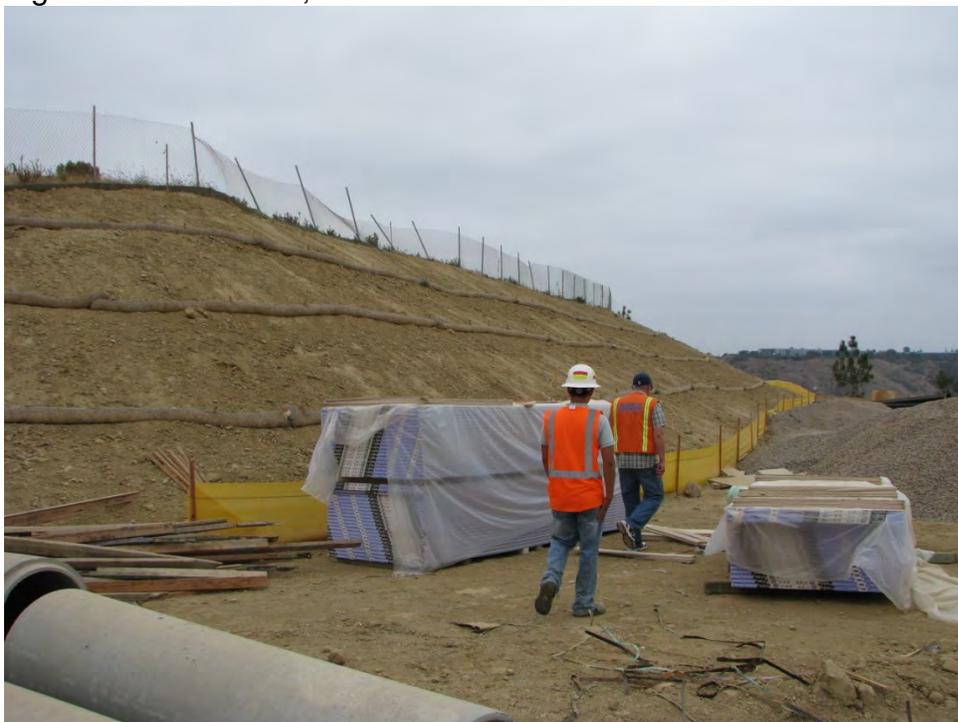
2. The site had inadequate erosion control and sediment control BMPs throughout the site.
3. The steep slopes on the east side of the site had fiber rolls and a silt fence at the toe of the slope. However, there was no erosion control. The slopes were bare and require erosion control BMPs because they are at risk for mobilization during a heavy rain (Figure 8).

Figure 8. Slope east side; bare soil

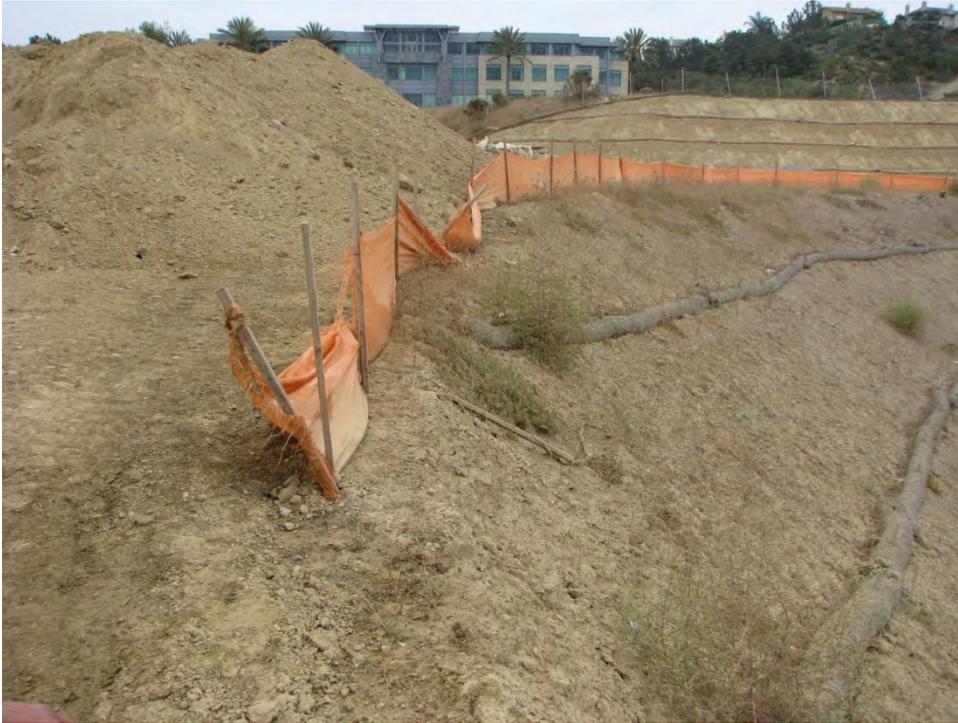
4. There is a stockpile located next to a steep slope. The silt fence between the stockpile and slope is in need of repair (Figures 9). Mr. Do was unaware of when the adjacent/downstream slope had been last sprayed with hydroseed.

Figure 9. Sediment stockpile with broken silt fence

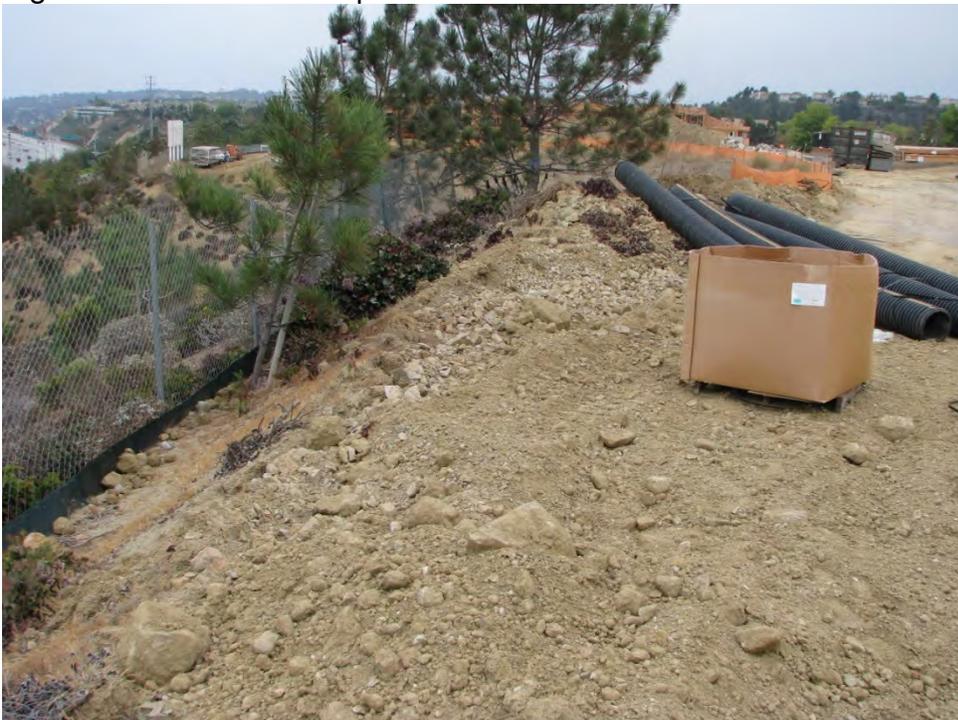
5. The site generally slopes towards the westerly direction. The perimeter controls along the west side were inadequate for containing the sediment within the construction site (Figures 10-12). There was evidence of a sediment discharge from the site and onto the adjacent downstream property (Figure 12).

Figure 10. Perimeter south west side

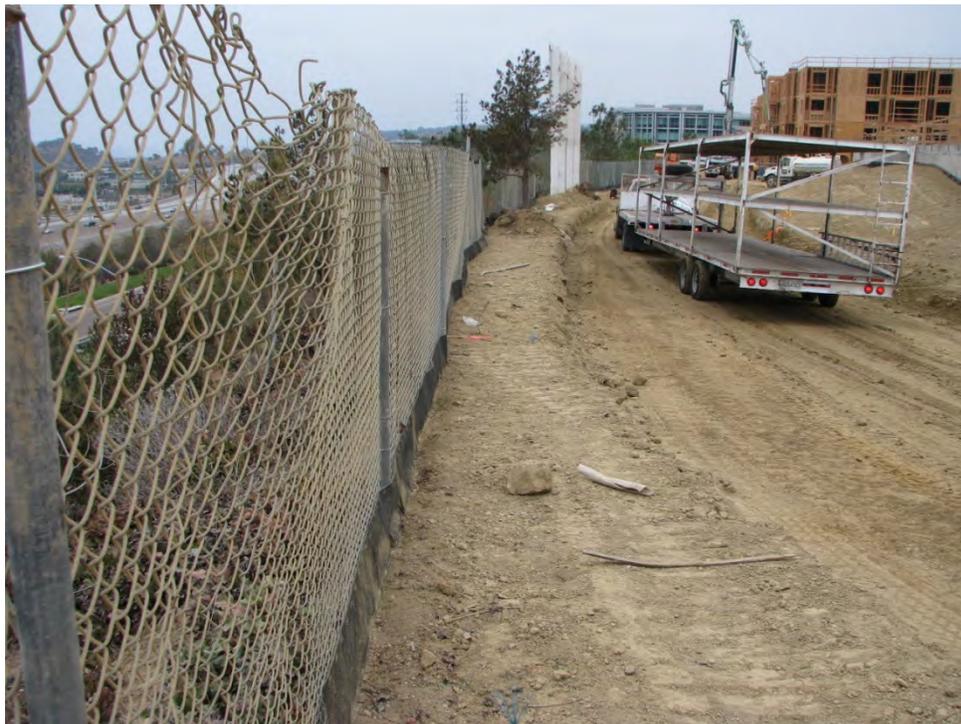
Figure 11. Perimeter west side

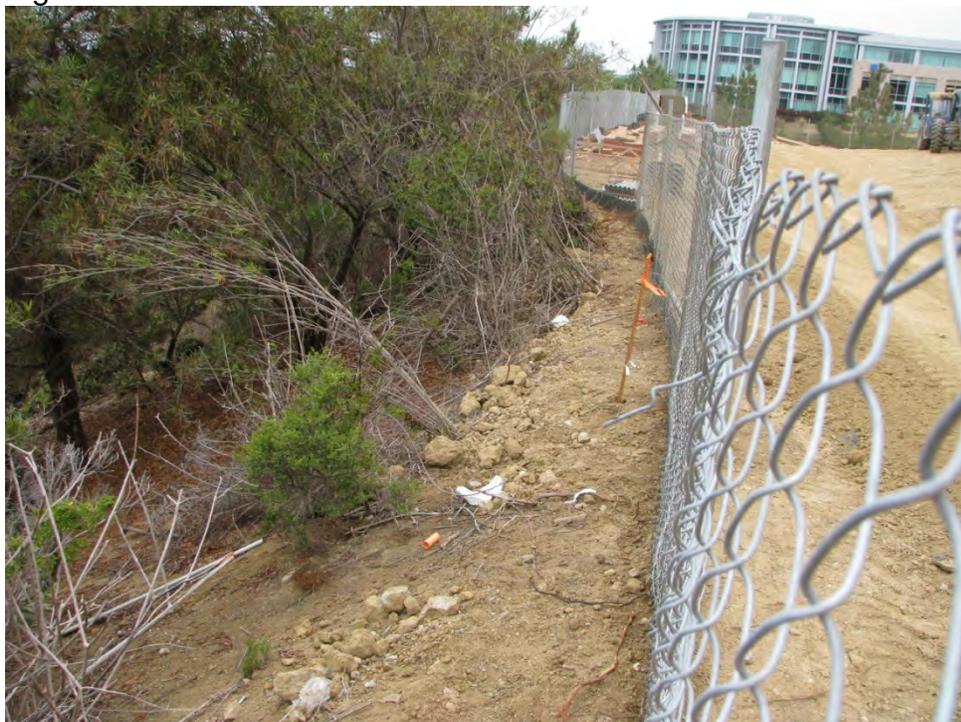
Figure 12. Sediment discharge outside site boundary

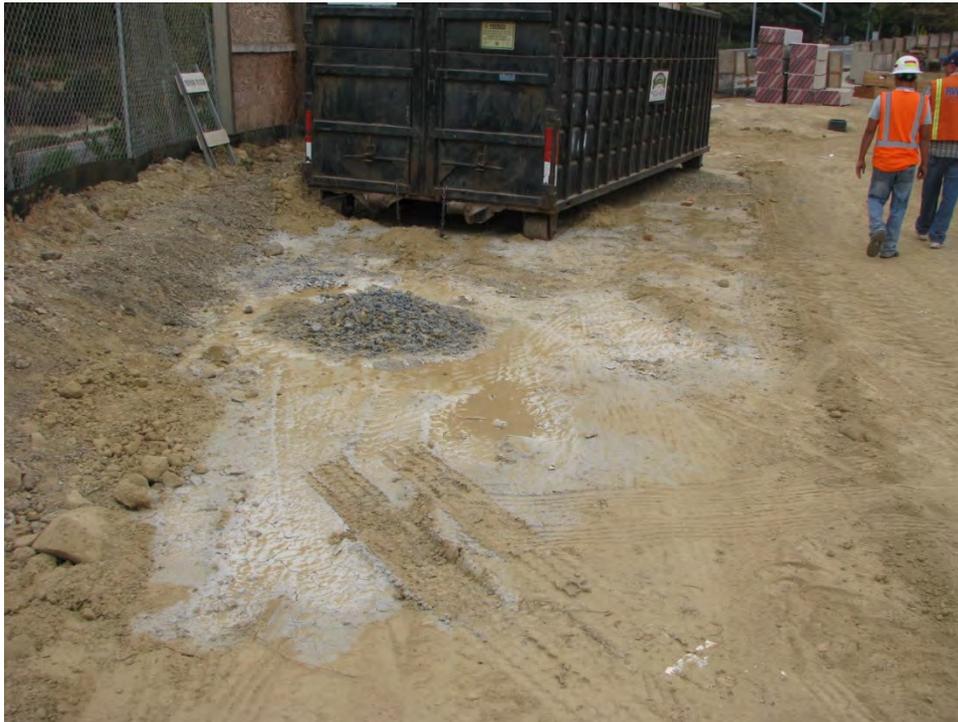
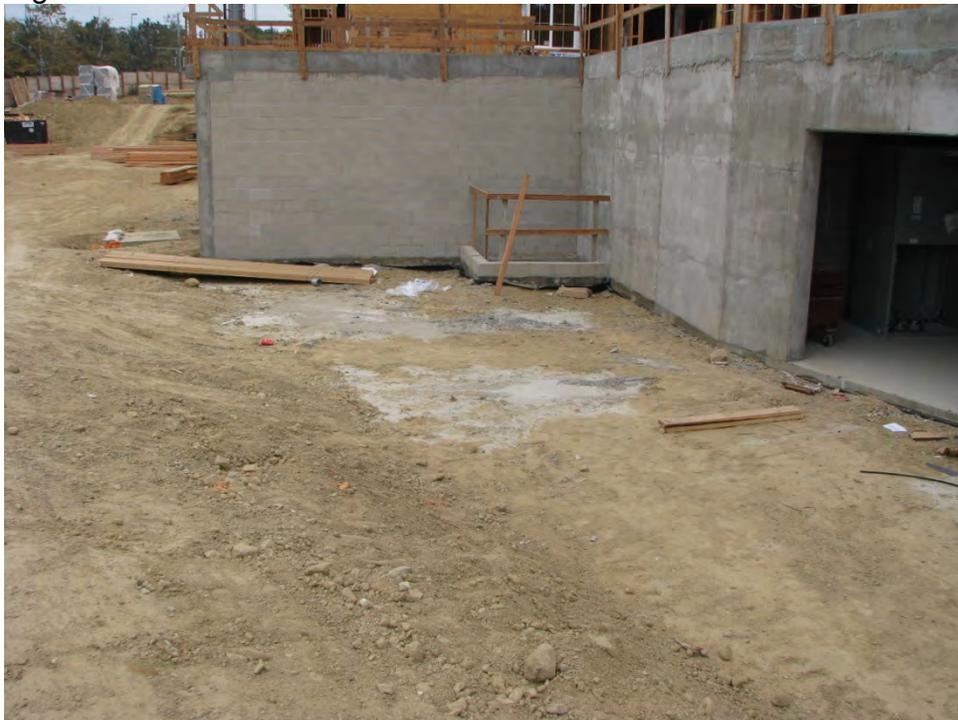
Figure 13. Concrete washout with no containment

Figure 14. Concrete washout with no containment

5. A designated concrete washout area for the site must be established and used. Concrete must not be allowed to come into contact with bare ground.
6. Site entrance/exit BMPs are inadequate and require maintenance.

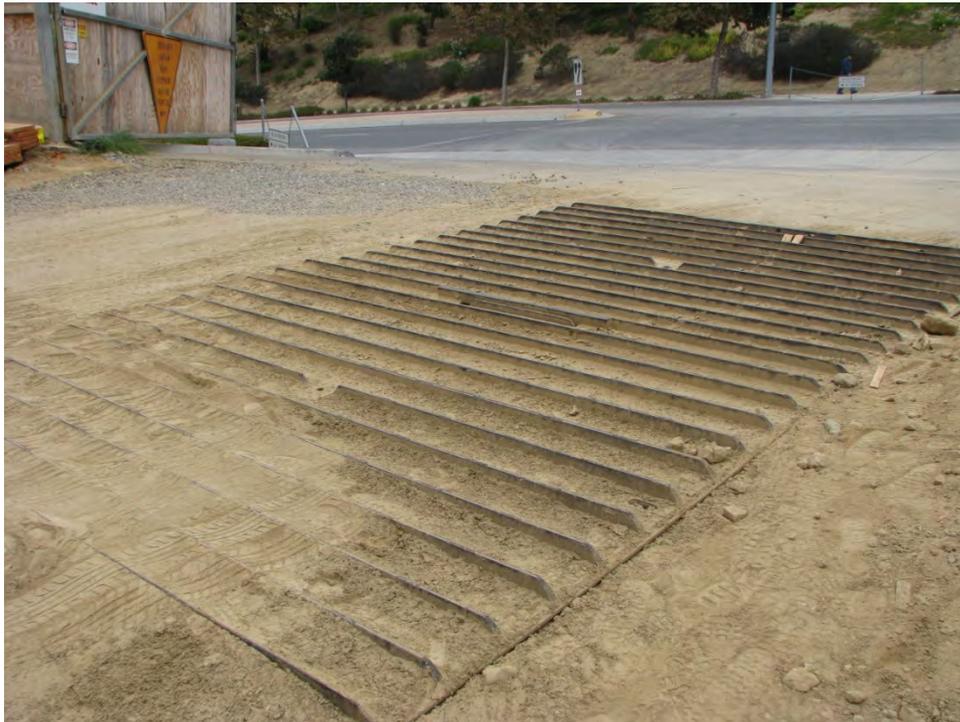
Figure 15. Shaker plates north entrance

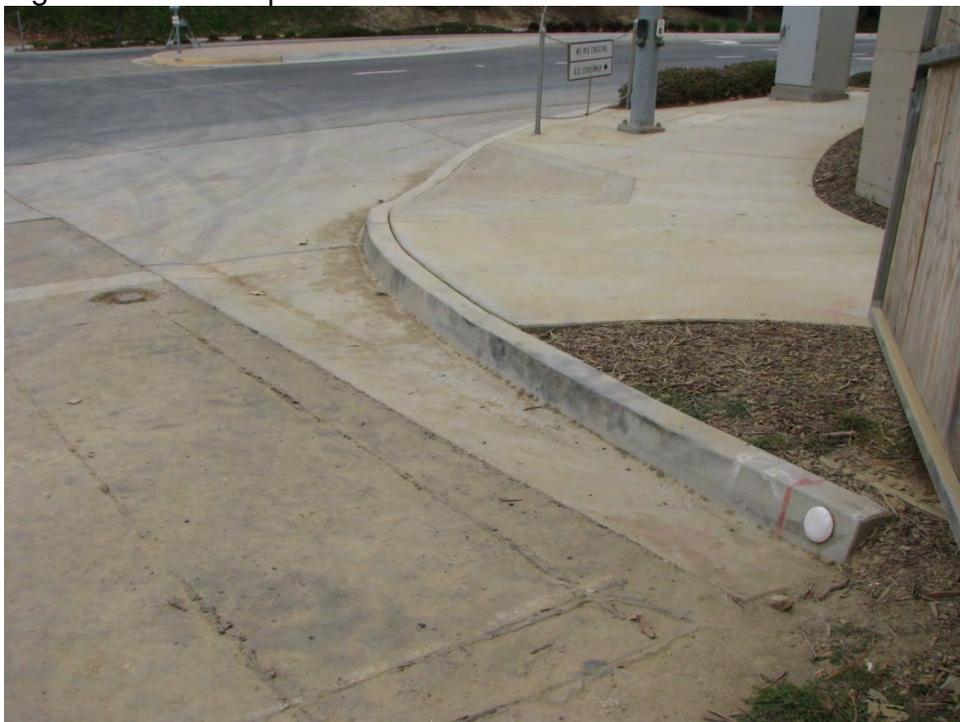
Figure 16. Public street outside construction site

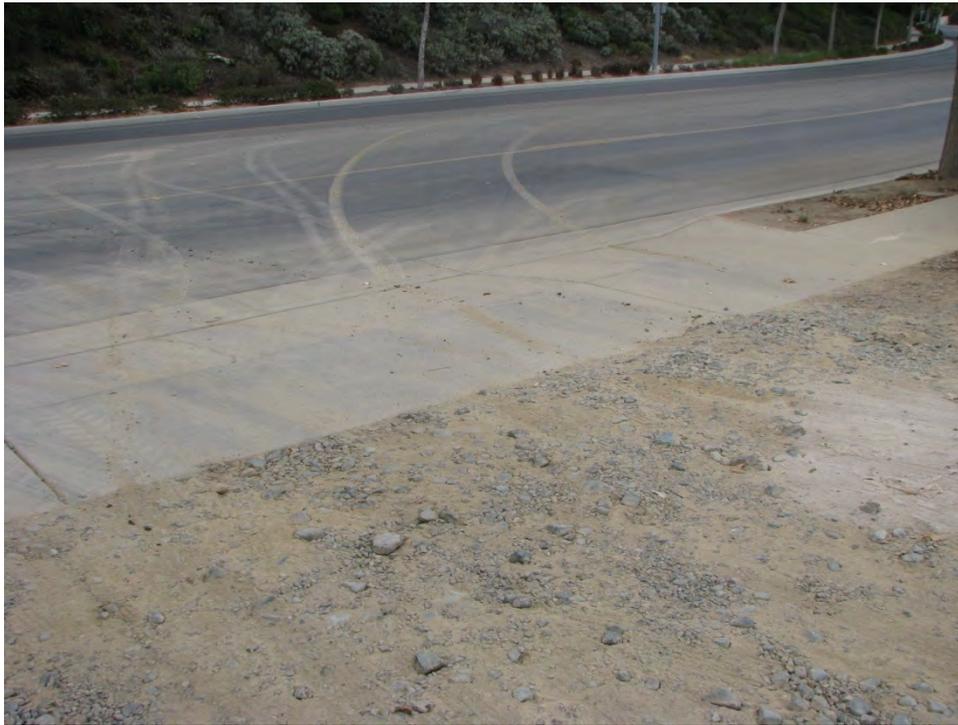
Figure 17. Gravel at south entrance

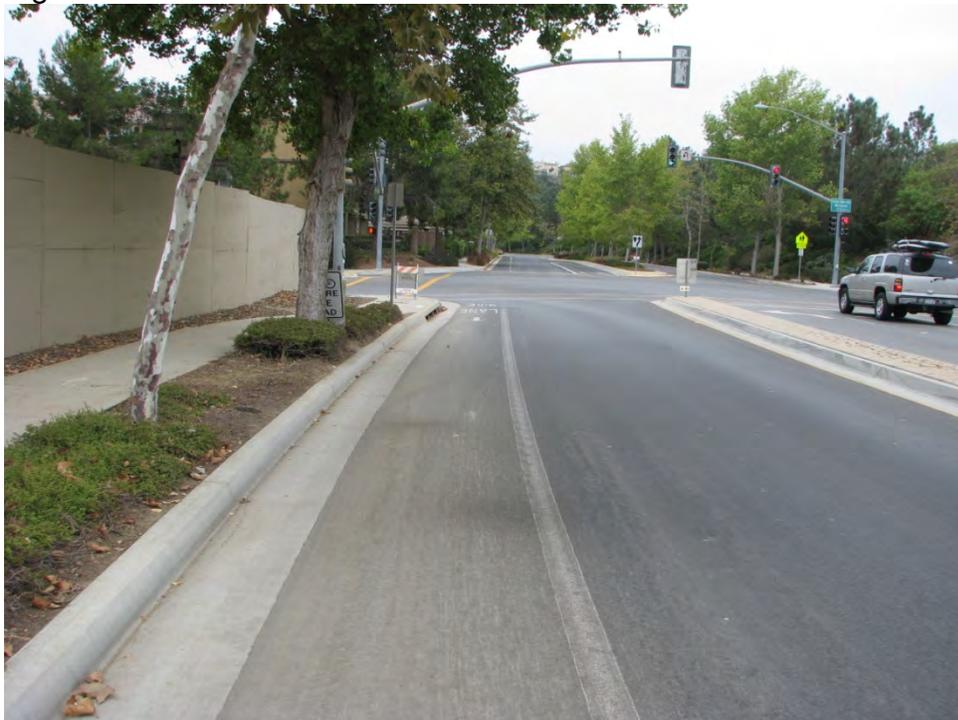
Figure 18. Nearest storm drain downstream; no inlet protection

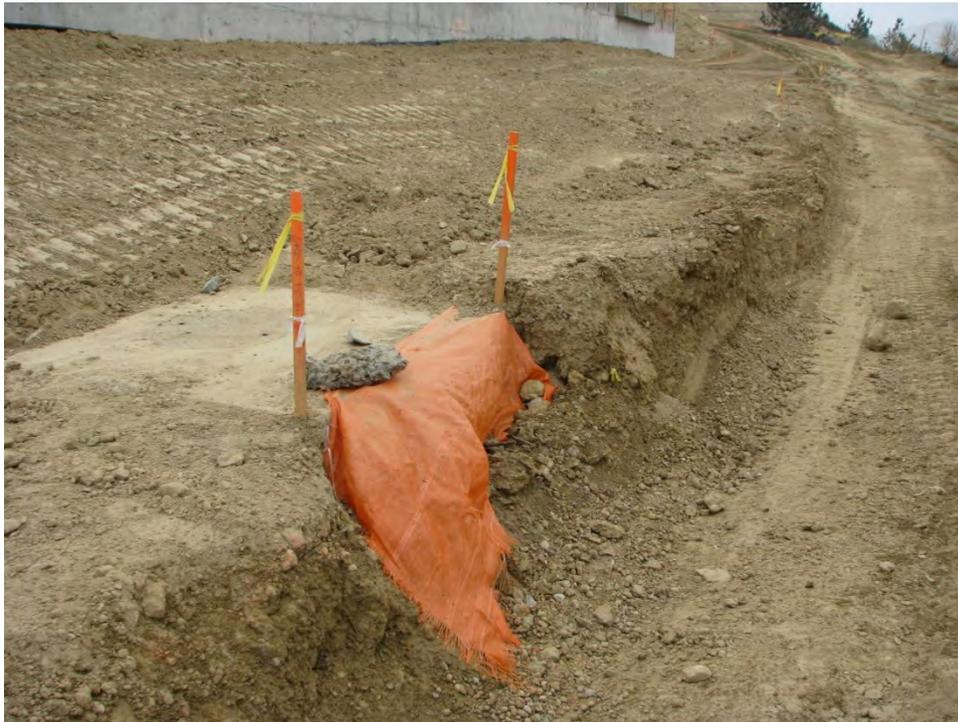
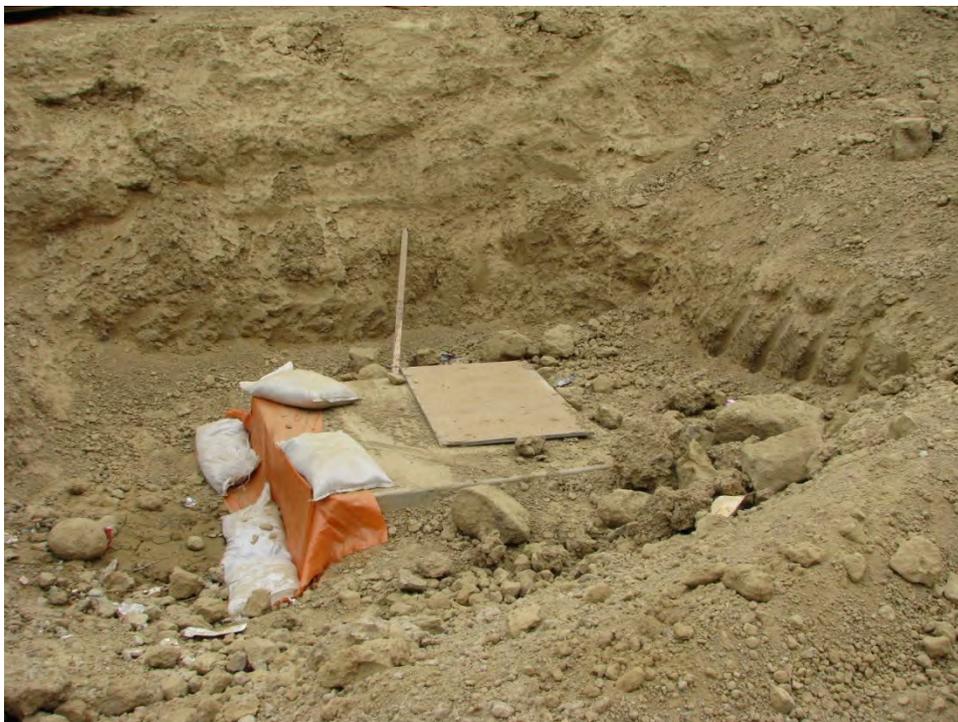
Figure 19. Live storm drain covered with permeable fabric

Figure 20. Live storm drain covered with permeable fabric

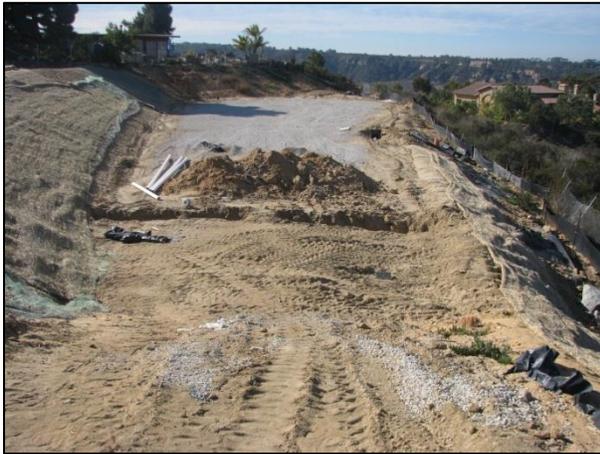
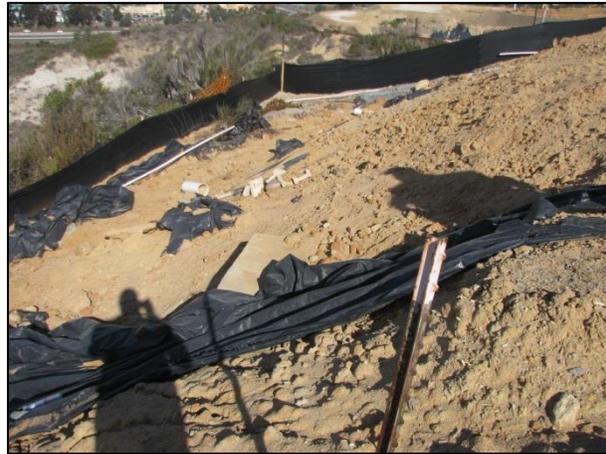
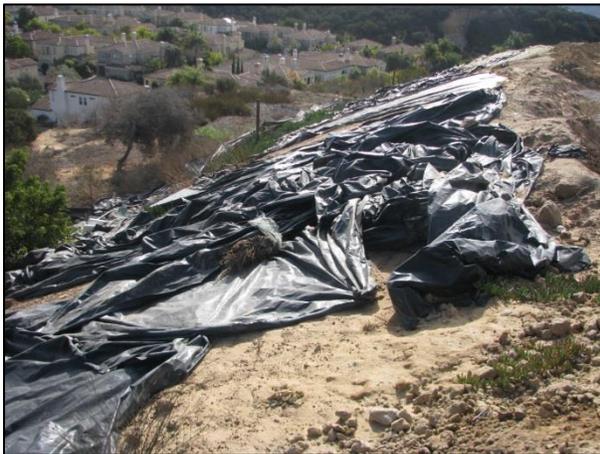
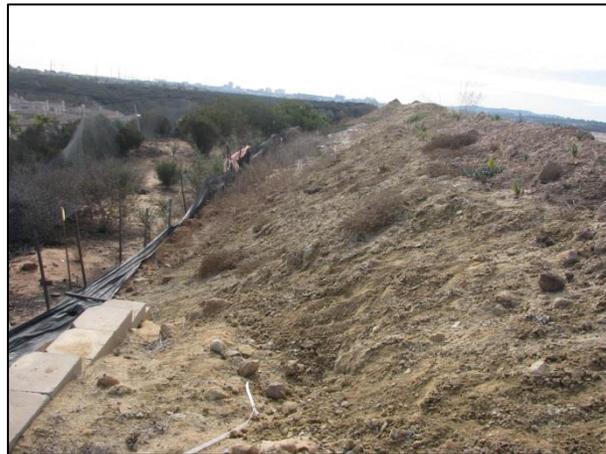
- a. Several slopes located in the interior and exterior of the site appeared to be inactive and had inadequately implemented, inadequately maintained, or did not have erosion control BMPs to provide effective soil cover and stabilization (see Photos 1-4);

- d. Linear sediment controls were not observed along the toe of slopes and grade breaks of exposed slopes, as required for Risk Level 2 sites (see Photos 1-4)

- e. Silt fence was observed around the perimeter of the site, but did not appear to be adequately maintained to sufficiently control erosion and sediment discharges from the site (see Photos 4 and 7); and

Photos 1-4 show lack of erosion and sediment control BMPs required to be implemented by Risk Level 2 dischargers for slopes throughout the site.

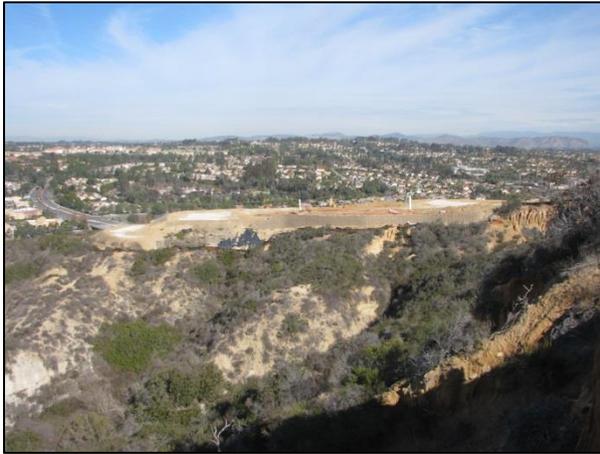
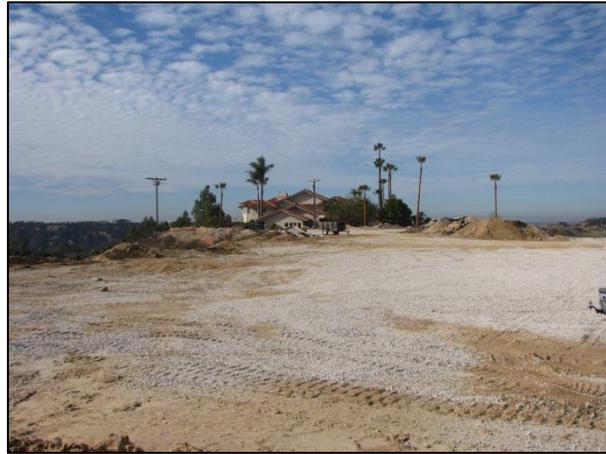
- b. Most of the building pads appeared to be inactive and had a layer of gravel, but no erosion control BMPs (e.g. soil binder, bonded fiber mulch) providing effective soil cover were observed (see Photos 1, 5 and 6);

Photos 5-6 show lack of erosion control BMPs implemented to provide effective soil cover for building pads that appears to be inactive at the site (also see Photo 1).

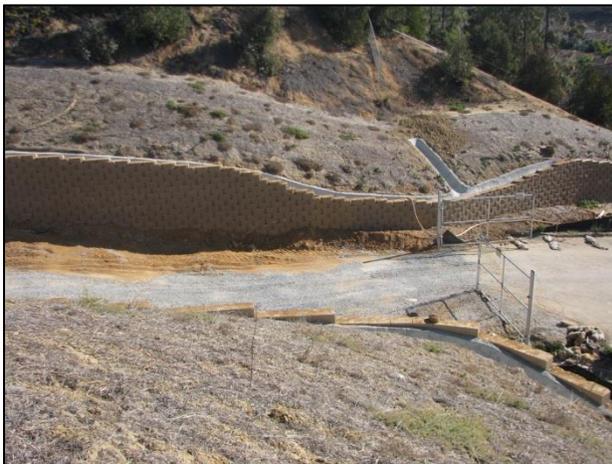
Photo 7 shows the entrance/exit to site lacking adequate stabilization to control erosion and sediment discharges from the site, and lack of BMPs to prevent tracking of sediment from the site.

5. Refresh or replace rock and/or place additional BMPs (e.g., shaker plate or rumble strip, stone pads, concrete or steel wash racks) at entrance/exit to site to prevent offsite vehicle tracking of sediment;

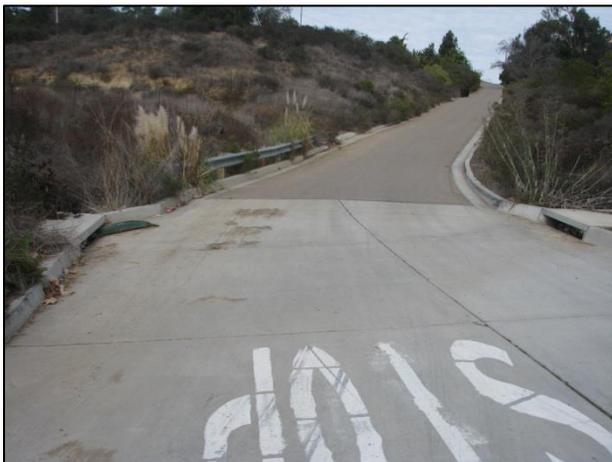
9. Storm drain inlets were inadequately protected, and evidence of sediment in surface runoff discharged from the site leading to the inlets was observed (see Photos 8).

Photo 8 shows lack of BMPs to protect storm drain inlets, with evidence of sediment in surface runoff discharged from the site leading to the inlets.

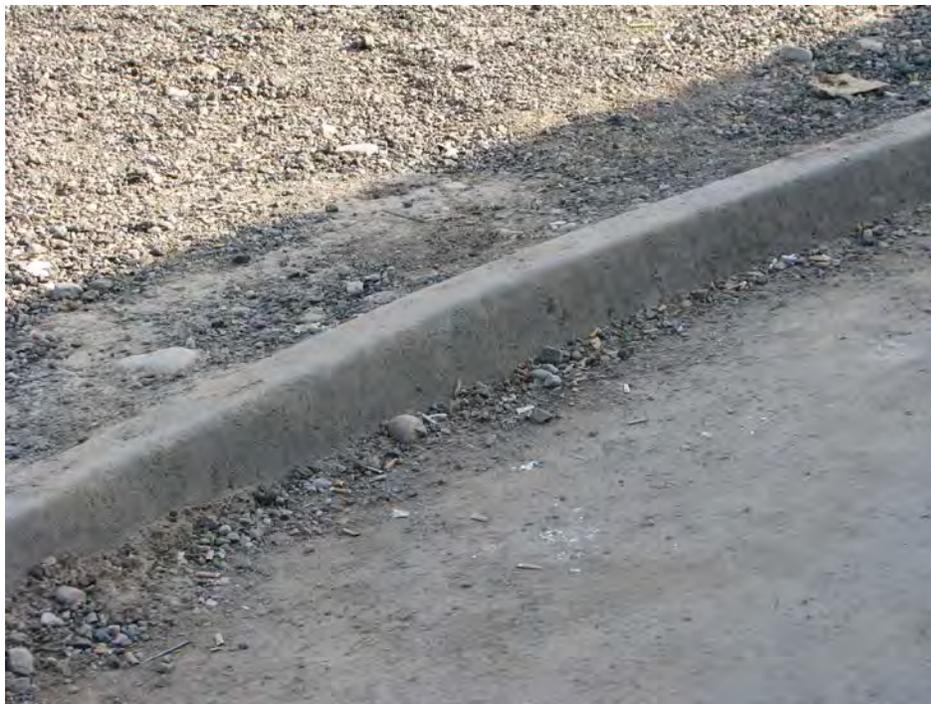
1. The site was littered with cigarette butts, trash, debris, and other construction-related waste throughout. (See Figures 1-4, 14-25).
2. None of the finished curbs within the site had sediment control BMPs (such as silt fence) installed. As a result, the streets were covered in sediment (Figures 1, 3, 16-22).
3. There were no sediment control BMPs at one construction site exit/entrance located on Mira Lee Way, and sediment had been tracked into the street (Figure 5).
4. There was an uncovered stockpile, although it appeared to be active (Figure 6).
5. Two concrete wash-out bins were leaking, and waste material discharged to the surrounding the soil (Figures 7-8).

Figure 1. Near trailer; cigarette butts

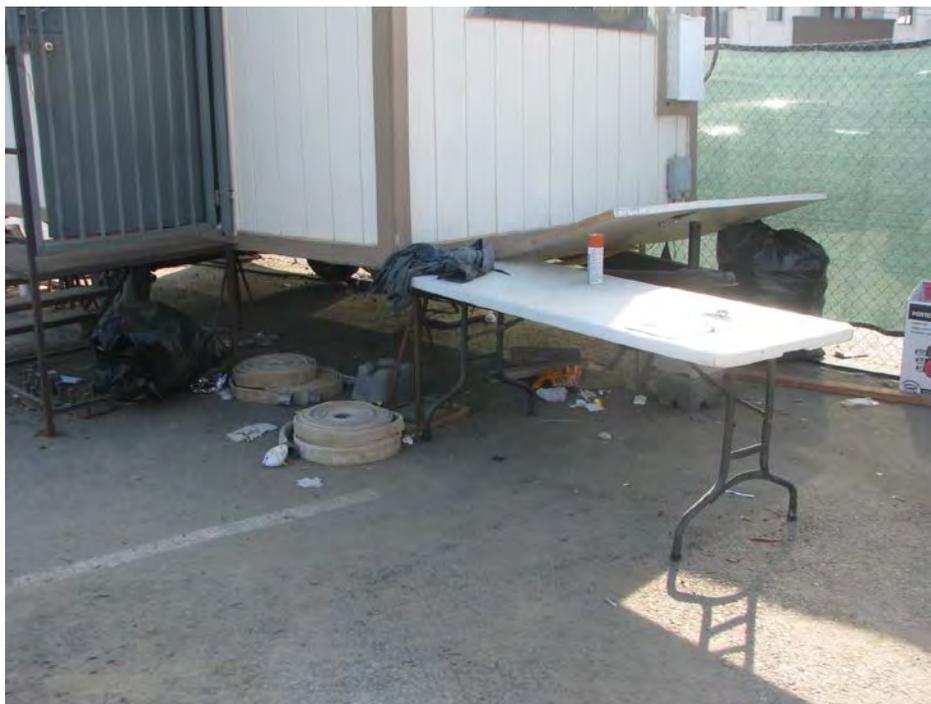
Figure 2. Trailer, debris and trash

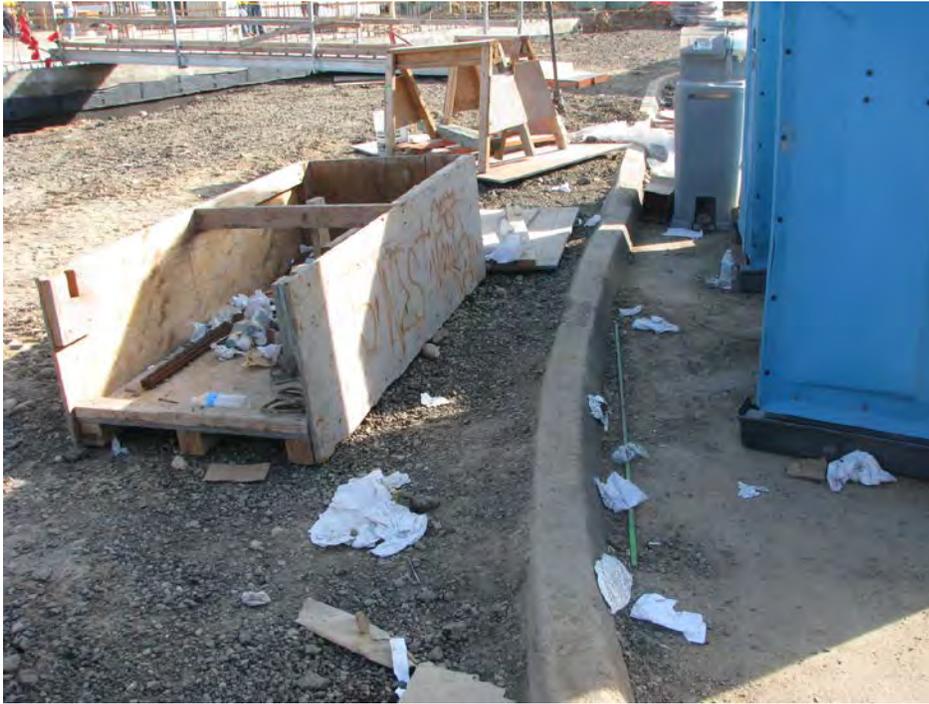
Figure 3. Site interior; trash

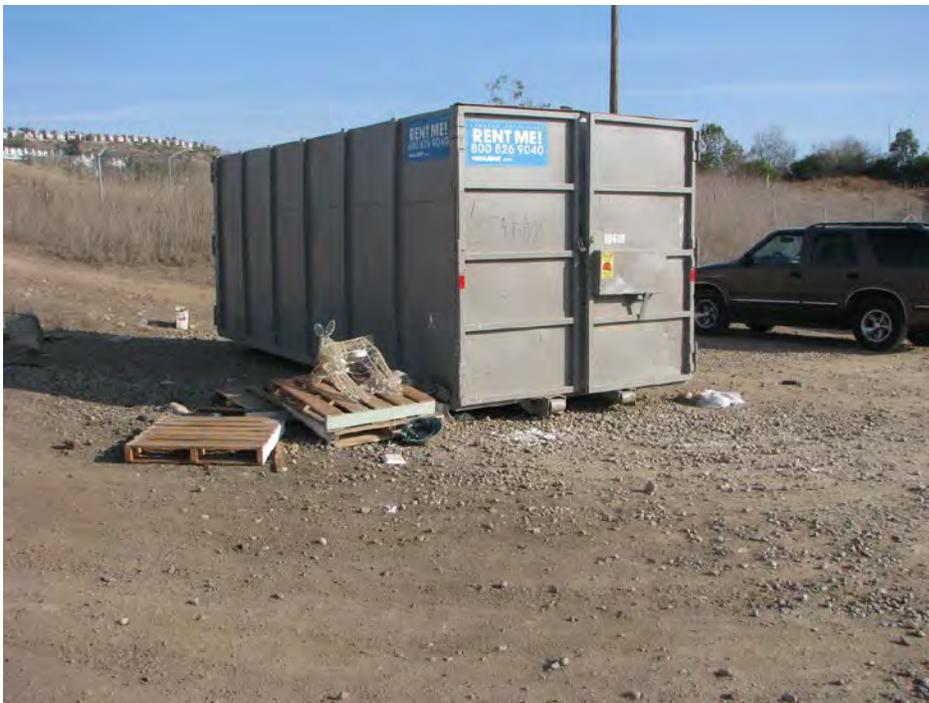
Figure 4. Site interior; construction debris

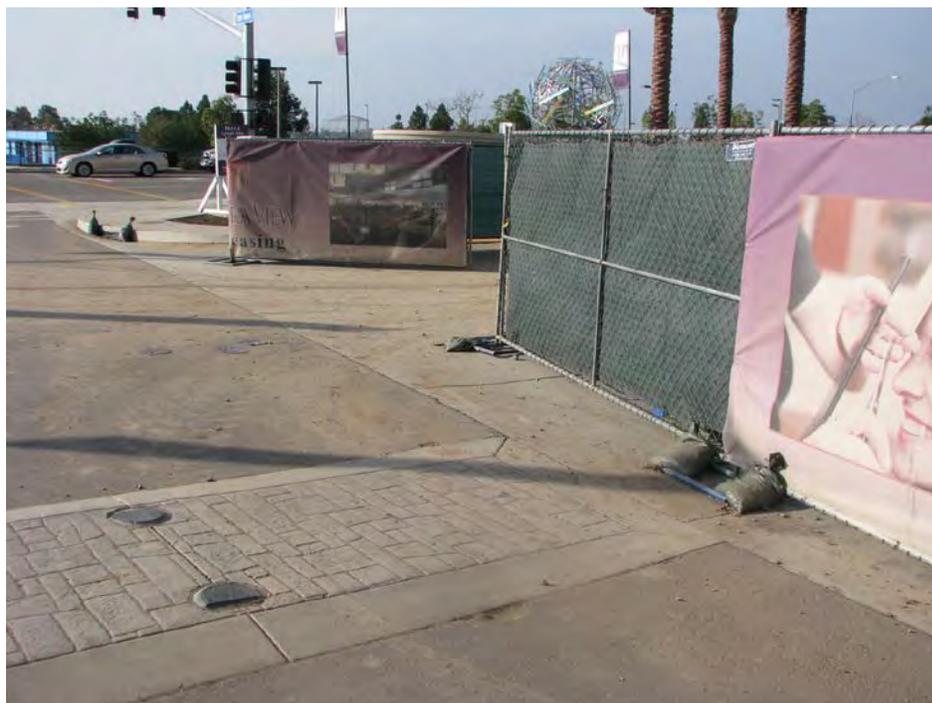
Figure 5. South-facing construction entrance; no BMPs; sediment tracking onto street

5. The concrete washout BMPs must be fixed or replaced to prevent leaks. Concrete waste must not be allowed to come into contact with bare ground.
6. Site entrance/exit BMPs are required.

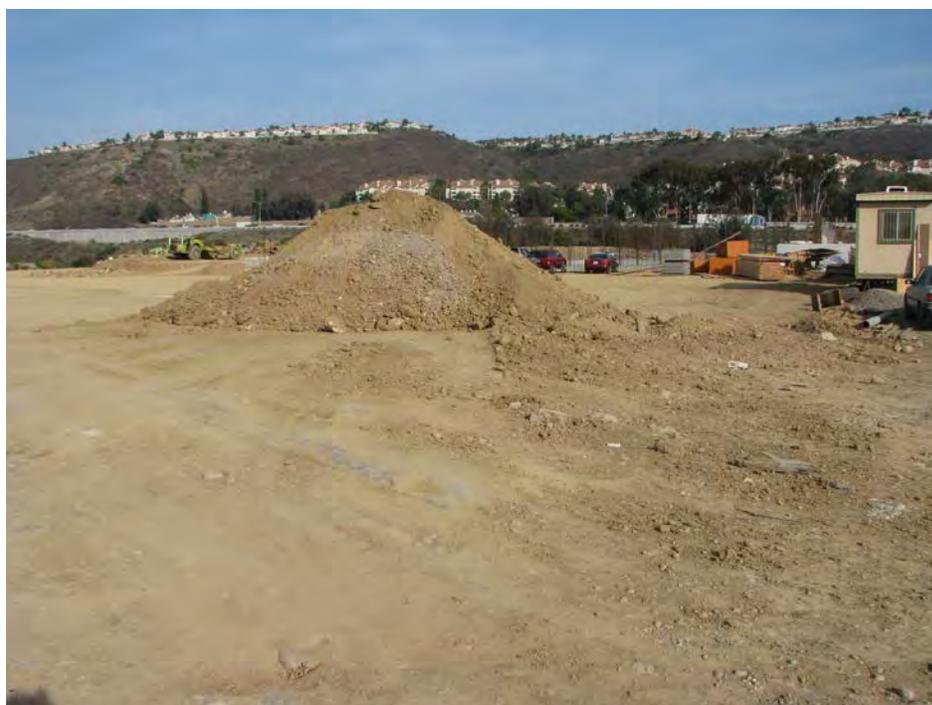
Figure 6. Sediment stockpile

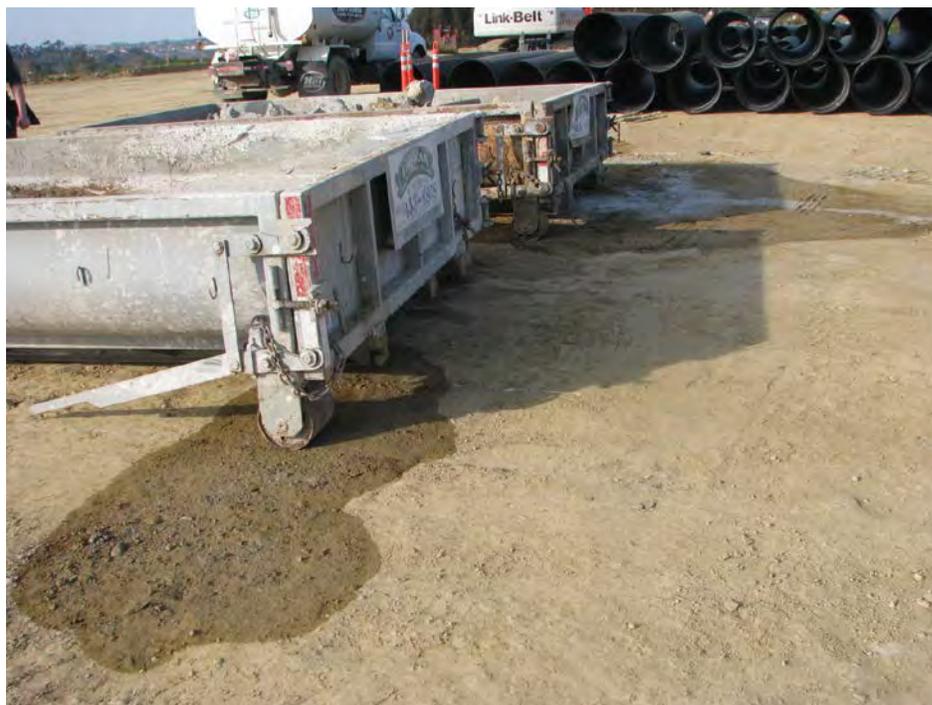
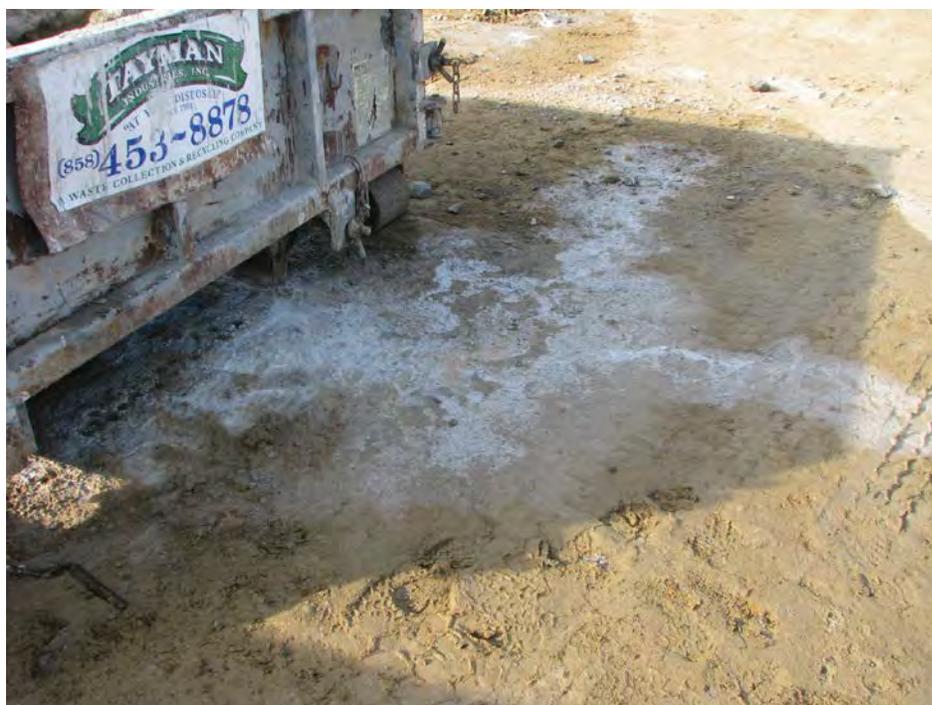
Figure 7. Leaking concrete washouts

Figure 8. Concrete staining on soil from leaking washouts
