Subject: Notice of Violation No. R9-2014-0024, City of San Diego Construction Management Program, NPDES Order Nos. R9-2013-0001 and R9-2007-0001, Municipal Storm Water Permits

**NOTICE OF VIOLATION
No. R9-2014-0024**

Facility: Torrey Hills Unit 19
Inspection Date: 09/20/2013

Facility: Estates at Costa del Mar
Inspection Date: 1/7/2014

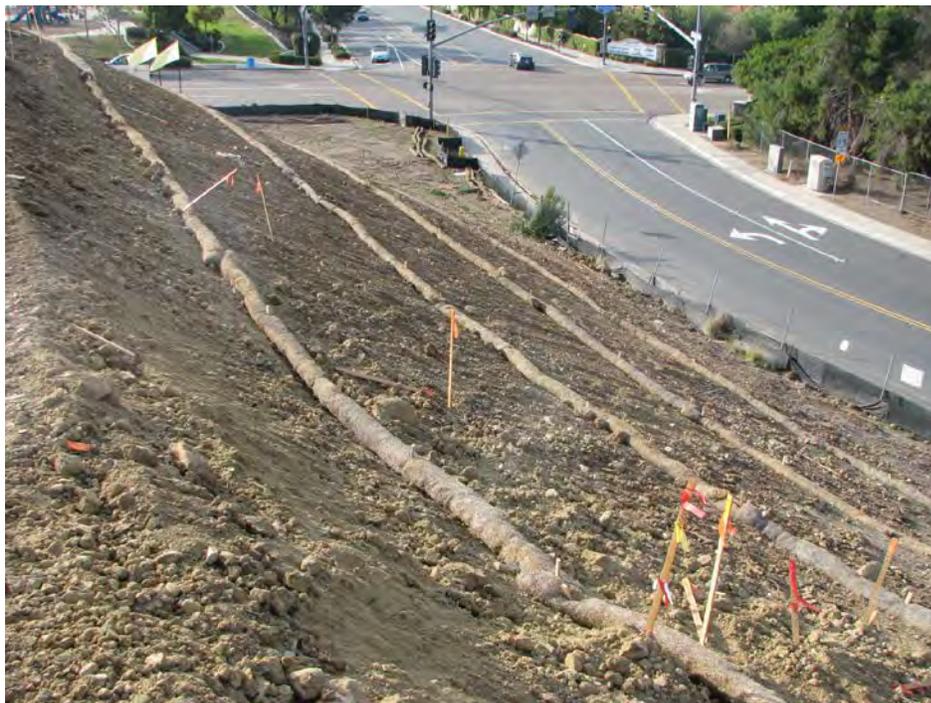
Figure 9. Slope on north side with no erosion control

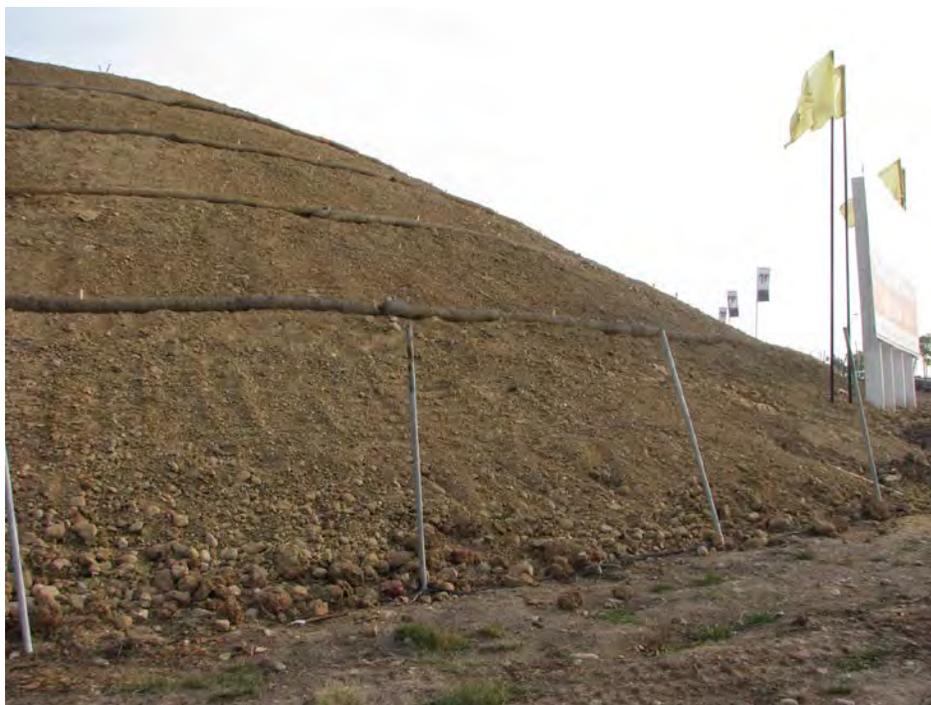
Figure 10. Slope is 2:1 Horizontal: Vertical according to SWPPP

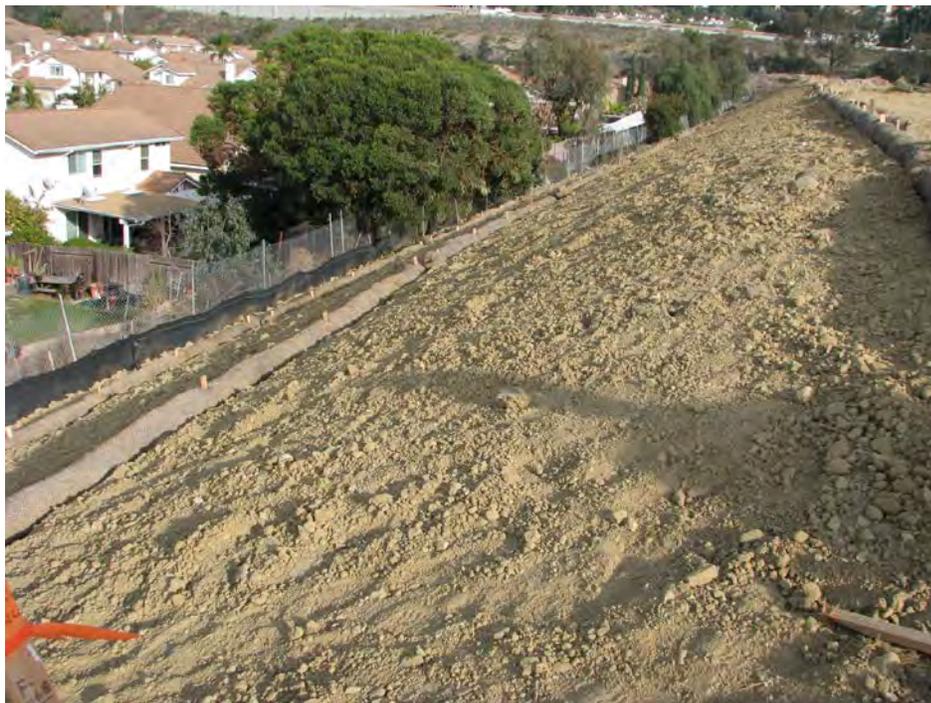
Figure 11. North slope looking easterly

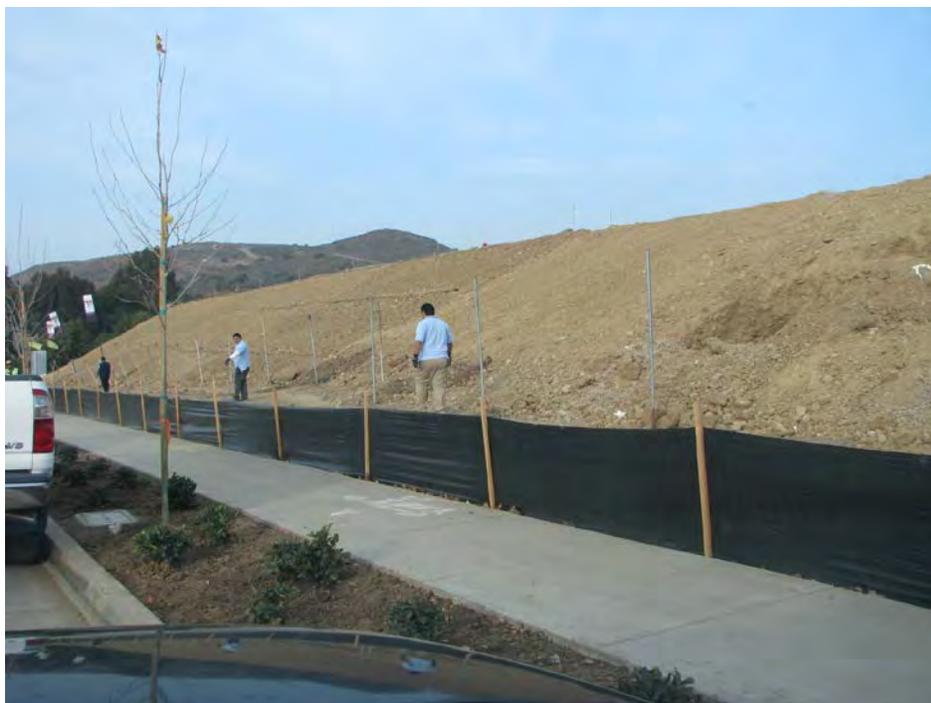
Figure 12. Slope on west side of property

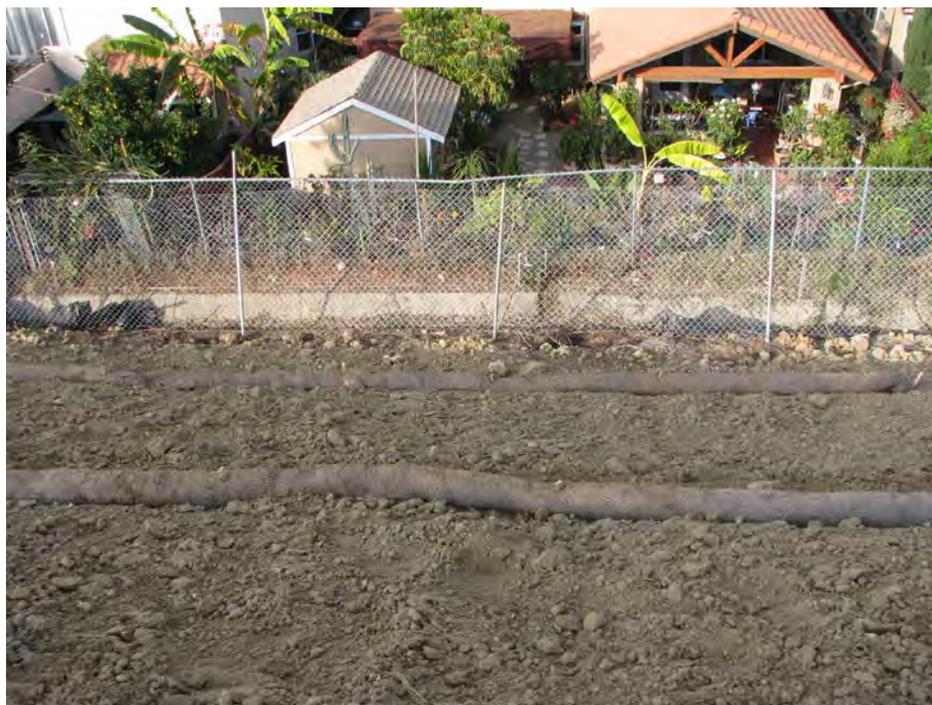
7. The silt fence along the north side of the property had fallen and was in need of repair (Figure 13).
8. Sediment control BMPs throughout the site need replacement or had not been maintained. Examples include broken gravel bags (Figure 22).

Figure 13. Damaged silt fence

3. All sediment control BMPs must be adequately maintained. The silt fence on the north side of the property requires replacement.
4. Sediment control BMPs such as silt fence should be installed at finished curbs to prevent sediment from reaching the streets.

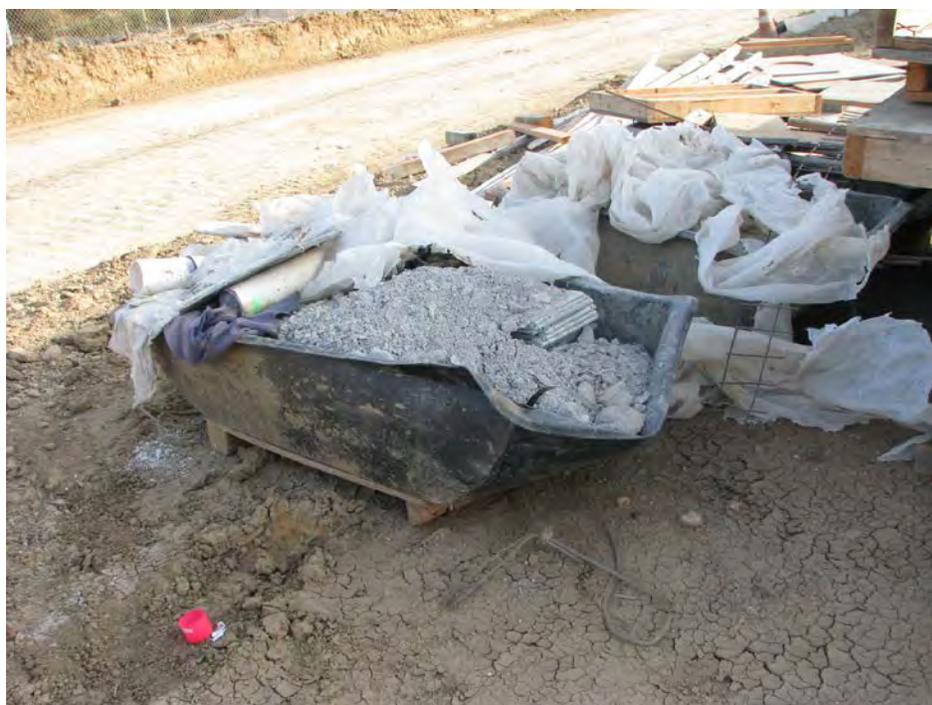
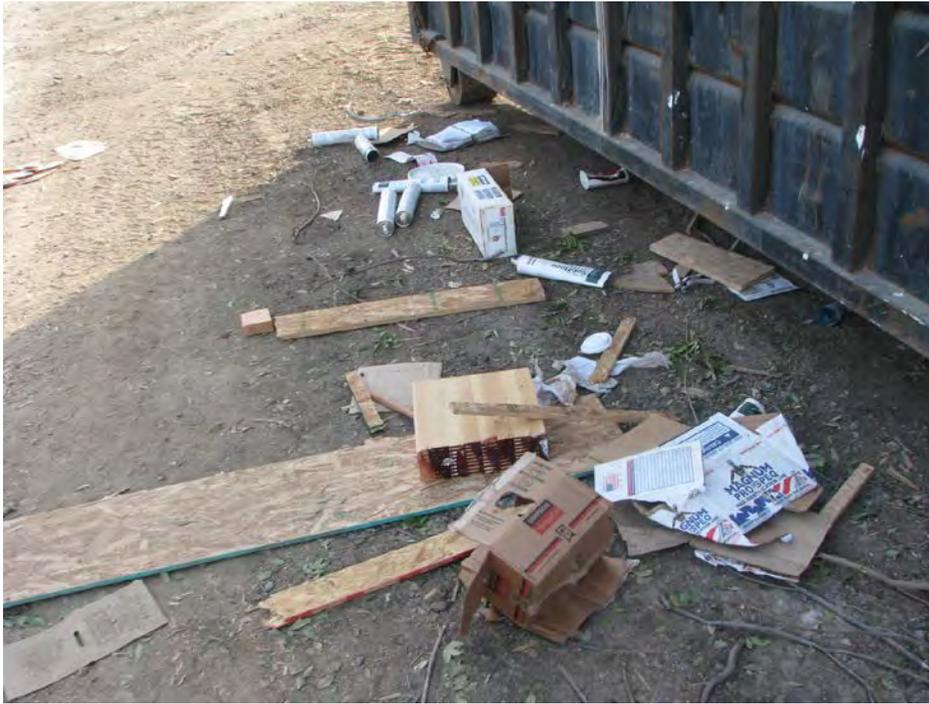
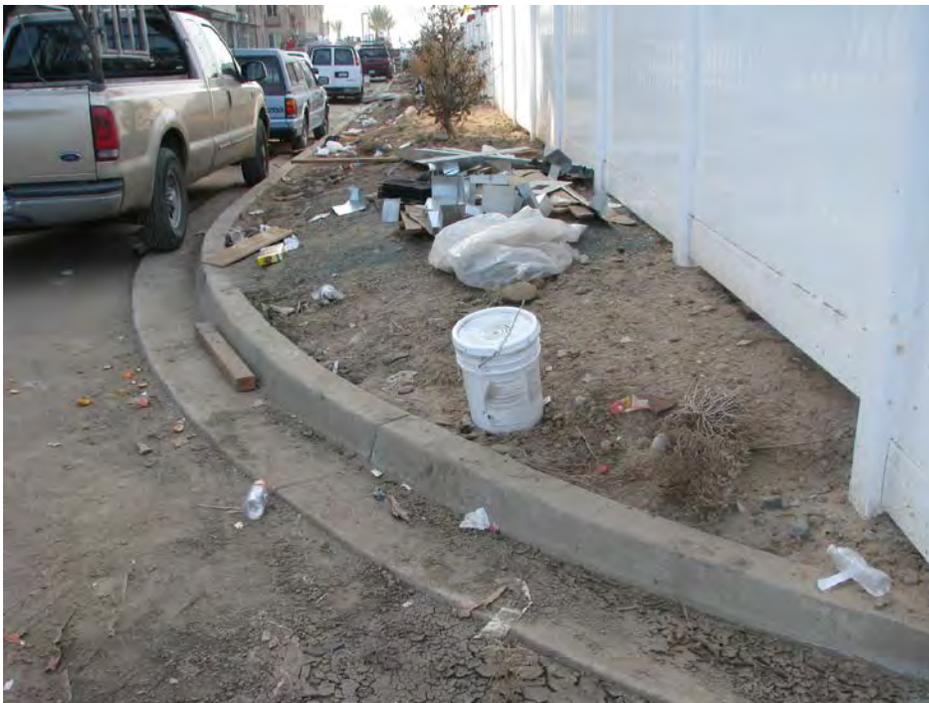
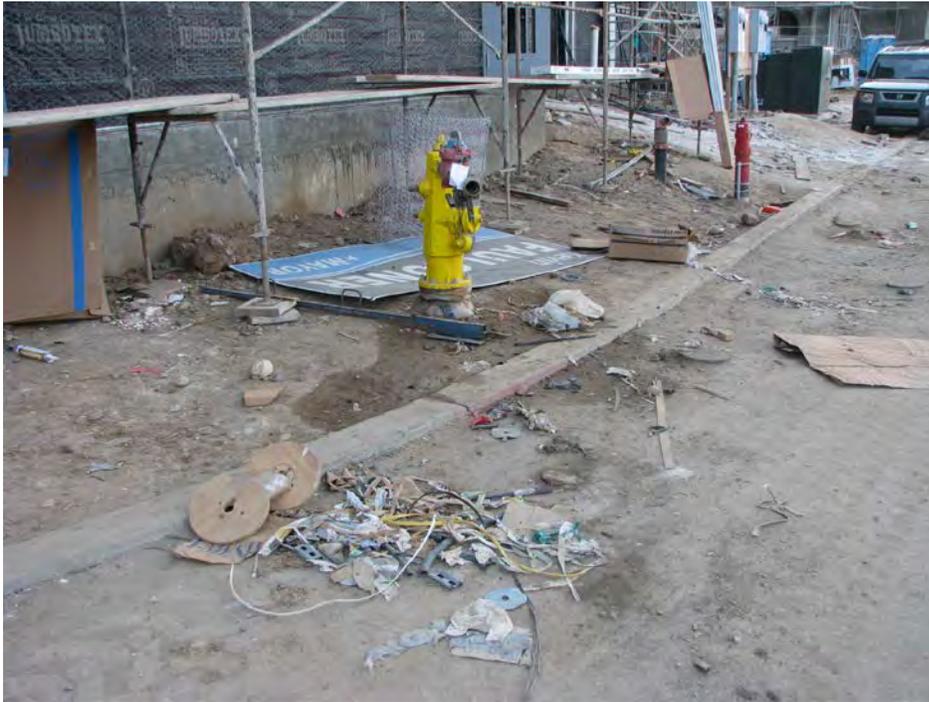
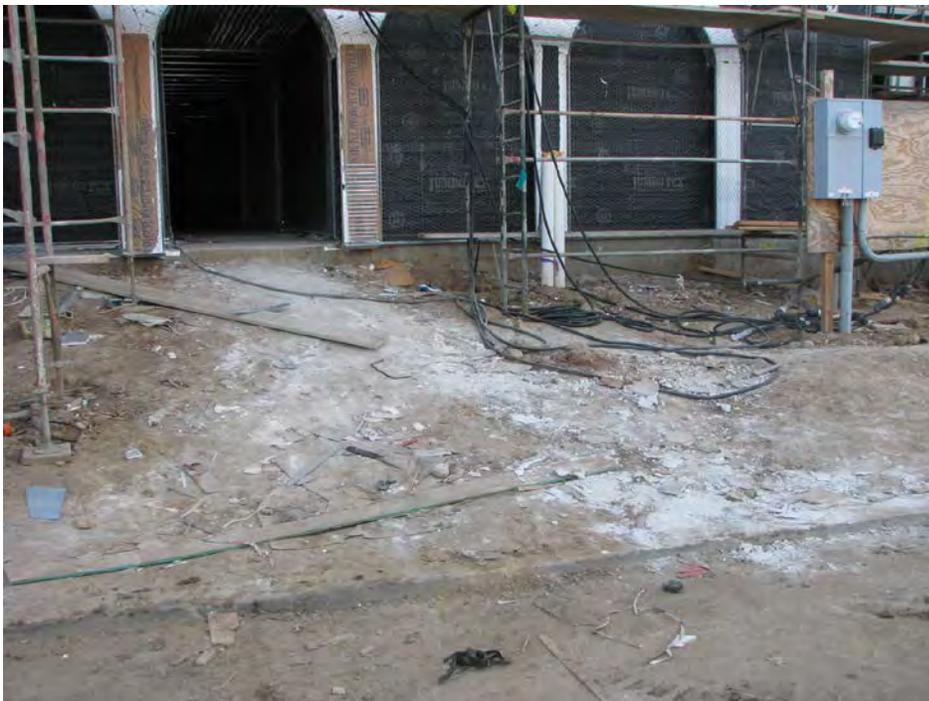
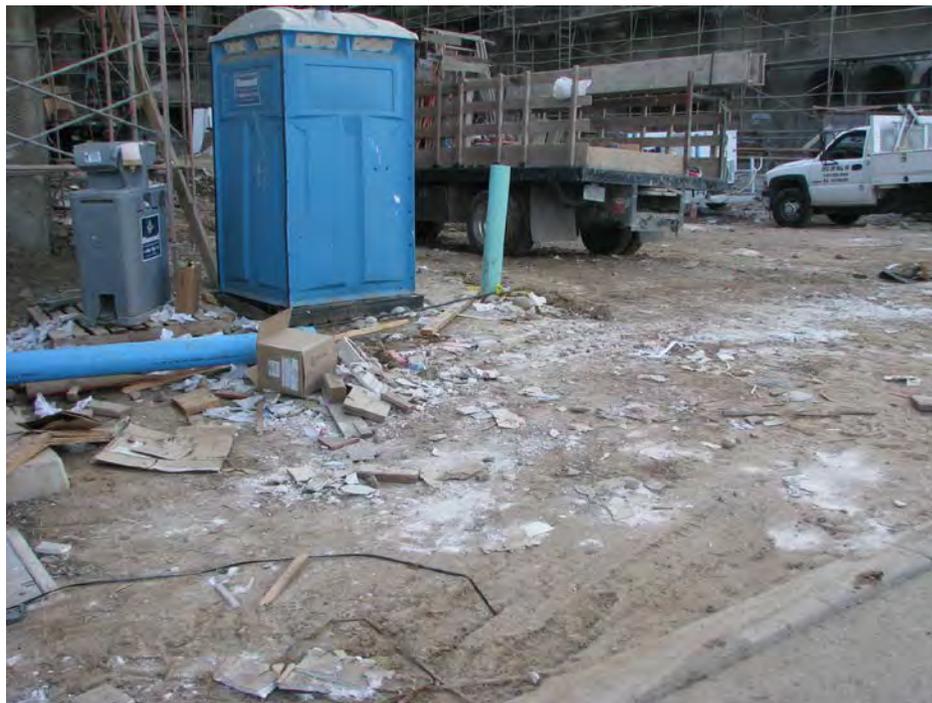
Figure 14. Construction debris

Figure 15. Construction debris

Figure 16. Construction debris

Figure 17. Construction debris

Figure 18. Construction debris

Figure 19. Construction debris

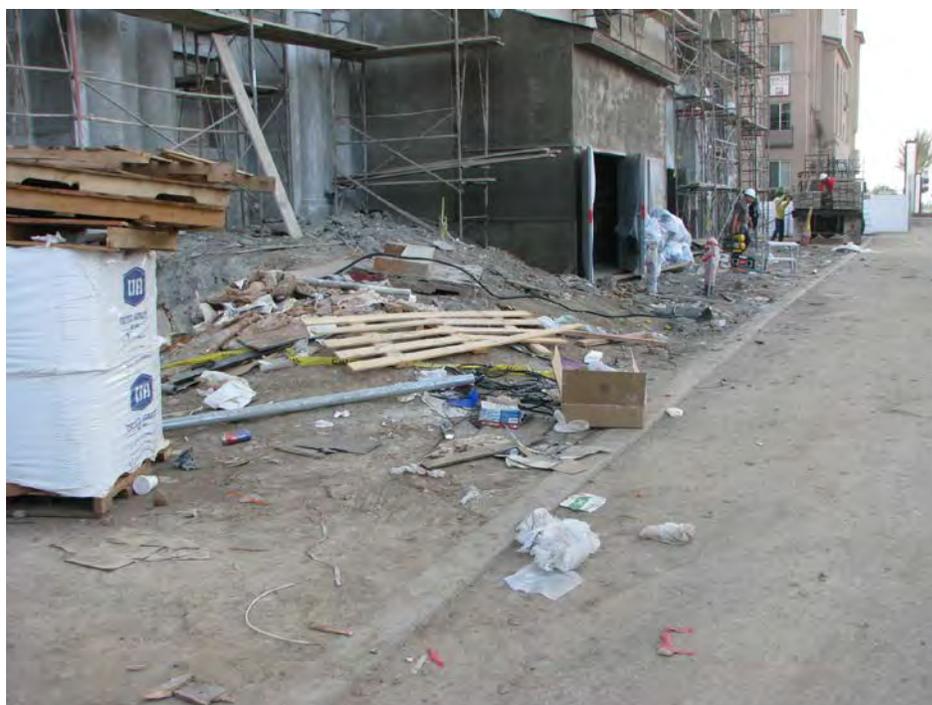
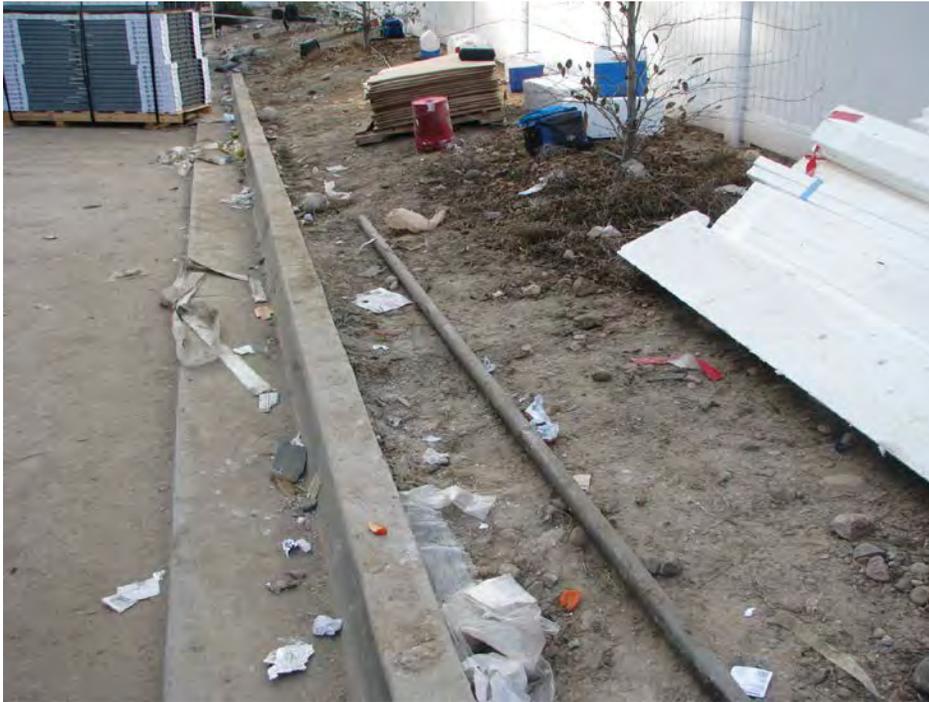
Figure 20. Construction debris

Figure 21. Construction debris

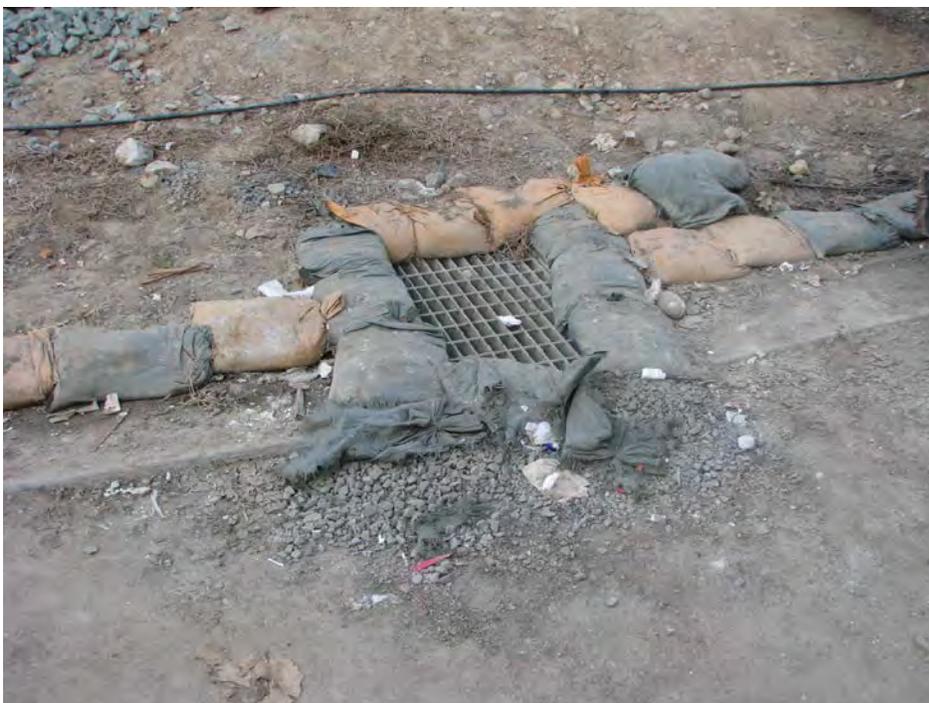
Figure 22. Broken gravel bags

7. Storm drain inlets within the construction site require protection to prevent sediment, trash, and construction debris from entering.
8. Gravel bags that have been broken need replacing.

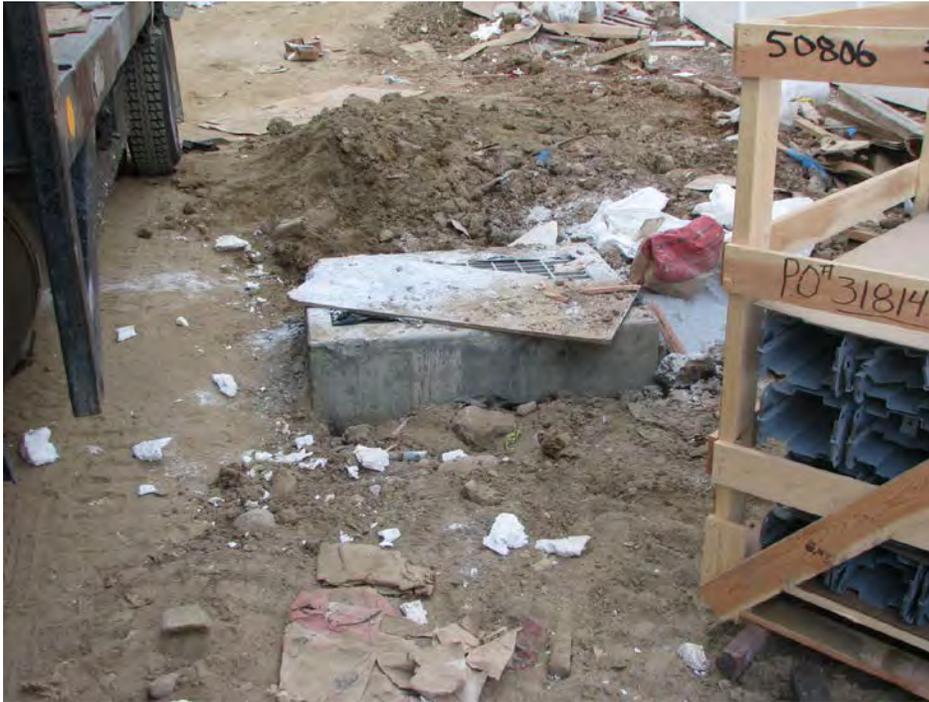
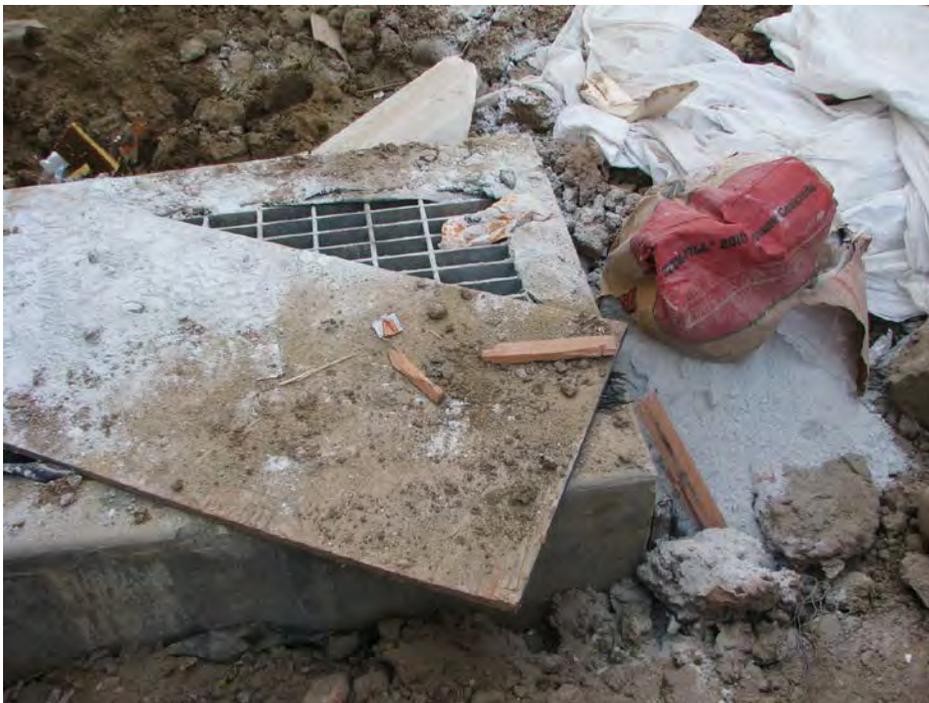
9. Mortar mix and other construction wastes had entered an unprotected inlet (Figures 23-24).
10. Several chemical containers were found throughout the site without secondary containment or other proper storage practices (Figure 25).

Figure 23. Storm drain littered with construction debris

Figure 24. Storm drain littered with construction debris

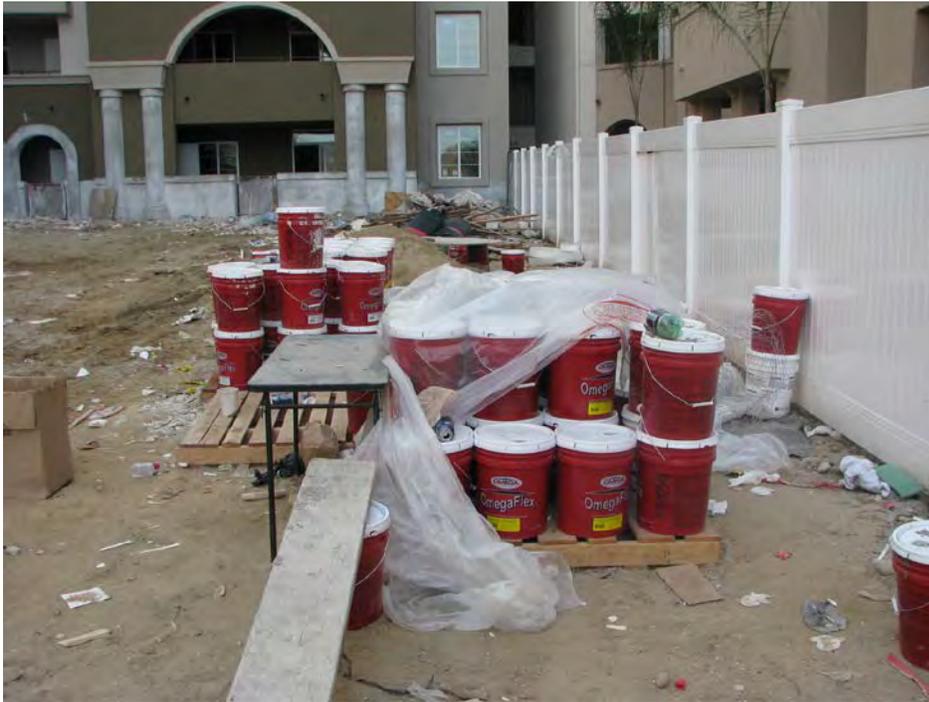
Figure 25. Improperly stored chemicals
