STATE WATER RESOURCES CONTROL BOARD
DIVISION OF WATER RIGHTS

**NORTH COAST WATERSHED
RESERVOIR INVESTIGATION**

Reservoir ID UN000139

Date of Inspection: October 16, 2013

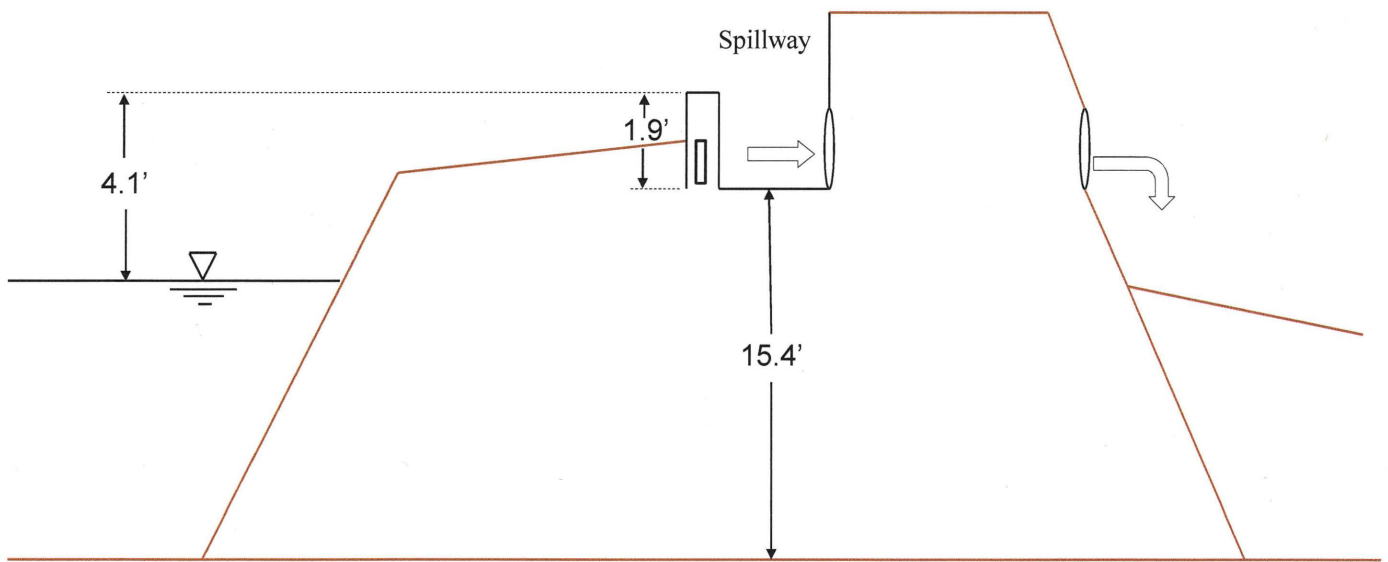
Cross-Sectional View of Earthen Dam and Spillway Structure

Dam Height: The dam height was determined using a laser range finder. The height from the toe of the dam to the crest measured 18.5 feet. The height from the toe of the dam to the top of the concrete spillway measured 17.3 feet. There are two rectangle holes cut in the cement below the top of the spillway which appear to have been the original spillway. Sedimentation at the spillway wall has backfilled over the two spillway holes. The bottom of the two spillway holes measured 15.4 feet from the toe of the dam.

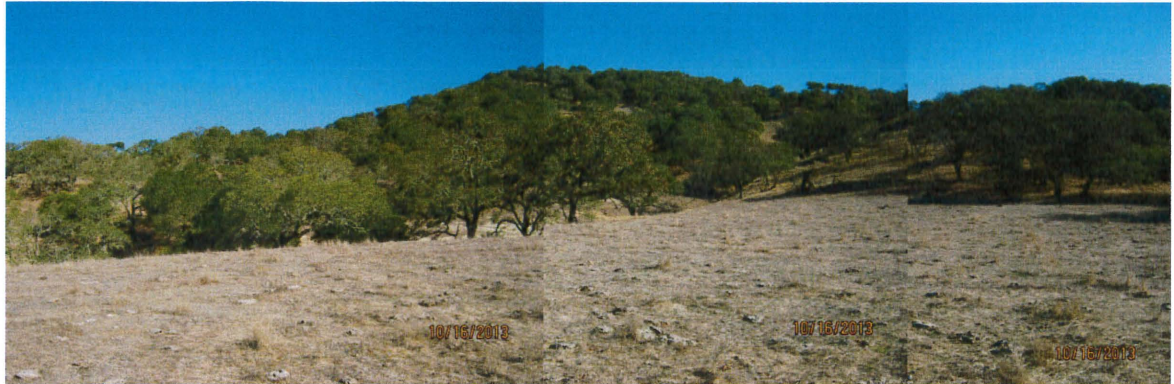
Figure 1: Defined channel above the reservoir tributary to the Unnamed Stream as seen from the pasture on the northeastern side of the reservoir.

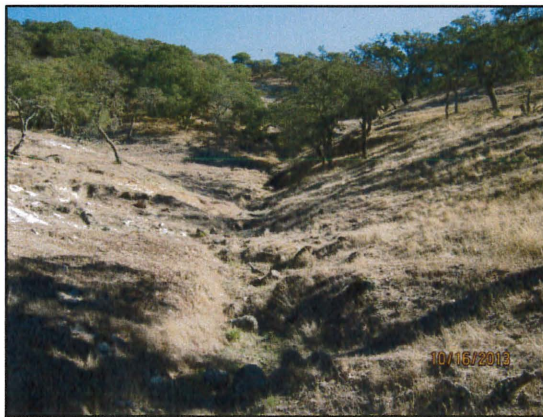
Figure 2: Defined channel as seen looking east.

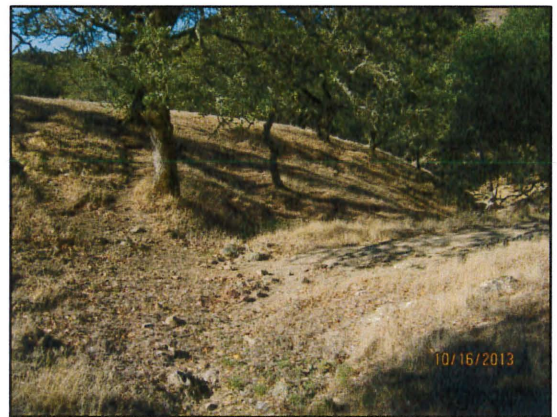
Figure 3: Defined channel as seen looking west towards the Unnamed Stream. Signs of cattle crossing seen on both sides of the channel.

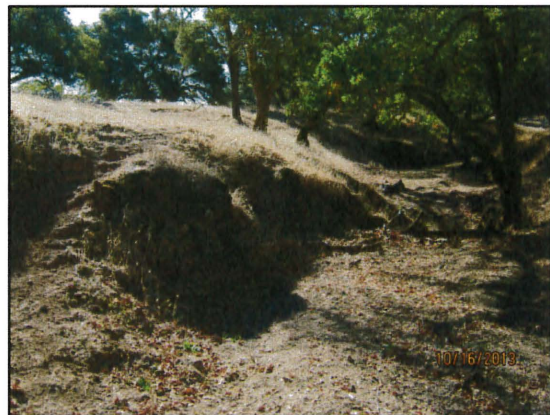
Figure 21: Unnamed Stream as seen looking southeast downstream of Figure 20. Cattle trail out of the channel shown on the left. Flashboard dam top seen in the channel at the tree on the right.

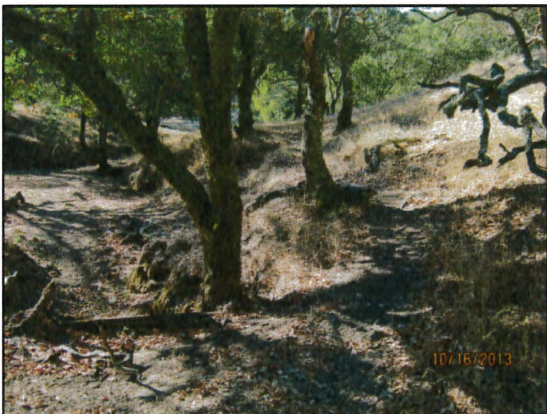
Figure 22: Unnamed Stream as seen looking southeast. Flashboard dam silted over in the channel and cattle trail to the right.

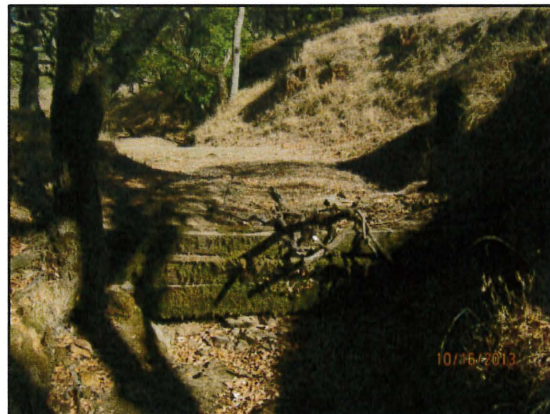
Figure 23: Unnamed Stream as seen looking northwest, upstream, at the flashboard dam.

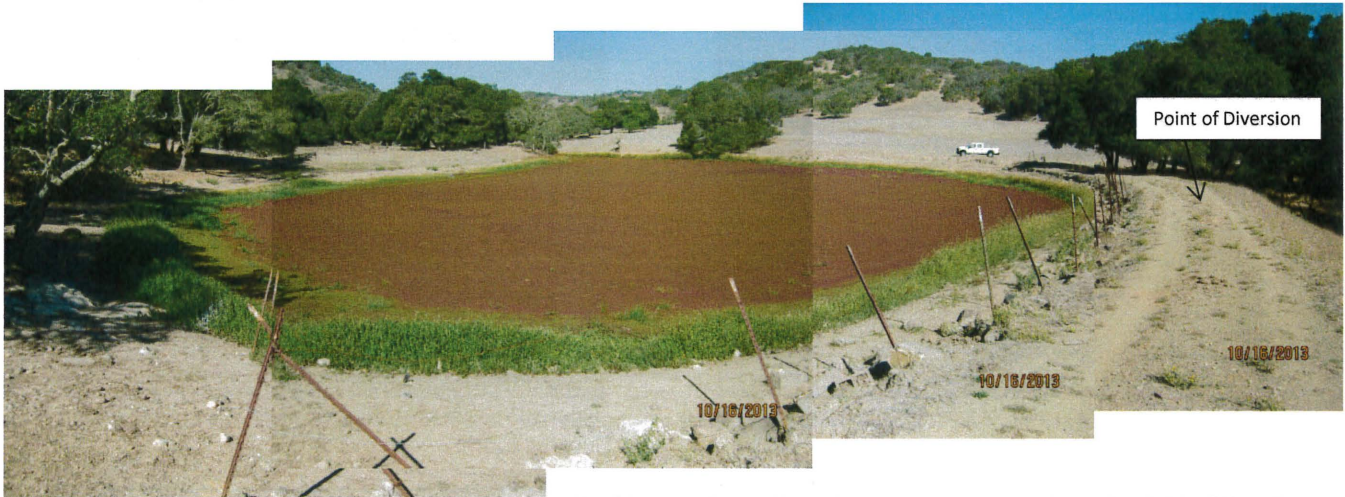
Figure 30: Reservoir as seen from the southeast corner looking north. Earthen dam runs northeast along the right of the photo.

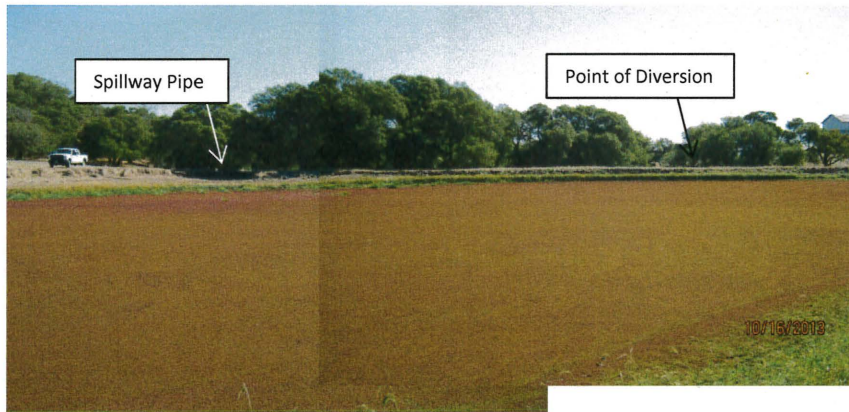
Figure 31: Spillway and point of diversion as seen looking southeast from the western bank of the reservoir.

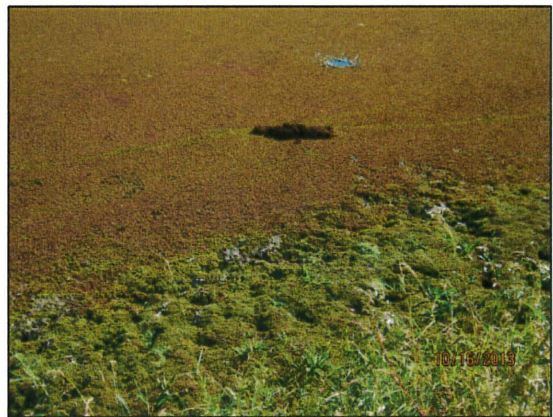
Place of Use: It appears as shown by cattle hoof marks around the reservoir that the place of use is at the reservoir. The reservoir has a vegetative surface cover with clumps of grass grown approximately 10 feet to 15 feet from the water's edge. A rock was thrown near one of the grass clumps to determine if there was water or mud under the grass clump growing in the vegetative cover. The rock made a low thumping sound as it passed through the vegetative cover and sank to the bottom. Additionally the clumps of grass appear to be growing on top of the thick vegetative cover. A hole in the vegetative cover remained after tossing the rock, and the splashing sound confirms the reservoir seasonally stores water. The vegetative cover completely blankets the reservoir. While taking GPS measurements downstream of the reservoir, the vegetative cover was seen dried on rocks and snags in the stream channel.

Figure 33: Close up of the reservoir surface cover. Rock hole in the upper portion of the photo.

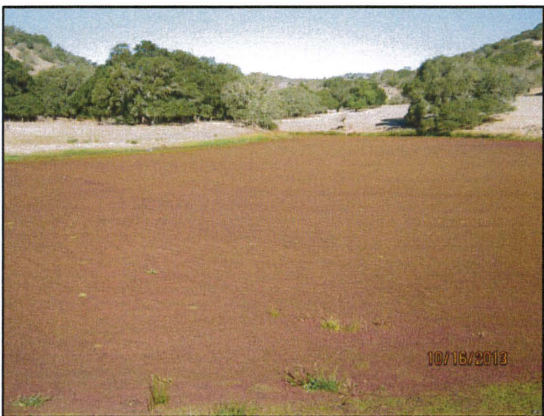
Figure 38: From the spillway looking northwest across the reservoir. It appears the grassy vegetation in the foreground is growing on top of the reservoir surface cover.

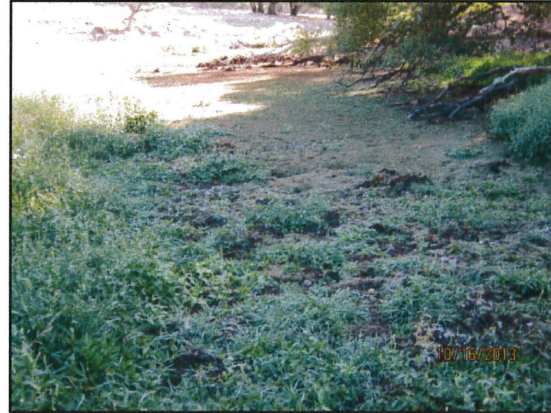
Figure 41: Signs of cattle below the high waterline in the northern part of the reservoir.

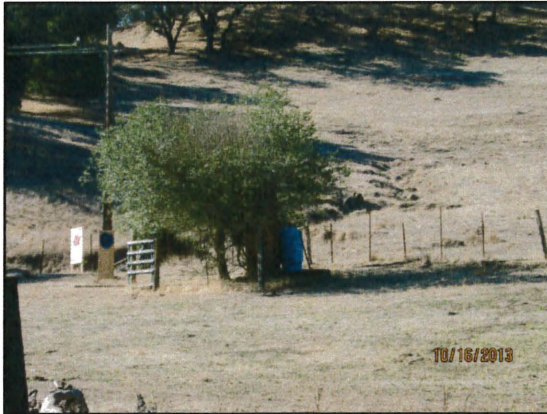
Alternative Supply Available: There is a water well approximately 150 feet to the west of the reservoir. There is PVC and metal piping near the water well and damaged electrical conduit. Mr. Dal Poggetto did not know if the water well is functional.

Figure 52: Water well approximately 170 feet from the western bank of the reservoir. A third defined channel can be seen in the background.

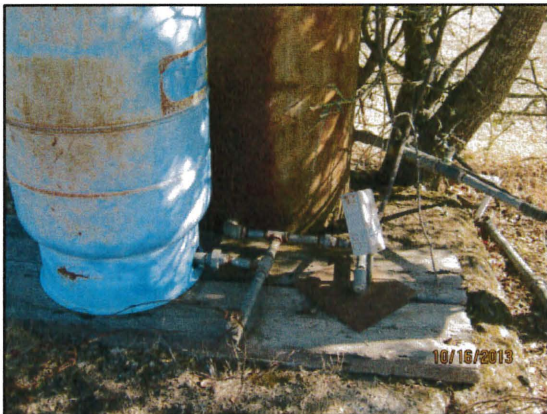
Figure 54: Water well platform and connections.

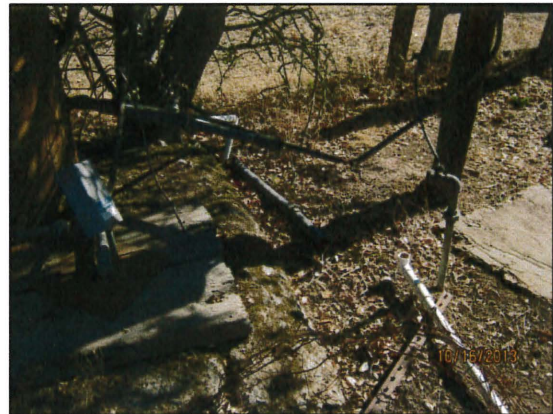
Figure 55: Water well piping.

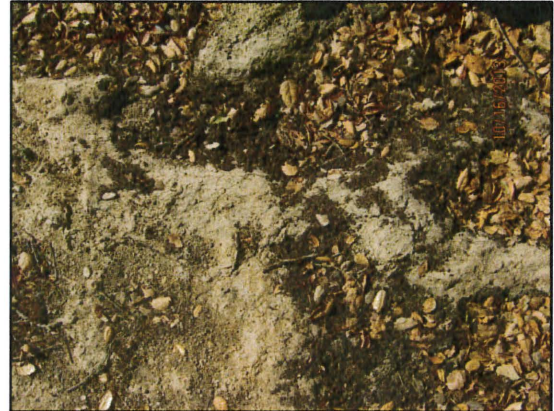
Figure 59: Dried reservoir vegetation cover that has been washed downstream. Photo approximately 100 feet below the spillway.

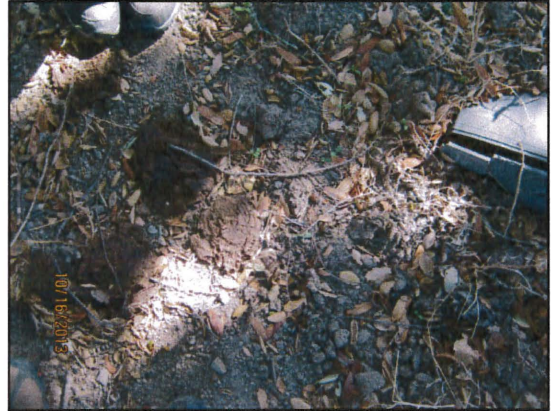
Figure 83: Cattle droppings and abandoned battery in the Unnamed Stream near the base of the earthen dam.

The Division should notify Newton Dal Poggetto Successor Trust of the findings of this reservoir inspection and actions that can be taken to either pursue a water right or render the reservoir incapable of storing water. The Division might also want to inform the San Francisco Bay Regional Water Quality Control Board of the reservoir surface cover and its presence downstream as it could potentially be a water quality issue or an invasive species. The San Francisco Bay Regional Water Quality Control Board should also be informed of the presents of cow dung and cattle trails in the Unnamed Stream.
