California Natural Resources Agency
Department of Water Resources
Division of Safety of Dams

Memorandum of Field Inspection
King Ridge Dam and Reservoir, Violation, No. 7000-121
Sonoma County
7 February 2013
Jim Lowe

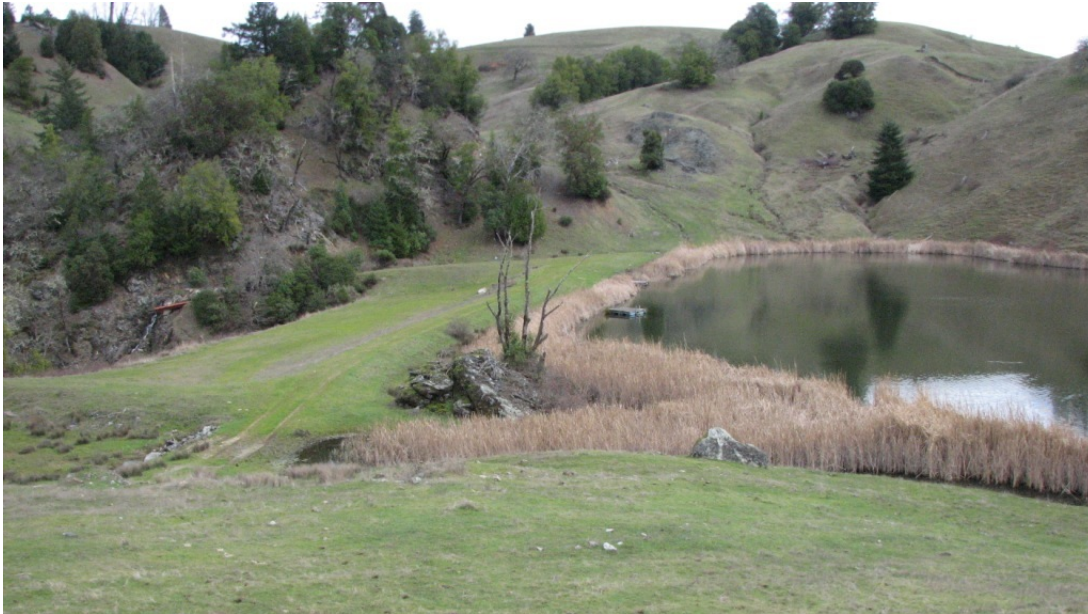
Tule along the upstream face waterline, along the right spillway approach, and within the left spillway entrance channel, should also be thinned or removed. Tule provides attractive habitat for destructive burrowing rodents, and tule within spillways can trap and accumulate floating debris which could in turn impede spillway flows.

The embankment as viewed from the left abutment. Note the tule along the waterline, and the left spillway entrance channel in the bottom center of the photograph.

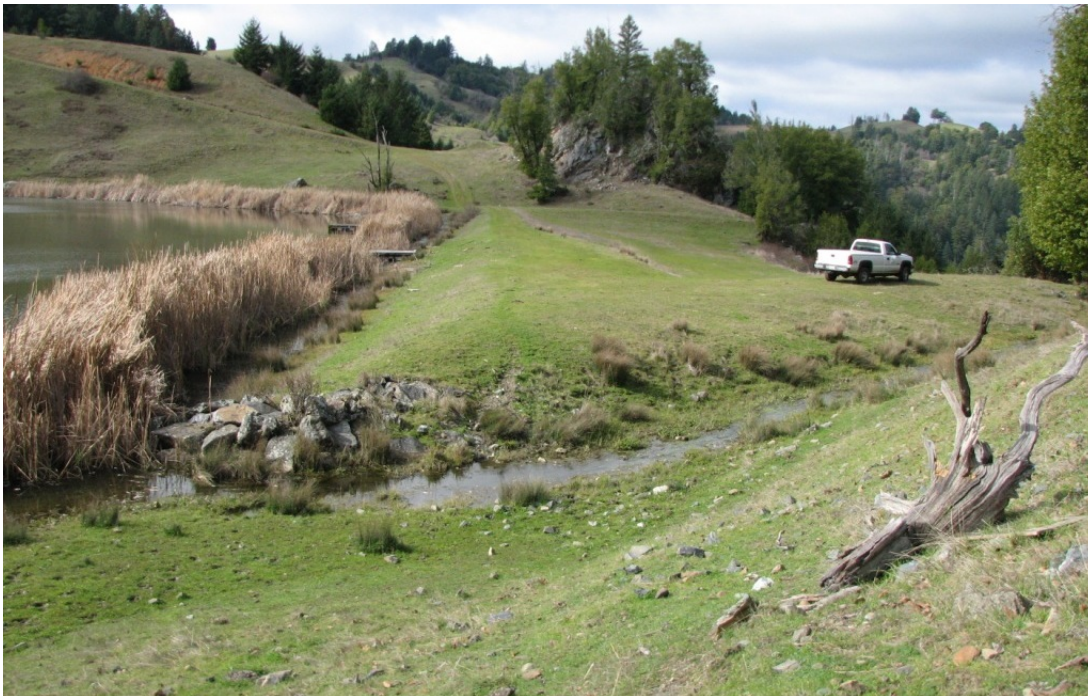
The crest and right spillway as viewed from the right abutment. Flow is about 6 inches deep in the center of the vee-shaped spillway channel.

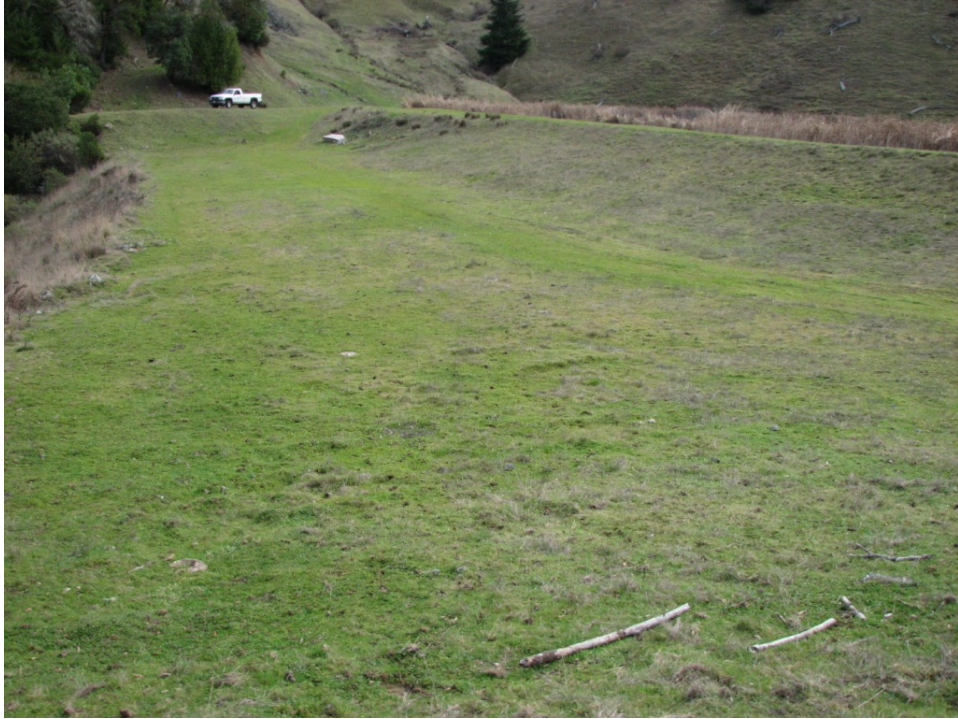
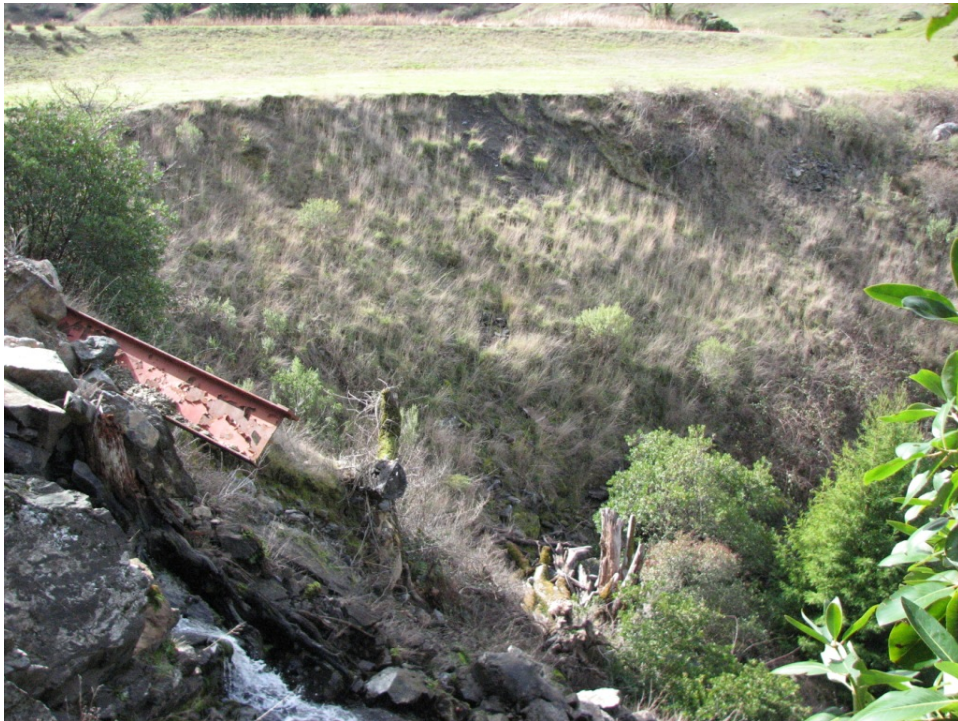
A closer look at the bench below the crest of the dam. The bench has an irregular downstream lip, and the downstream face below the bench (bottom photograph) is also quite irregular.

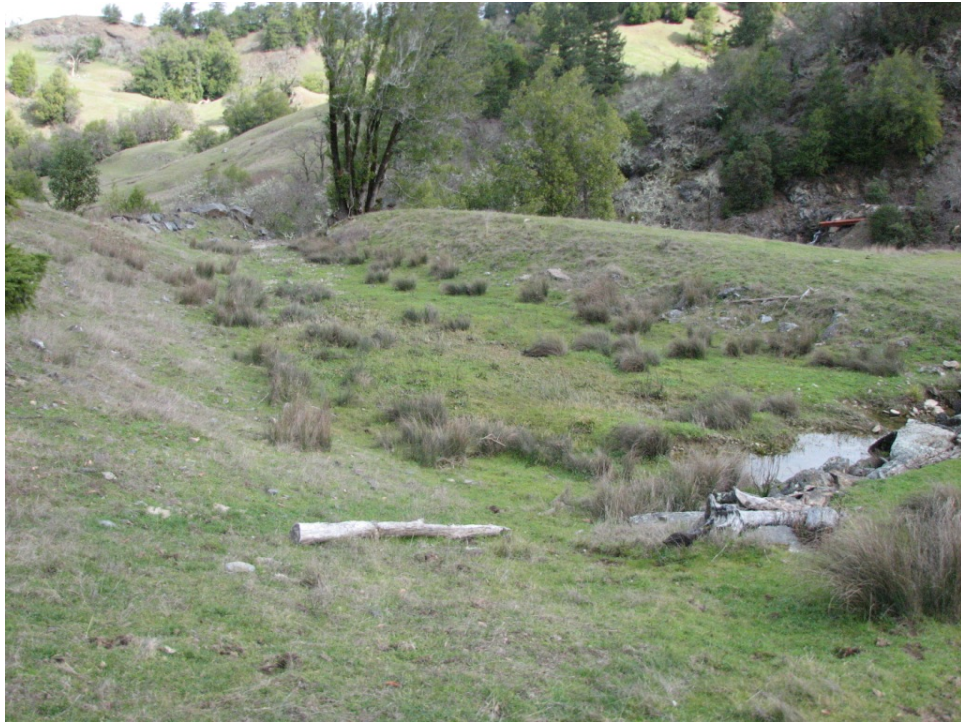
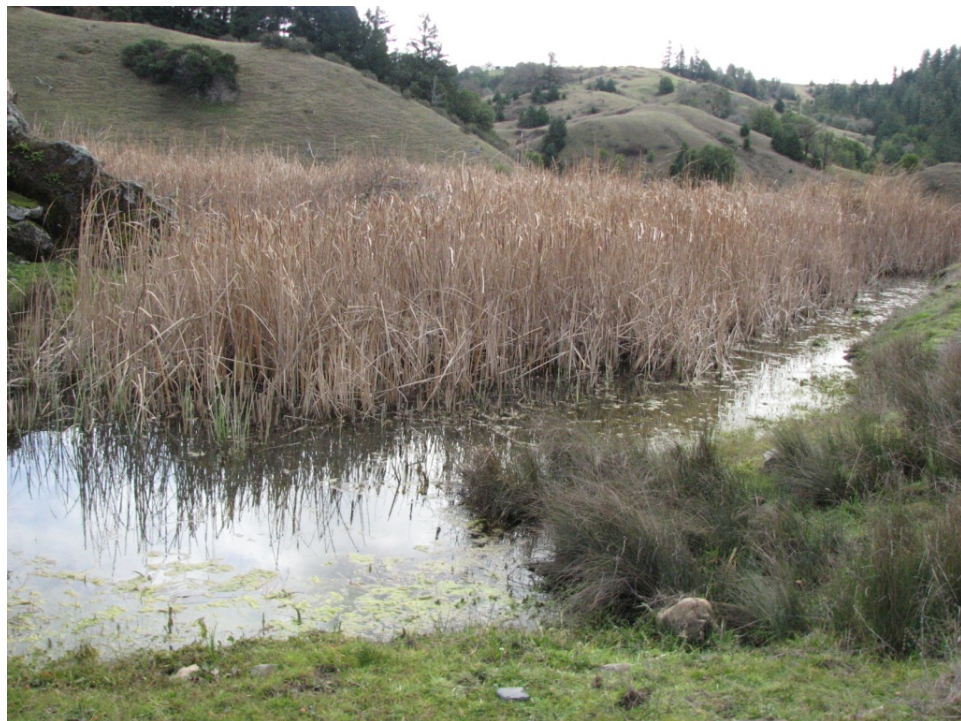
The left spillway channel, above, and entrance channel, below. This second spillway is roughly a foot higher than the right spillway.
