California Natural Resources Agency
Department of Water Resources
Division of Safety of Dams

Memorandum of Field Inspection
King Ridge Dam and Reservoir, Violation, No. 7000-121
Sonoma County
18 June 2014
Jim Lowe

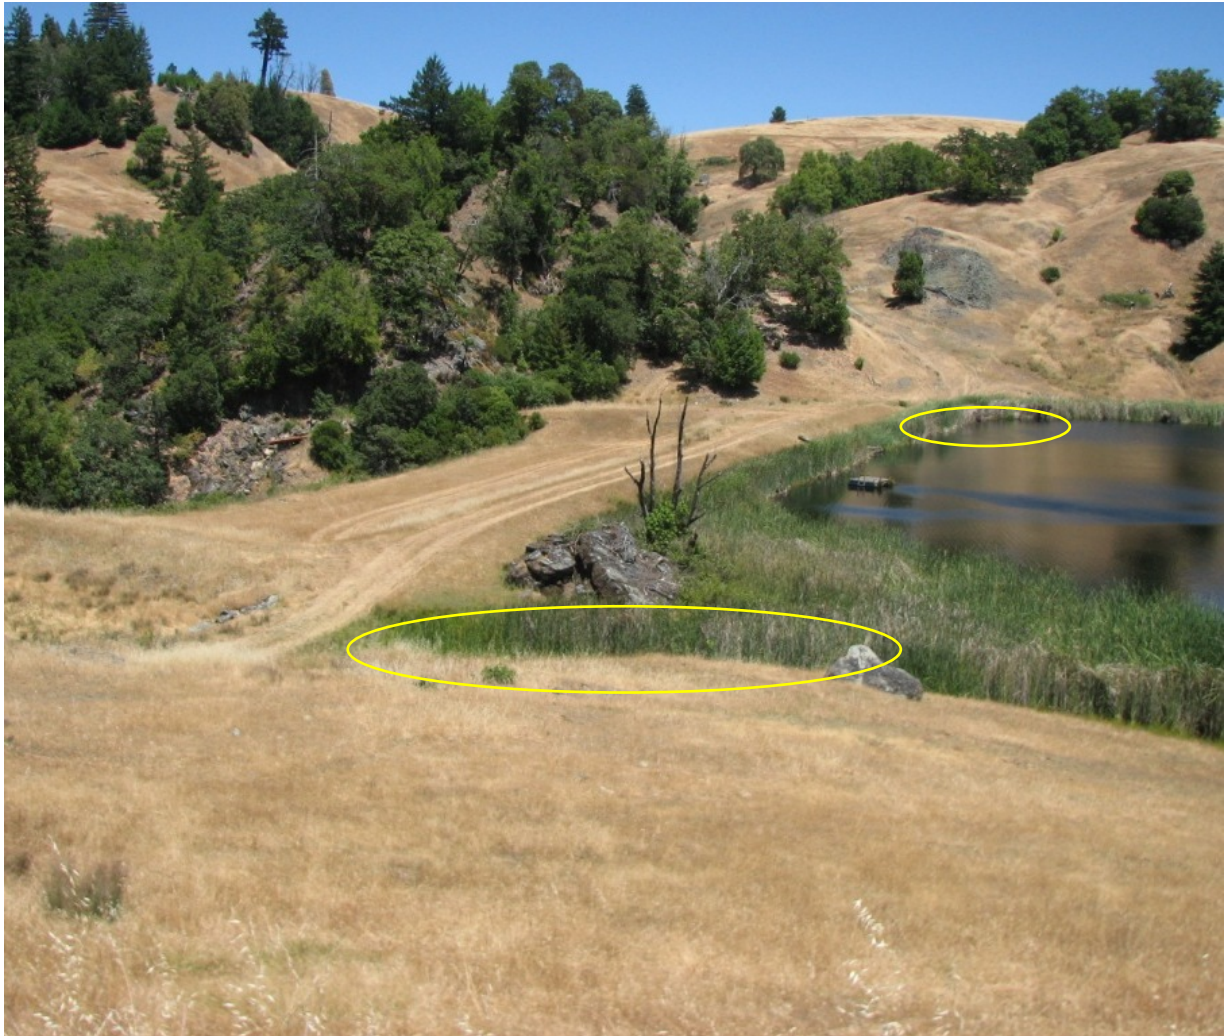
Tule along the upstream face waterline, along the right spillway approach, and within the left spillway entrance channel, should also be thinned or removed. Tule provides attractive habitat for destructive burrowing rodents, and tule within spillways can trap and accumulate floating debris which could in turn impede spillway flows.

The upstream face, crest, and downstream bench as viewed from the left upstream abutment. The left spillway entrance channel is in the foreground and the right spillway entrance channel is at the opposite end of the embankment; both are circled for clarity. Both should be cleared of tule and cattails to permit unimpeded flow during storm events.

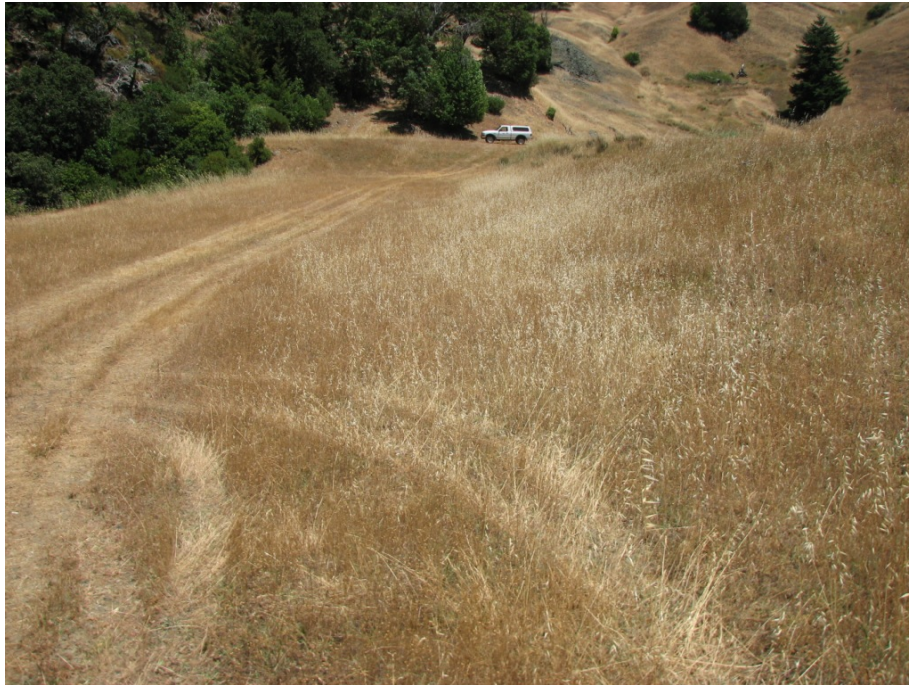
The roughly 40-foot wide downstream bench below the crest. The bench adds considerable additional width, and presumably strength, to the embankment.

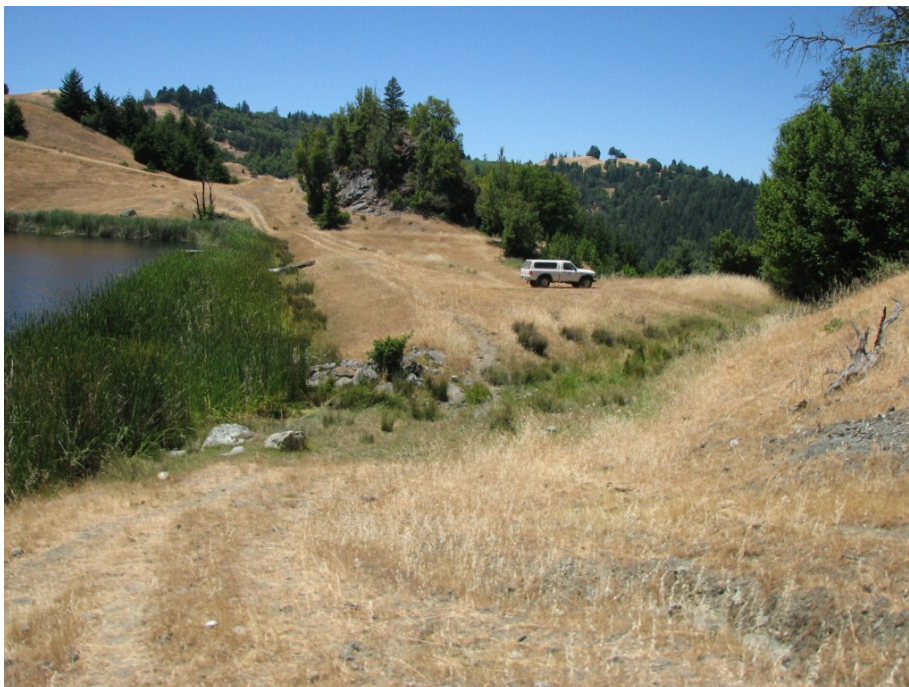
The right spillway entrance, control section and upper channel as viewed from the right abutment. Having two independent spillways adds spillway capacity and provides redundancy in the event one of the two becomes impaired.
