## North Coast Regional Water Quality Control Board

Inspection Report  
Stanshaw Creek Diversion  
Marble Mountain Ranch  
Douglas and Heidi Cole, Landowners  
92520 Hwy 96, Somes Bar  
Siskiyou County  
WDID No. 1A15024NSI

Date: March 9, 2015

Inspection Date: February 12, 2015

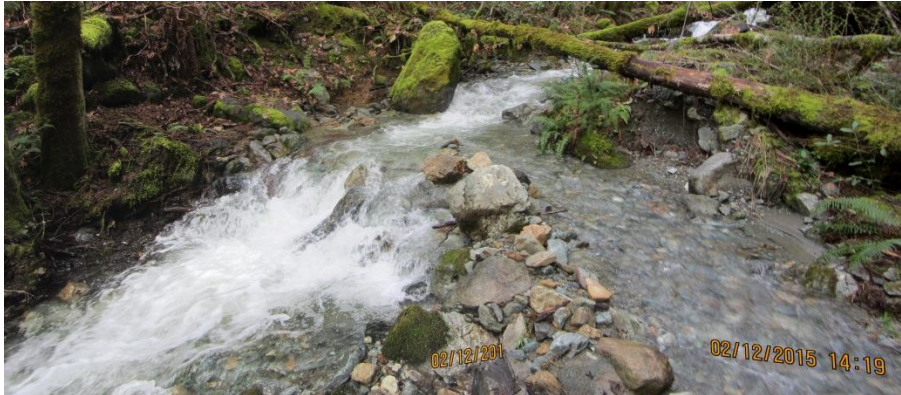
Image 3- shows Point 1, the Point of Diversion. The Stanshaw Diversion flows toward the lower right corner of this image. It appears the rock and cobble diversion structure fails episodically and likely requires periodic modification as Stanshaw Creek's flows change, in order to maintain a diverted flow. (Photos 8459, 8460 and 8461 stitched)

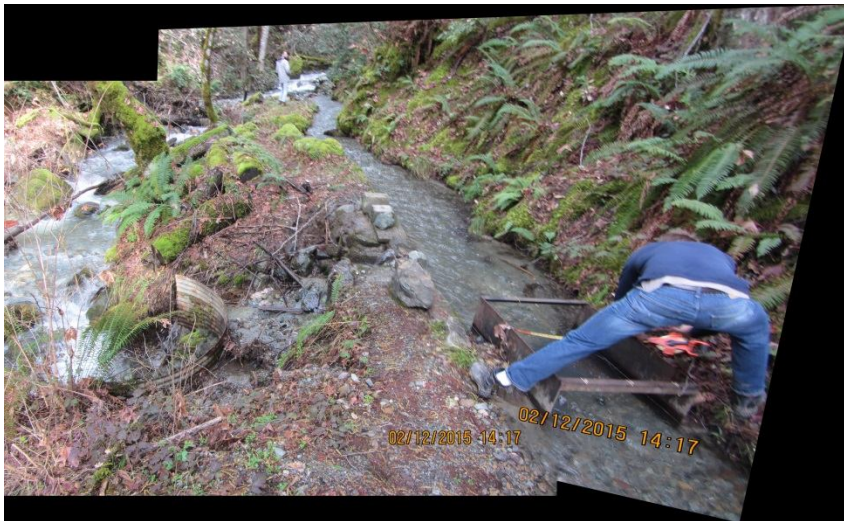
Image 4- shows Point 2, a failure along the outboard berm, approximately 70 feet downstream of Point 1, allowing some of the water in the ditch to flow down to Stanshaw Creek, potentially resulting in erosion and sediment transport. This location appears to have failed repeatedly in the past. The instream flume in the Ditch just downstream of this failure is used to measure flows entering the diversion. (Photo 8454 and 8455)

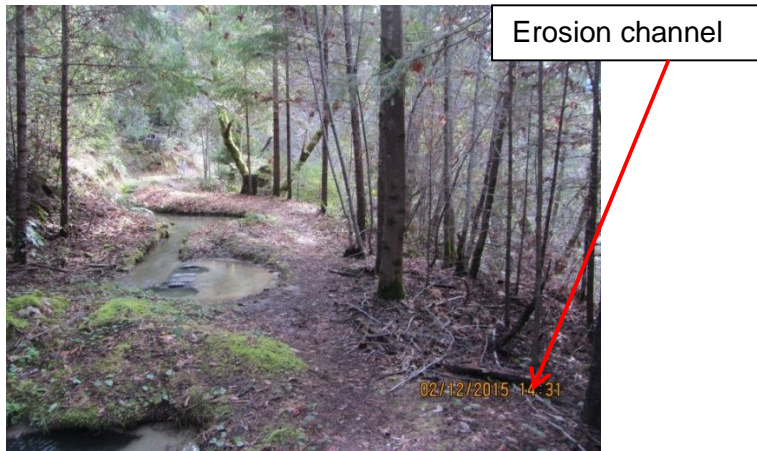
Image 5- shows Point 3, a tank or railroad tank car buried in the ditch channel, likely intended to trap sediment. The tank car is full of sediment. Water flowing in the ditch appears to have overtopped the outboard berm at this location and caused some erosion on the slopes below. (Photo 8467)

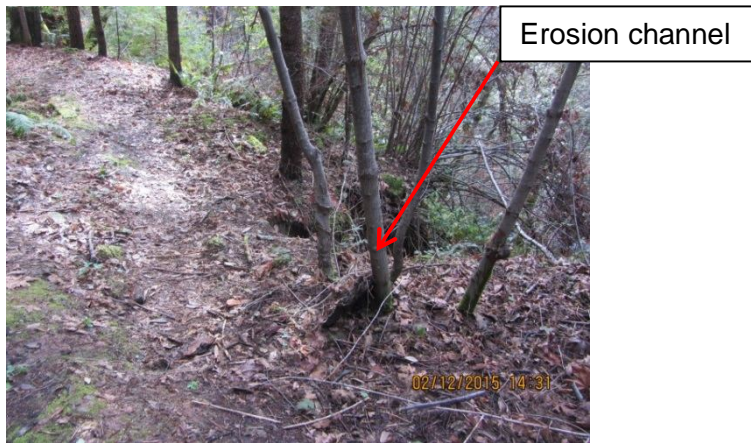
Image 6- shows the erosion channel downslope of Point 3.

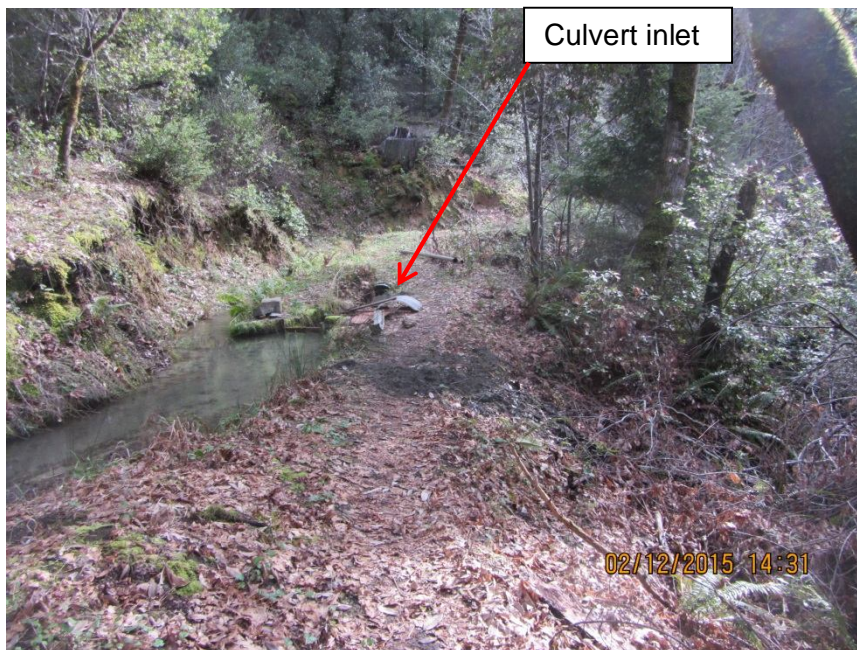
As discussed below, at inspection Points 4 and 5, and visible in image 1, the upper ditch crosses over an unnamed tributary to Stanshaw Creek. The tributary is conveyed under the ditch via culvert. At this location, there is also a culvert that drains a portion of the water in the ditch and discharges it through a shotgunned outlet onto the slope a short distance below the outfall for the stream crossing culvert. The combination of uncontrolled discharges and additional flows into the unnamed tributary has caused significant streambank erosion and channel widening in the tributary downstream of the culvert. The ditch may have historically failed at this location, which has likely also contributed to stream channel enlargement.

Image 9- at Point 4, shows the partial diversion of the ditch into an unnamed tributary to Stanshaw Creek through the inlet of a 12-inch culvert, before the diversion ditch is routed across the stream in a lined ditch. The culvert is shotgunned, which appears to have caused significant instream erosion in the downslope channel. The stream above the crossing is 3-4 feet wide at bankfull width; the eroded stream channel below the diversion crossing is 12-14 feet wide, and does not appear stable. At this location, I also observed muddy soils in the berm adjacent to the ditch, indicating that seepage from the ditch is saturating surrounding soils, which may lead to catastrophic failure of the ditch. (Photo 8441)

For either alternative, the ditch repair or decommissioning plan shall include specifications to restore the affected stream/unnamed tributary that crosses at inspection points 4/5, replant with native vegetation, and to protect streams from any further impacts or discharges associated with the ditch.

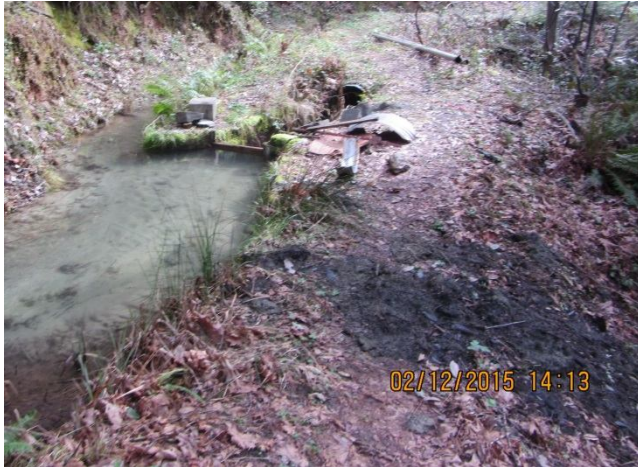
Image 10- at Point 4, shows a closer look at the seepage in the berm; note the muddy soils in the foreground. (Photo 8441 cropped)

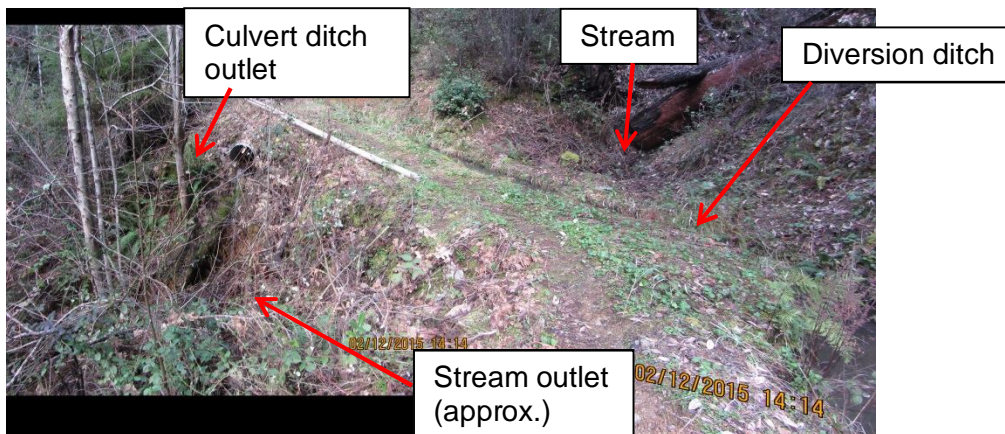
Image 9- at Point 5, shows the shotgunned 12-inch ditch culvert outlet, diversion ditch and native stream channel flowing under the diversion ditch. (Photos 8442, 8443, 8444, 8445 composite)

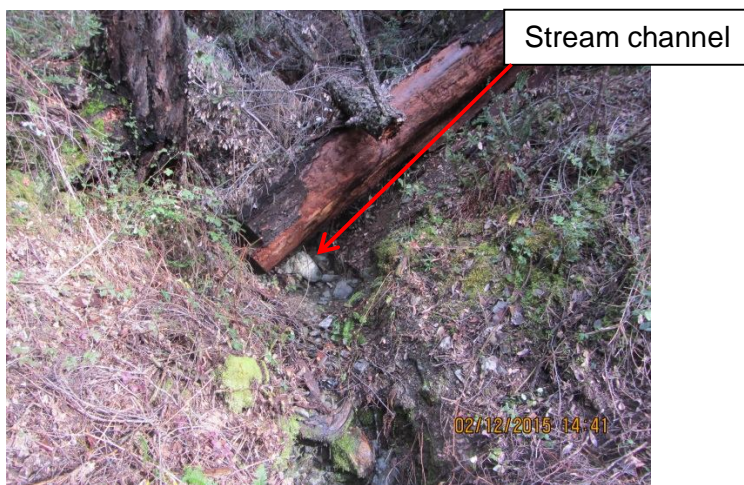
Image 10- shows the unnamed stream channel above Points 4 and 5; the upslope active bankfull stream channel width is approximately 3-4 feet.

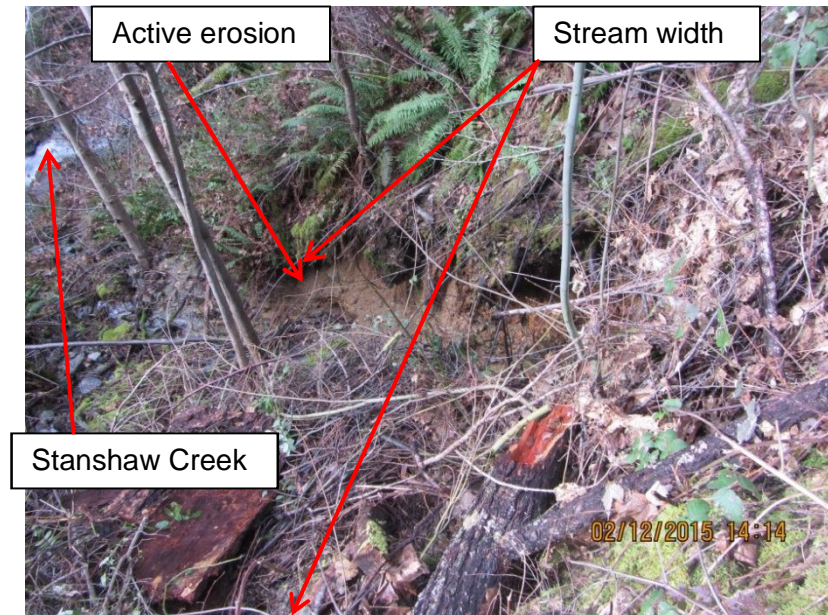
Image 11- shows the unnamed stream channel downstream of Point 5, and the erosion caused by water draining from the shotgunned culvert. Stanshaw Creek can be seen a short distance downslope. I conservatively estimate that this site has delivered 150-300yds<sup>3</sup> of sediment and debris to Stanshaw Creek over the life of the Diversion. (Photo 8478)

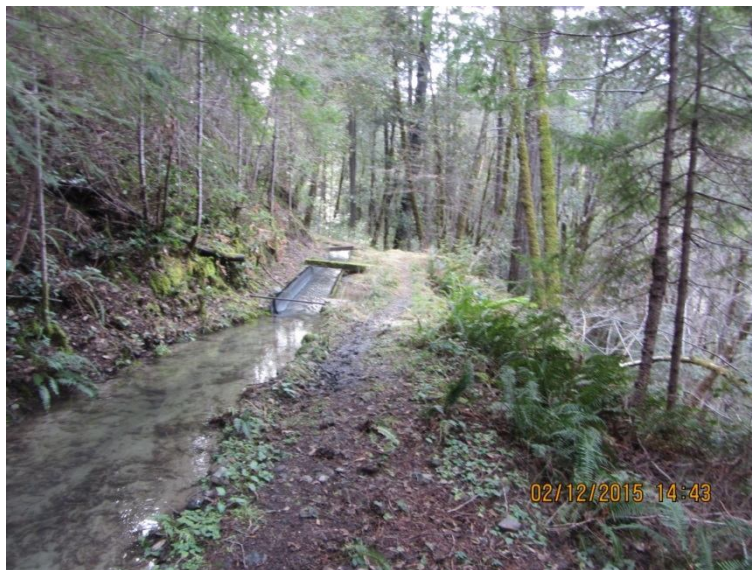
Image 12- shows Point 6, where the diversion channel is full, leaving no freeboard should it rain or the ditch receive a bank slump upstream. It appears the outboard berm may have failed in this area in the past, and at present is seeping, indicating that a portion of the berm may be saturated. Stanshaw Creek is within 200 feet; any failure here likely results in direct delivery of sediment and erosional debris. The flume section visible in the photo appears to have been installed to remedy previous ditch failures and/or to prevent future failures.

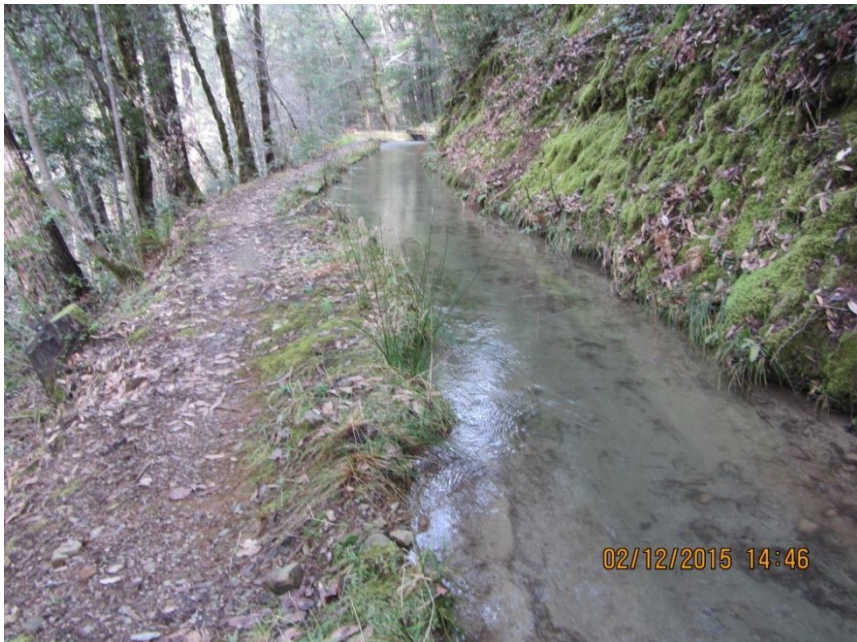
Image 14- shows point 8, an approximately 150-foot section of the channel downstream of Point 7, where the low berm and full ditch likely creates a high potential for berm or slope failure, erosion, and sediment transport downslope. I observed concrete blocks at various locations along the outboard edge of the berm throughout this segment, likely to rebuild or reinforce berm sections. (Photo 8486)

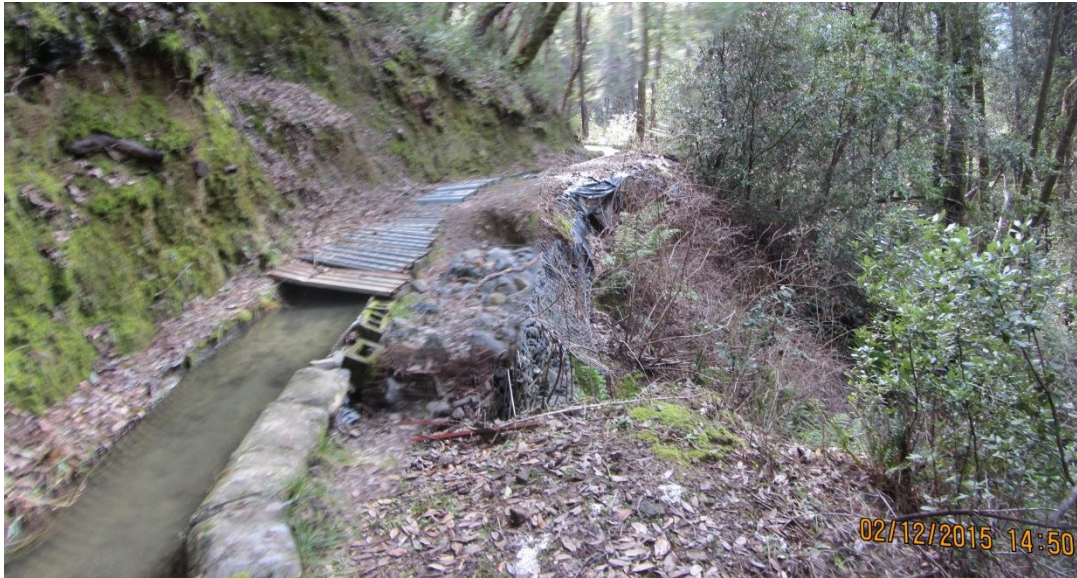
Image 15- shows Point 9, a significant failure point, likely caused by a cut bank slump filling the diversion channel and diverting the stream flow. Note the cut bank slump above and the erosion void downslope. This failure likely accelerated erosion on lower slopes and into the nearby streams. (Photo 8490 and 8491 composite)

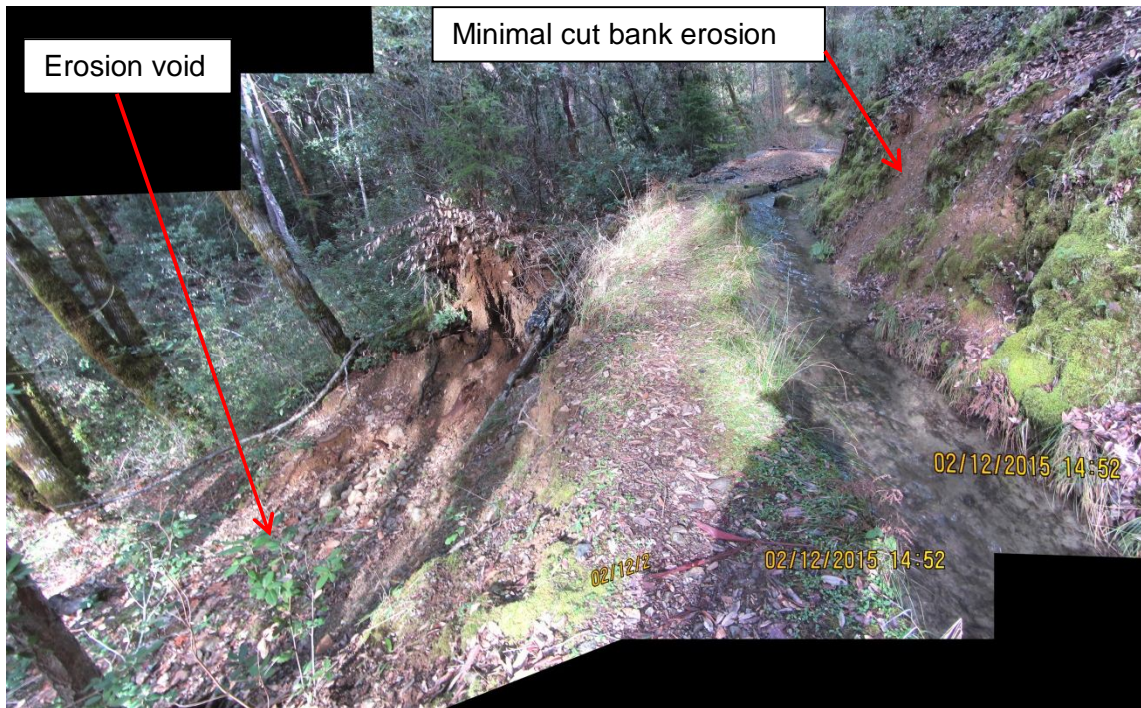
Image 16- Point 10 is an area of concern that includes an erosional channel likely formed by a berm failure and active erosion visible on the cut bank. I observed active cut bank erosion on many of the upper slopes above the diversion ditch and expect that bank slumps have and are contributing significantly to ditch failures. (Photos 8495, 8496, 8497, and 8498 composite image).

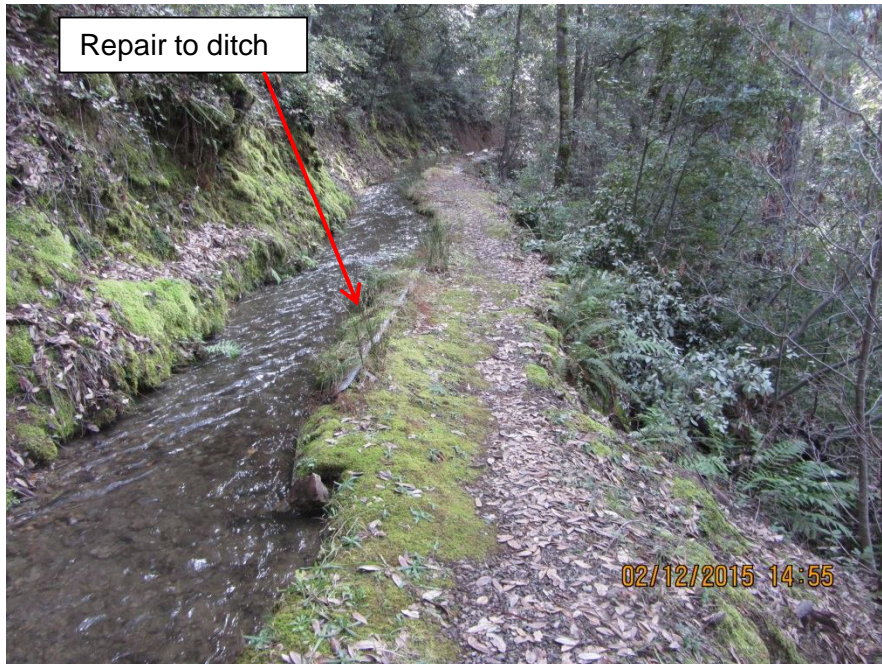
Image 17- Point 11 is another 150-200 feet of ditch with a low freeboard and evidence of past failures; this ditch segment leads to a section of ditch subject to a recent bank failure. I observed erosion scars on the lower slopes that are now overgrown with ferns and small shrubs. (Photo 8499)

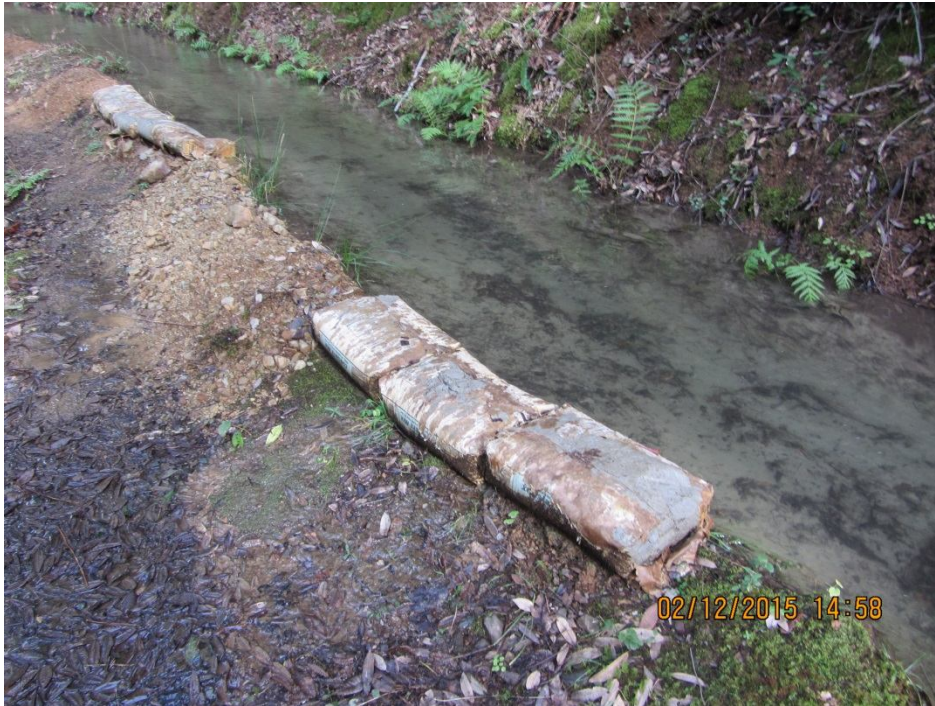
Image 19- Point 12, closer view of berm repair made with ready crete concrete sacks and soils. Note the saturated soils along the outboard berm where water is seeping. (Photo 8510)

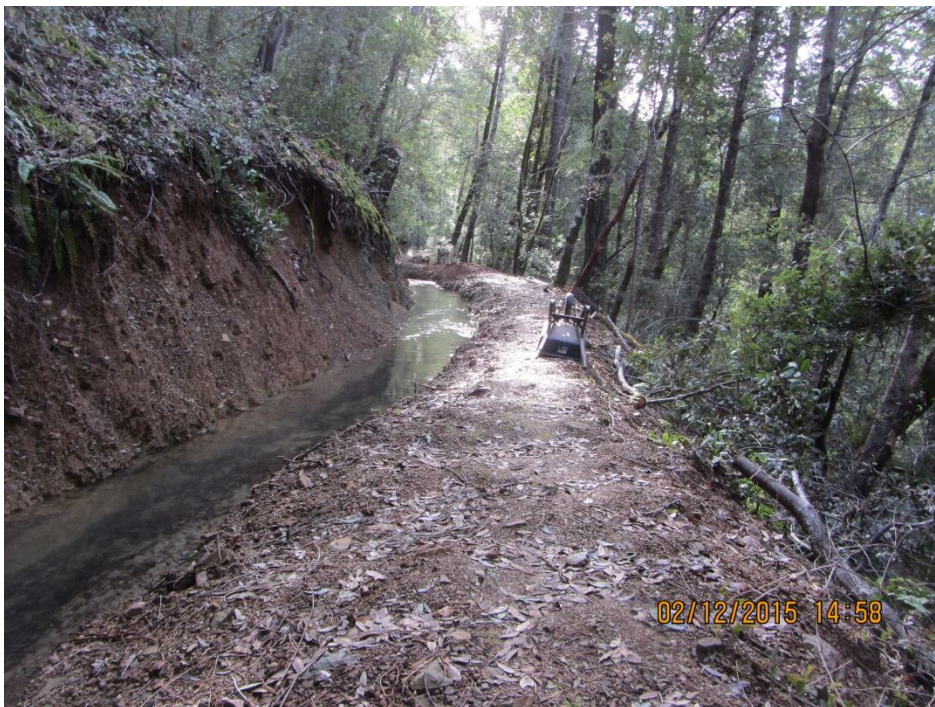
Image 20- Point 13 shows a large continuous cut bank slump that extends for approximately 220 feet. Based on my observations, it appears the cut bank slumped along this stretch over this past winter, delivering approximately 10 yds<sup>3</sup> of sediment into the ditch, blocking the channel, and causing water to overtop the berm

and erode the lower slopes. Cut banks are often chronic sources of erosion, delivering additional sediment to streams and ditches each year.

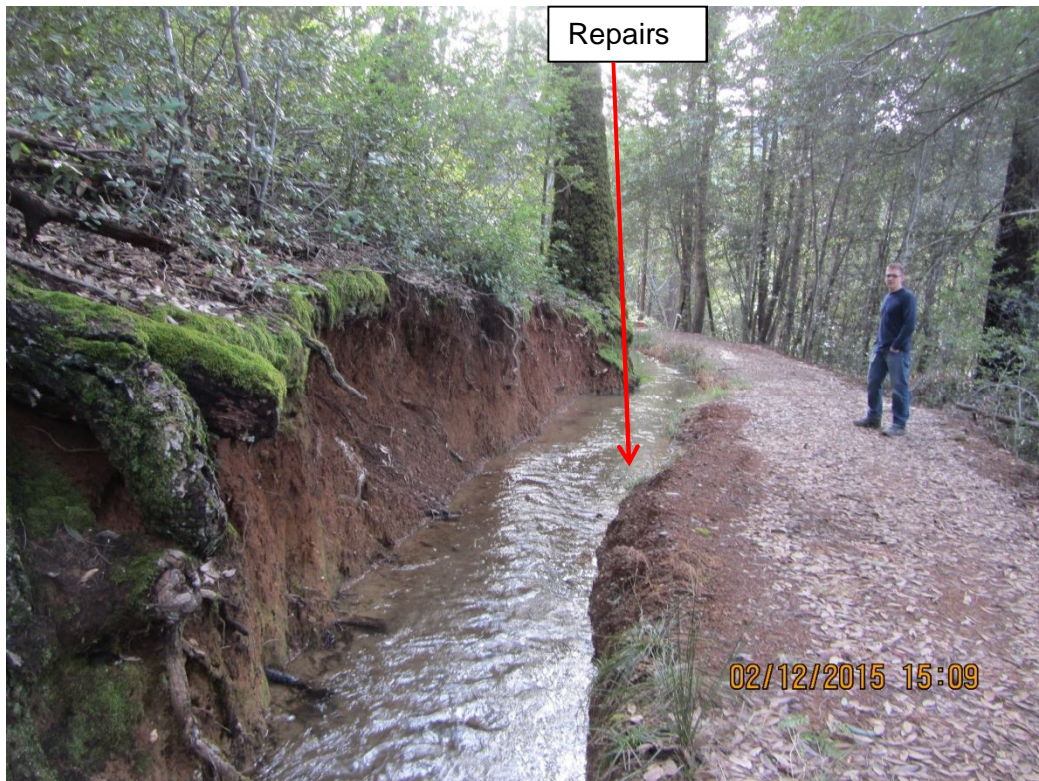
Image 22- Point 15 shows an active cut bank slump, and evidence of recent repairs to the ditch and berm. (Photo 8523)

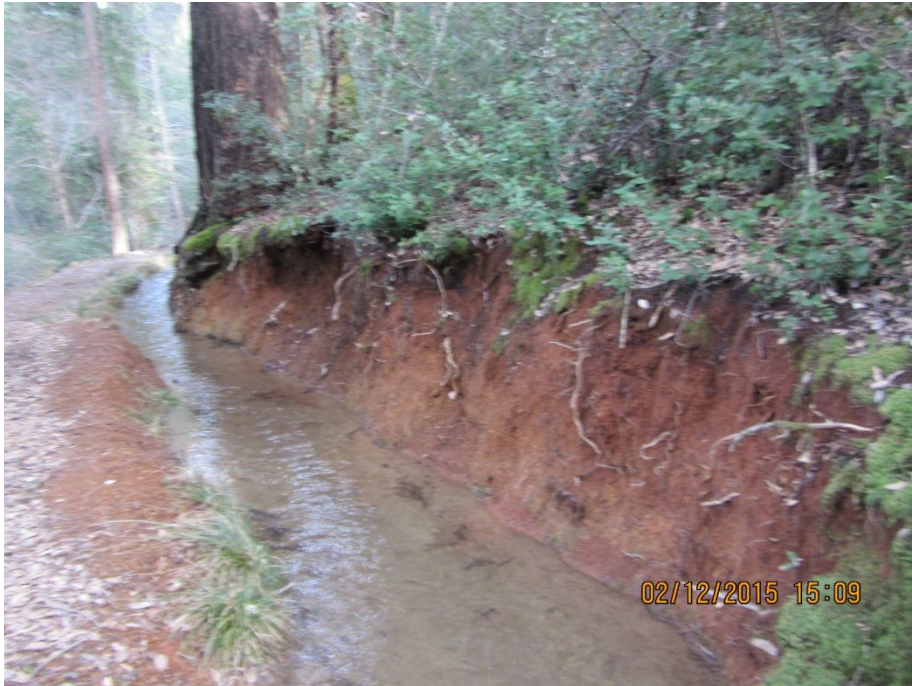
Image 23- Point 16, another cut bank that has a high risk of failure. Note the steep, near vertical slope of this cut bank, which indicates that the bank is still likely to erode. The roots hanging out of the cut bank are indicators of the erosion that has occurred. Most cut banks are originally constructed in a planar form with no visible roots protruding. Over time the cut bank erodes, exposing the roots, and leaving an indicator as to the amount of soil that has eroded or slumped. (Photo 8525)

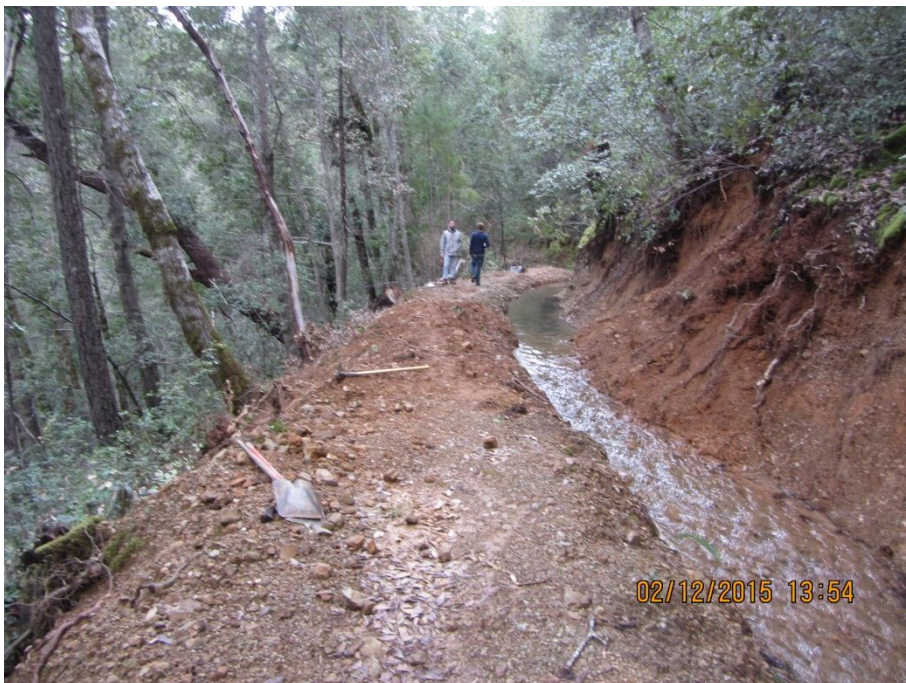
Image 24- Point 17 shows a segment of channel with an active cut bank slump and evidence of recent repairs to the outboard berm.

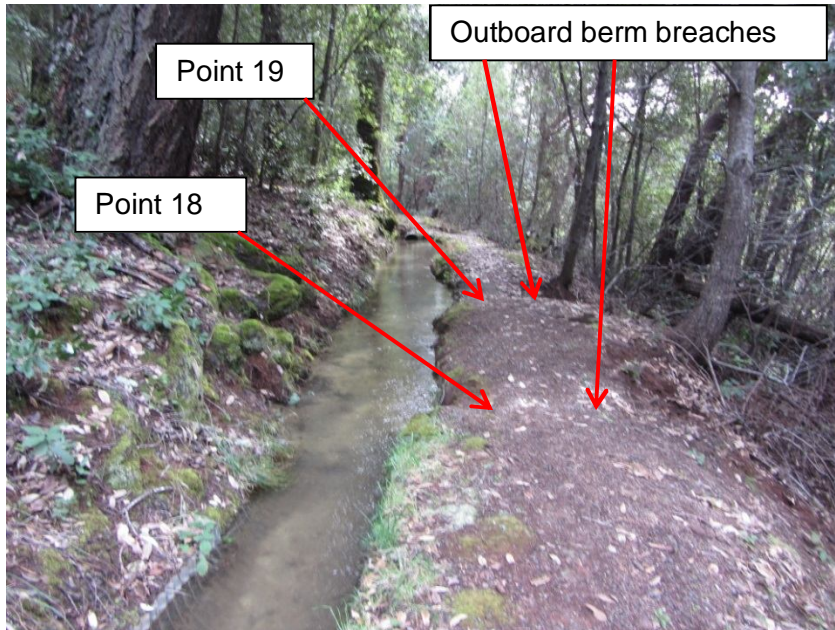
Image 25- shows two locations, points 18 and 19, where the outboard berm has apparently breached in the past, resulting in gully erosion on lower slopes. The failure at Point 19 resulted in the formation of a gully channel for a long distance down the slope, and may have contributed a significant sediment load to the Klamath River and possibly Stanshaw Creek. I did not follow the gully all the way down the slope, but did see an erosion channel from the lower road.
