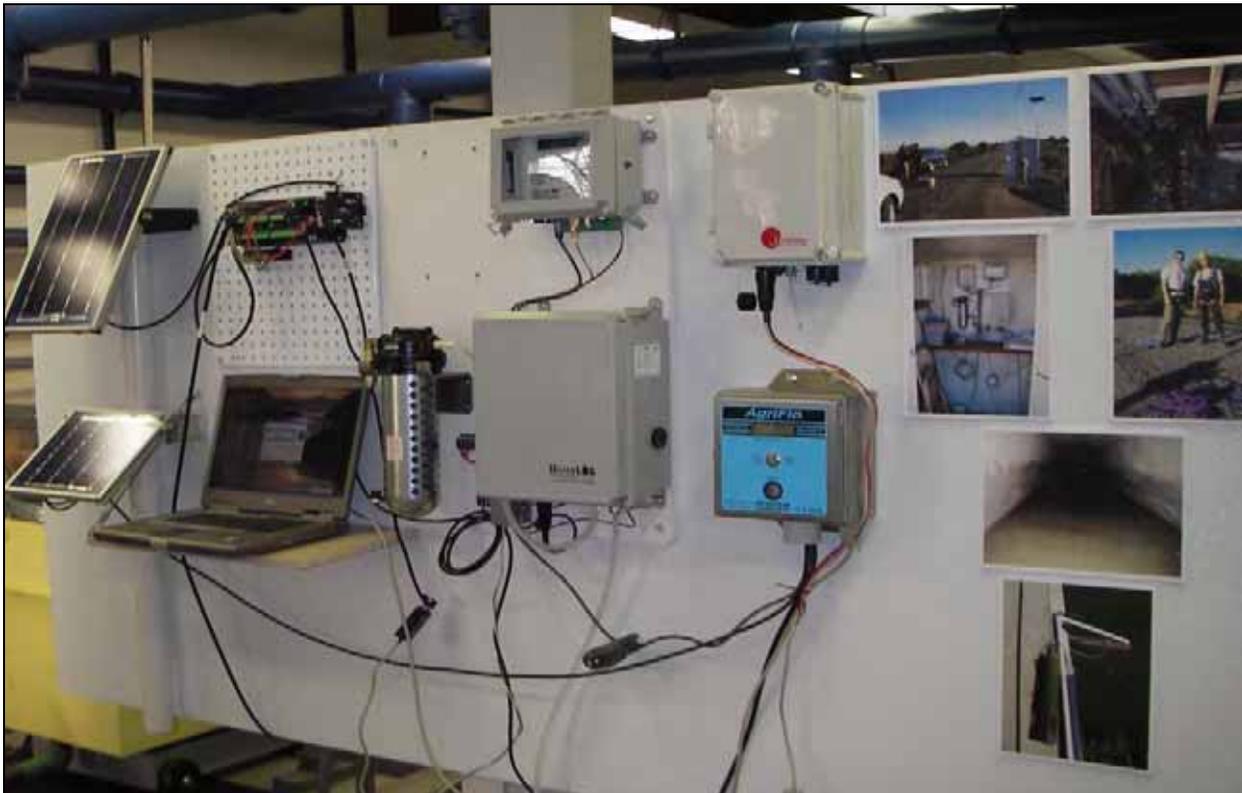
Field Monitoring Training Station in UOP Hydraulics Laboratory

The training station set up at the UOP Hydraulics laboratory was used to simulate a real field monitoring station and allowed trainees the opportunity for hands-on practice.

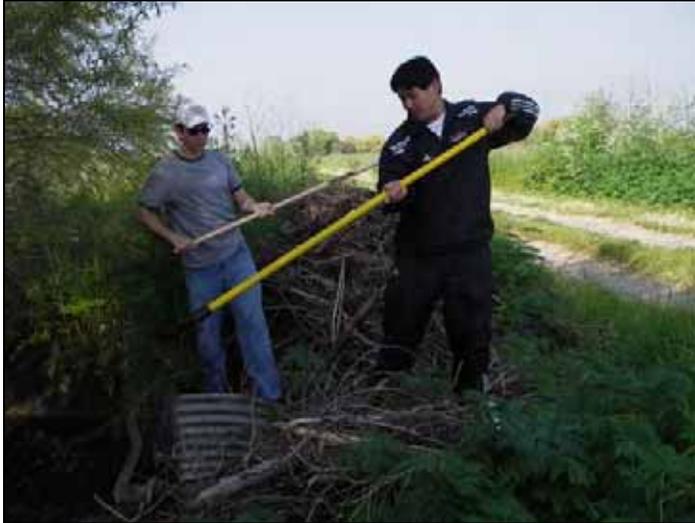
DO-60 Moffit 1 South
Student Interns clear debris from a weir in the wetlands.

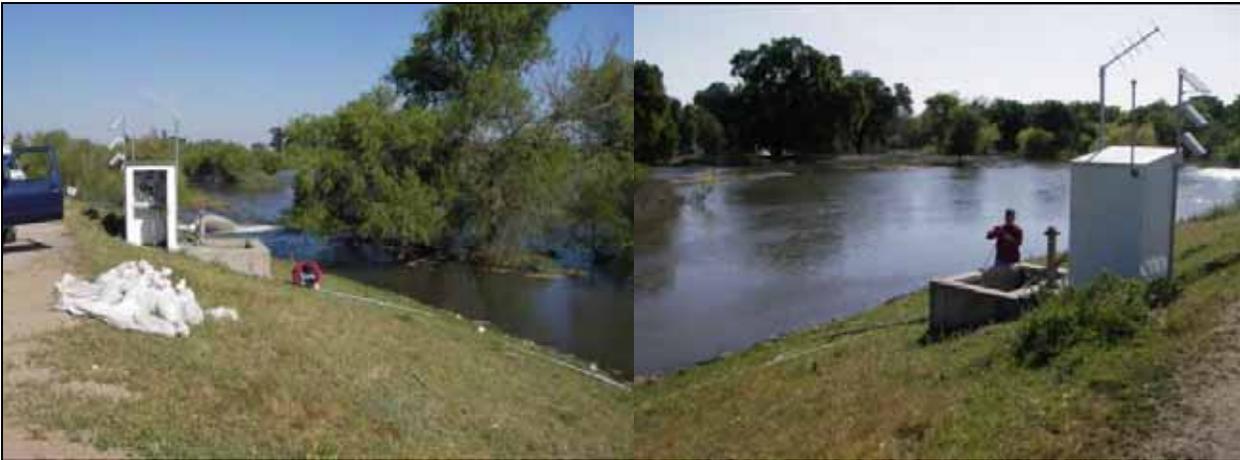
DO-57 Ramona Lake

Doing maintenance at the field station at Ramona Lake. The station at DO-57 was destroyed from high water levels in the SJR.

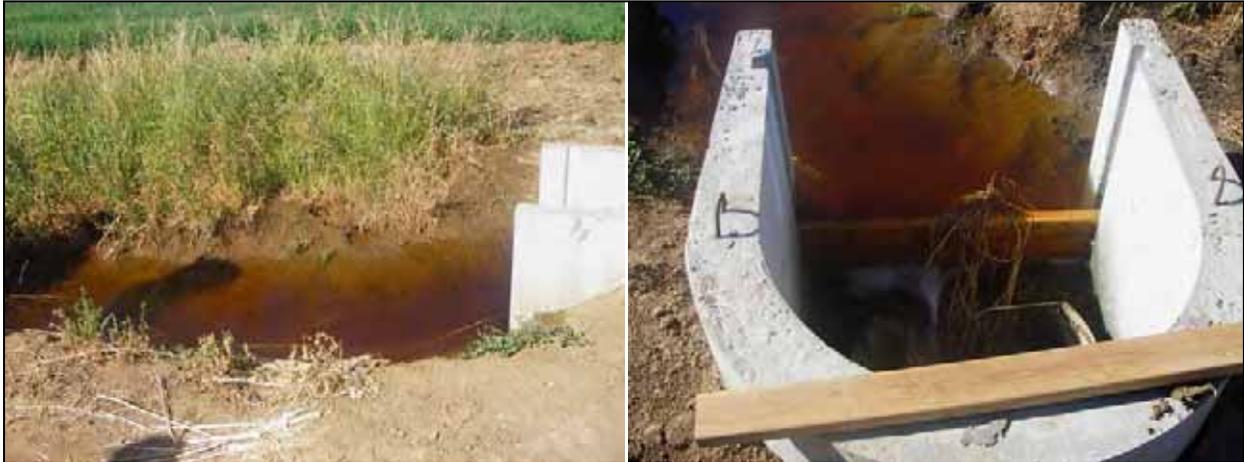
Drainage Ditch at Perez Farms

Cement weir structure at end of drainage ditch. Water is colored brown with tannins from the alfalfa field.

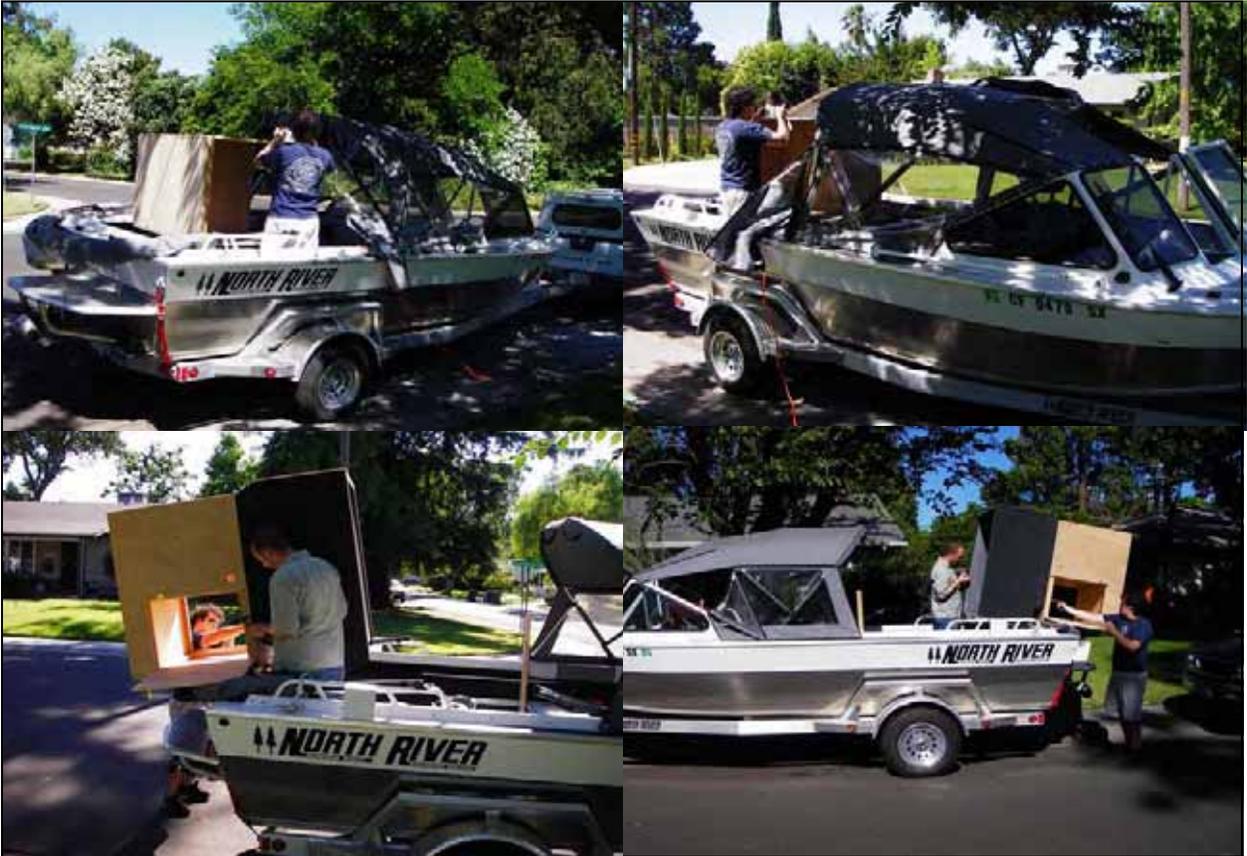
Boat Work

Student Intern and Justin Graham worked on building and installing a cabinet for the boat. The cabinet houses boat equipment and a laptop for sampling (See July 27, 2006).

Cabinet was built and installed on back of boat to house gear and laptop for sampling trips.

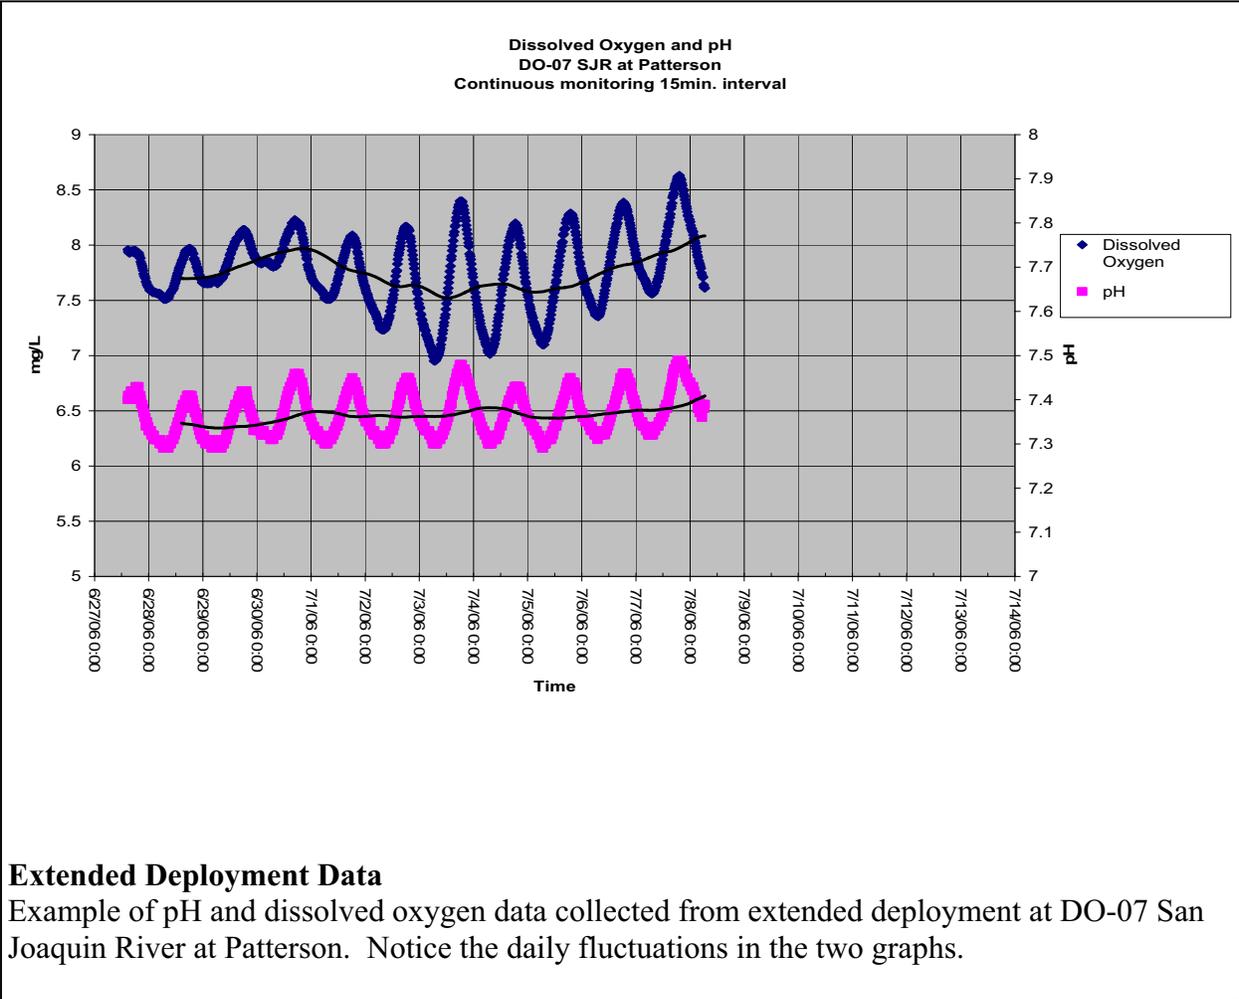
Extended Deployment Data

Example of pH and dissolved oxygen data collected from extended deployment at DO-07 San Joaquin River at Patterson. Notice the daily fluctuations in the two graphs.

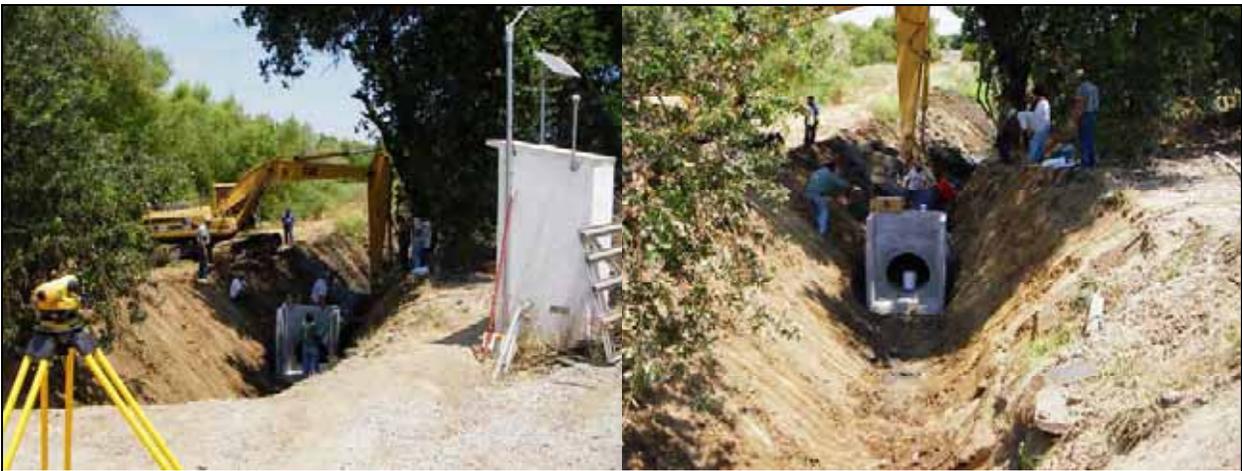
DO-35 Westley Wasteway

Checked on progress of Westley Wasteway. Irrigation District was installing a new weir board structure and reshaping canal. Installed new bubbler and EC line at a later date (see Aug 01, 2006).

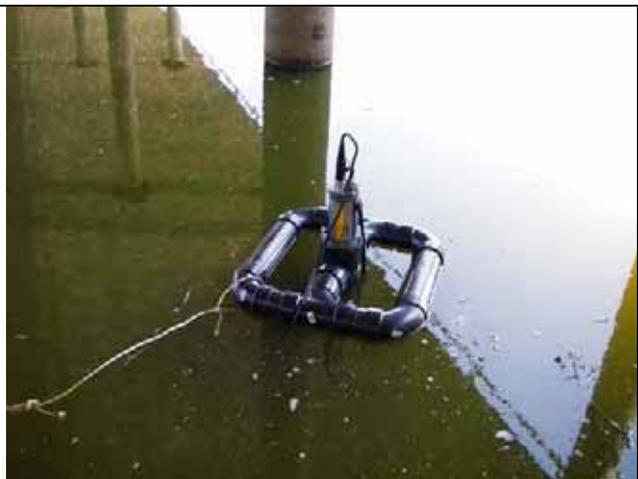
DO-10 SJR at Lander
Custom float holds sonde off of river bottom to take water quality measurements. The green tint is due to suspended algae in river.

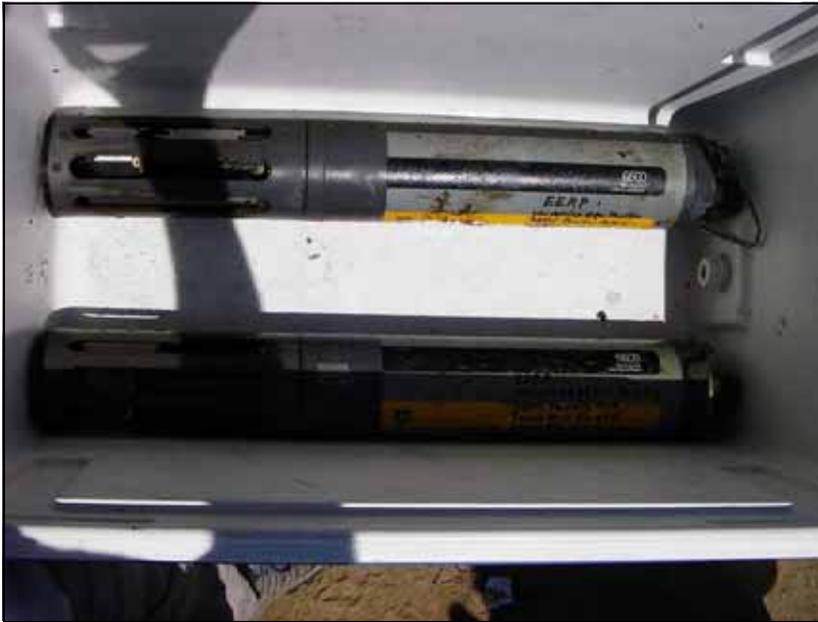
Post Deployment

Sondes were covered in algae and small aquatic macro invertebrates after being left in the field for an extended deployment. Sondes were put into coolers to keep the sensors moist while transporting.

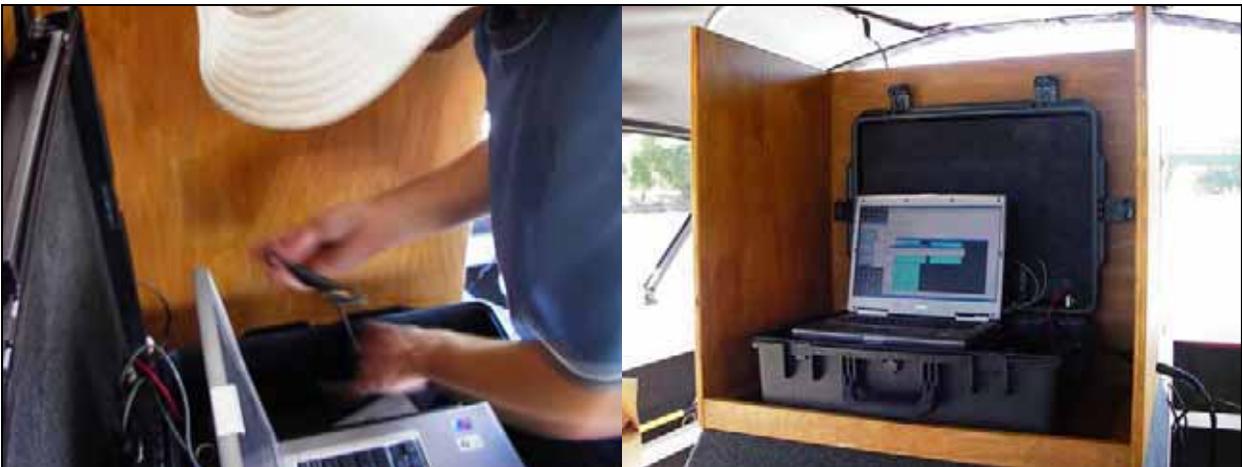
Boat Sampling Equipment

Jeremy Hanlon putting cables through cabinet box. Jeremy Hanlon created a linked Sontek, sonde, and GPS unit to provide his laptop with correlated sampling data while on the boat.

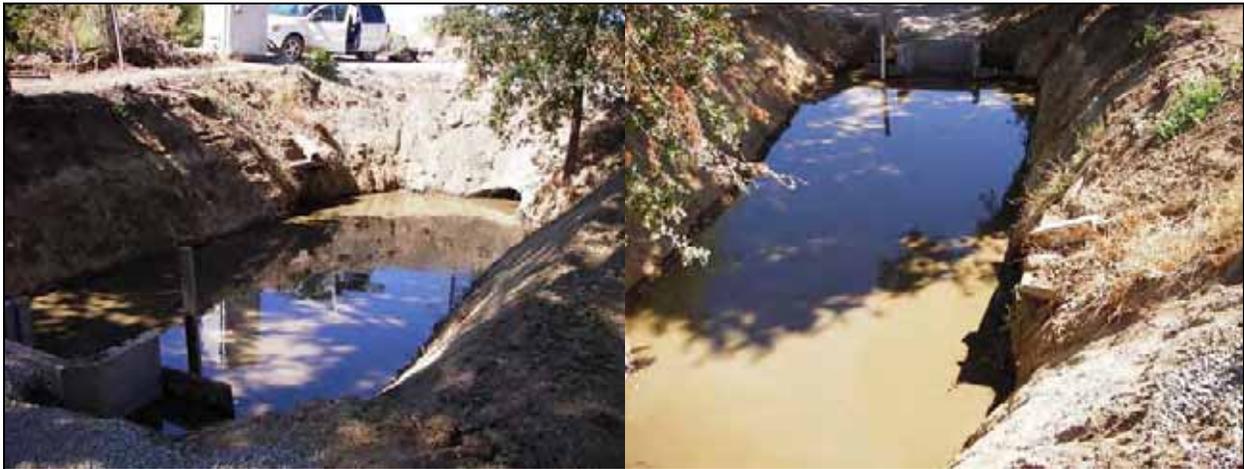
Pictures taken after weir boards installed. Bubbler and EC line have not yet been installed.

Visited DO-35 Westley Wasteway Flow station. Cut and installed five weir boards for a total of eight. Allowed pond to fill up and equilibrate. Took measurement for installation of bubbler line and EC probe (see September 5, 2006).

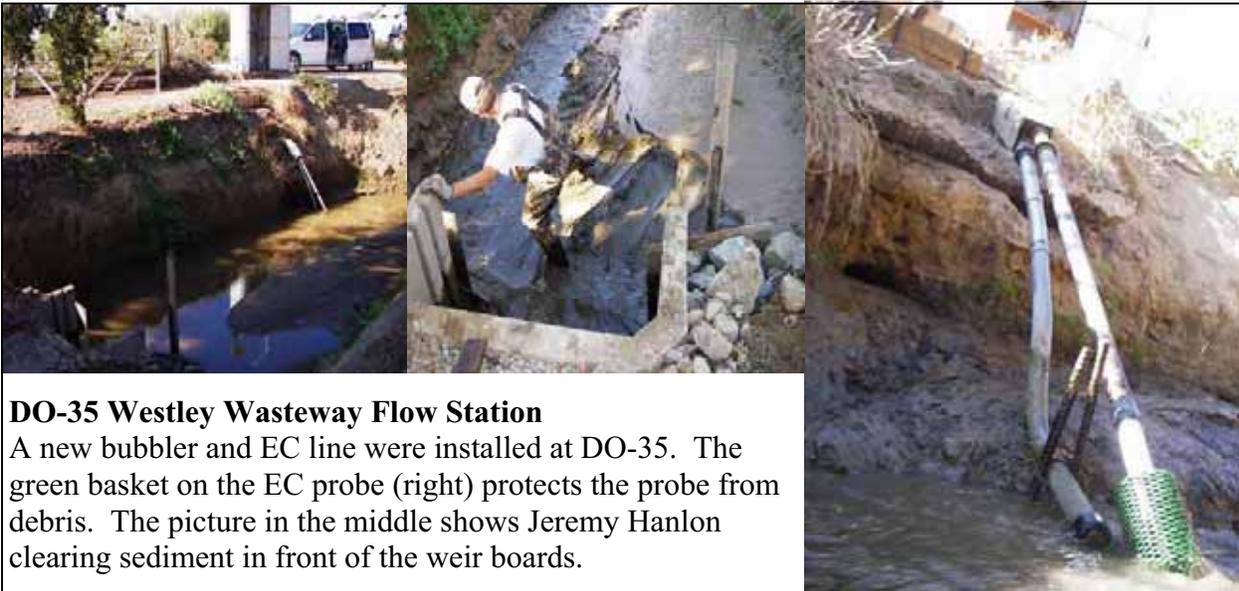
DO-35 Westley Wasteway Flow Station

A new bubbler and EC line were installed at DO-35. The green basket on the EC probe (right) protects the probe from debris. The picture in the middle shows Jeremy Hanlon clearing sediment in front of the weir boards.

DO-35 Westley Wasteway Flow station and DO-20 Los Banos Creek were upgraded. A new bubbler and EC line were installed at DO-35. A junction box and bubbler liner were installed at DO-20. Two weir boards were added at DO-65 Spanish Grant Drain.

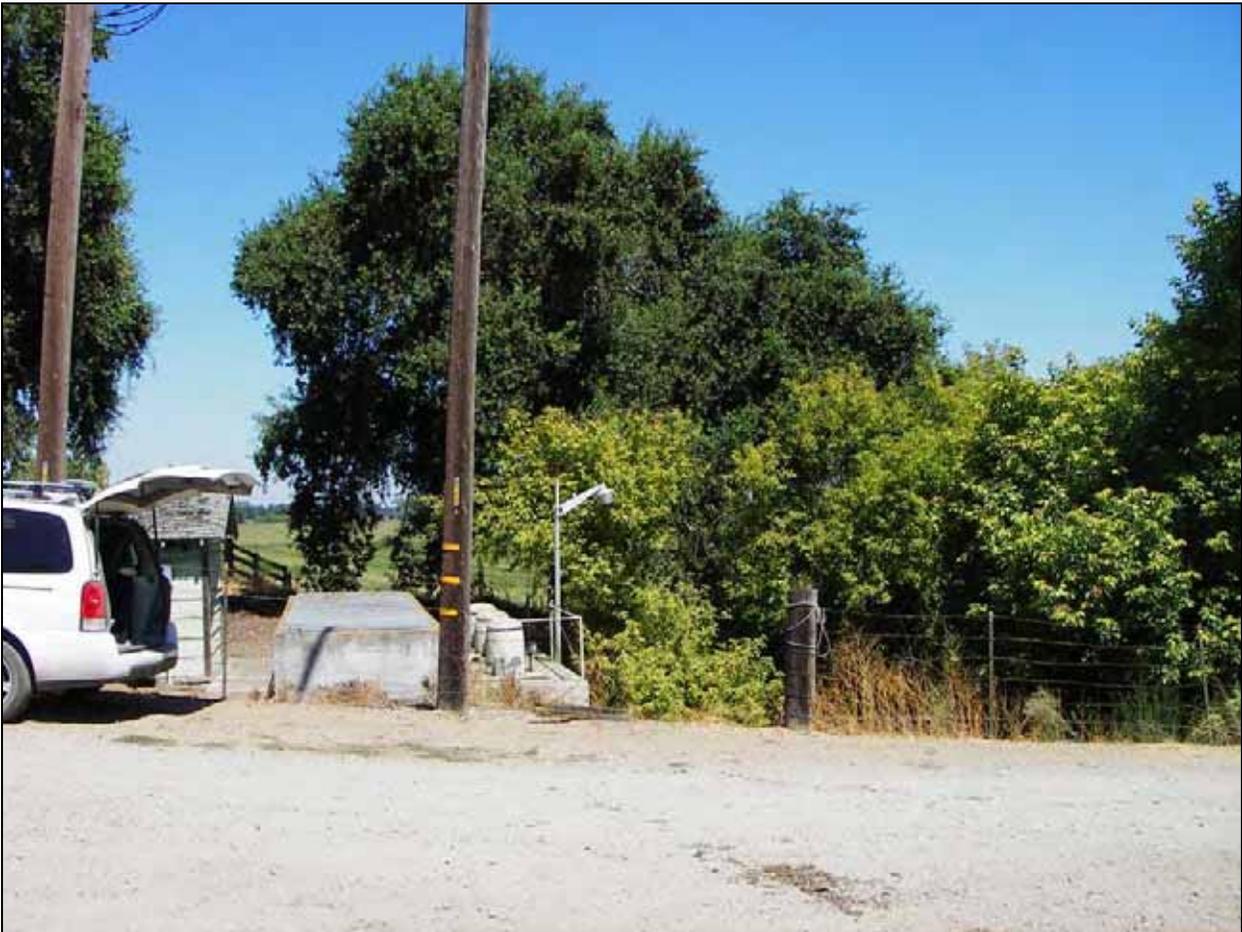
Photo of the usual sampling site. Due to the slippery slope that makes it unsafe to sample, samples were taken a few hundred feet to the right of this photo where it was safe to sample.

Sampling for core sites. Sonde for northern crew was having chlorophyll sensor wiper parking problems. Data was still usable. DO-25 Miller Lake was sampled at a new location upstream in the same channel on opposite bank 100 ft downstream of bridge because old sample location was no longer safe to access due to a slippery embankment.

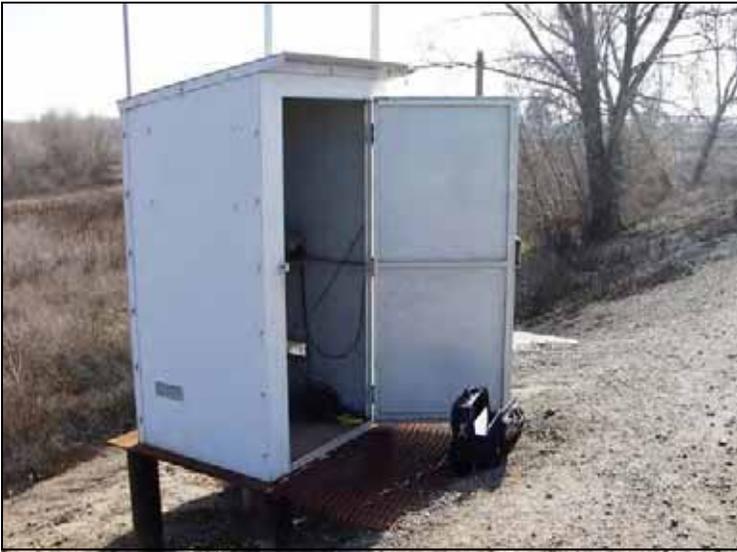
DO-31 New Jerusalem Drain
Station shed at DO-31. Data from monitoring equipment was stored on a data logger located in the station shed and downloaded during station maintenance.

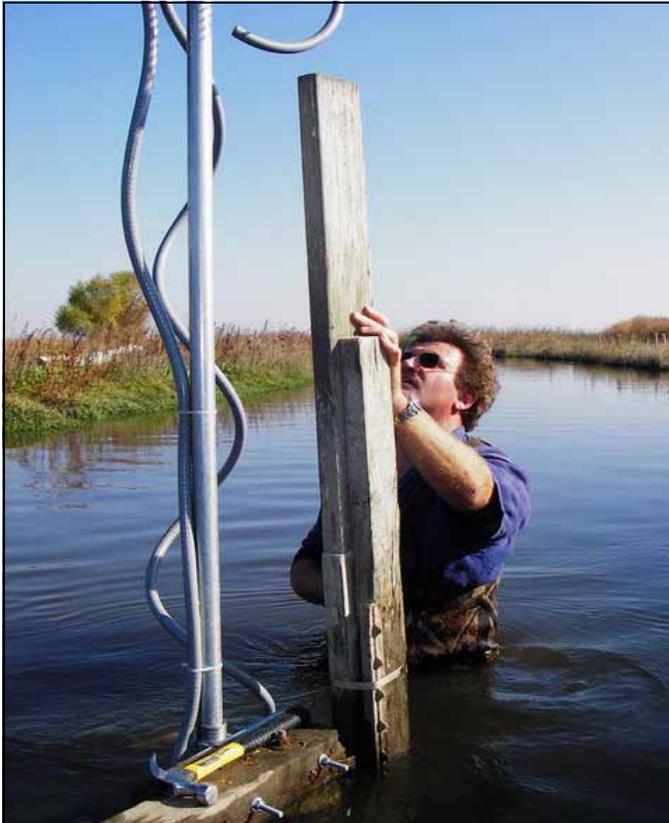
DO-20 Los Banos Creek
(Above) Nigel Quinn (LBNL) helping install Sontek mount to pylon. (Top right) Lara Sparks (Grasslands Water District/Department of Fish and Game) next to junction box for bubbler, EC, and Sontek lines. (Middle right) Jeremy Hanlon and Nigel Quinn installing Sontek mount.
