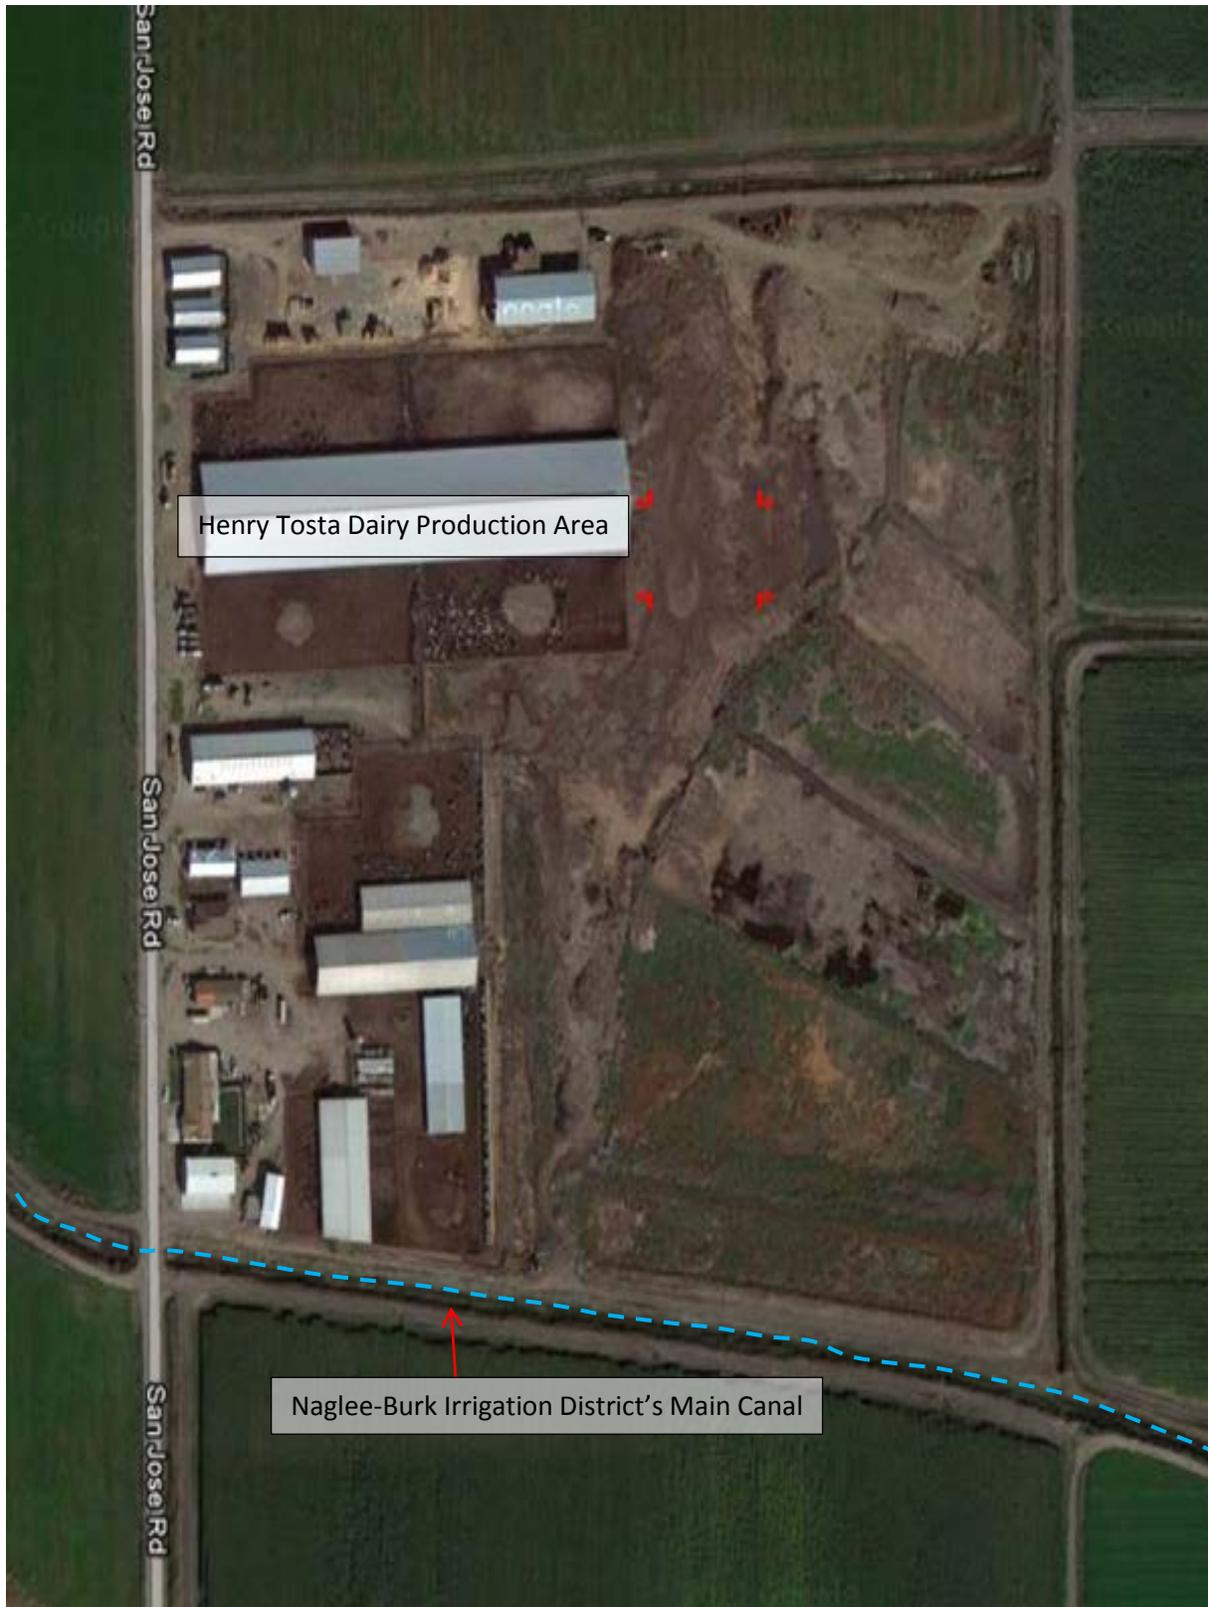
Aerial photo of Henry Tosta Dairy's production area. Note the large amount of manure to the right of all the structures on property. Excessive manure has been accumulating on site for at least the last five years.

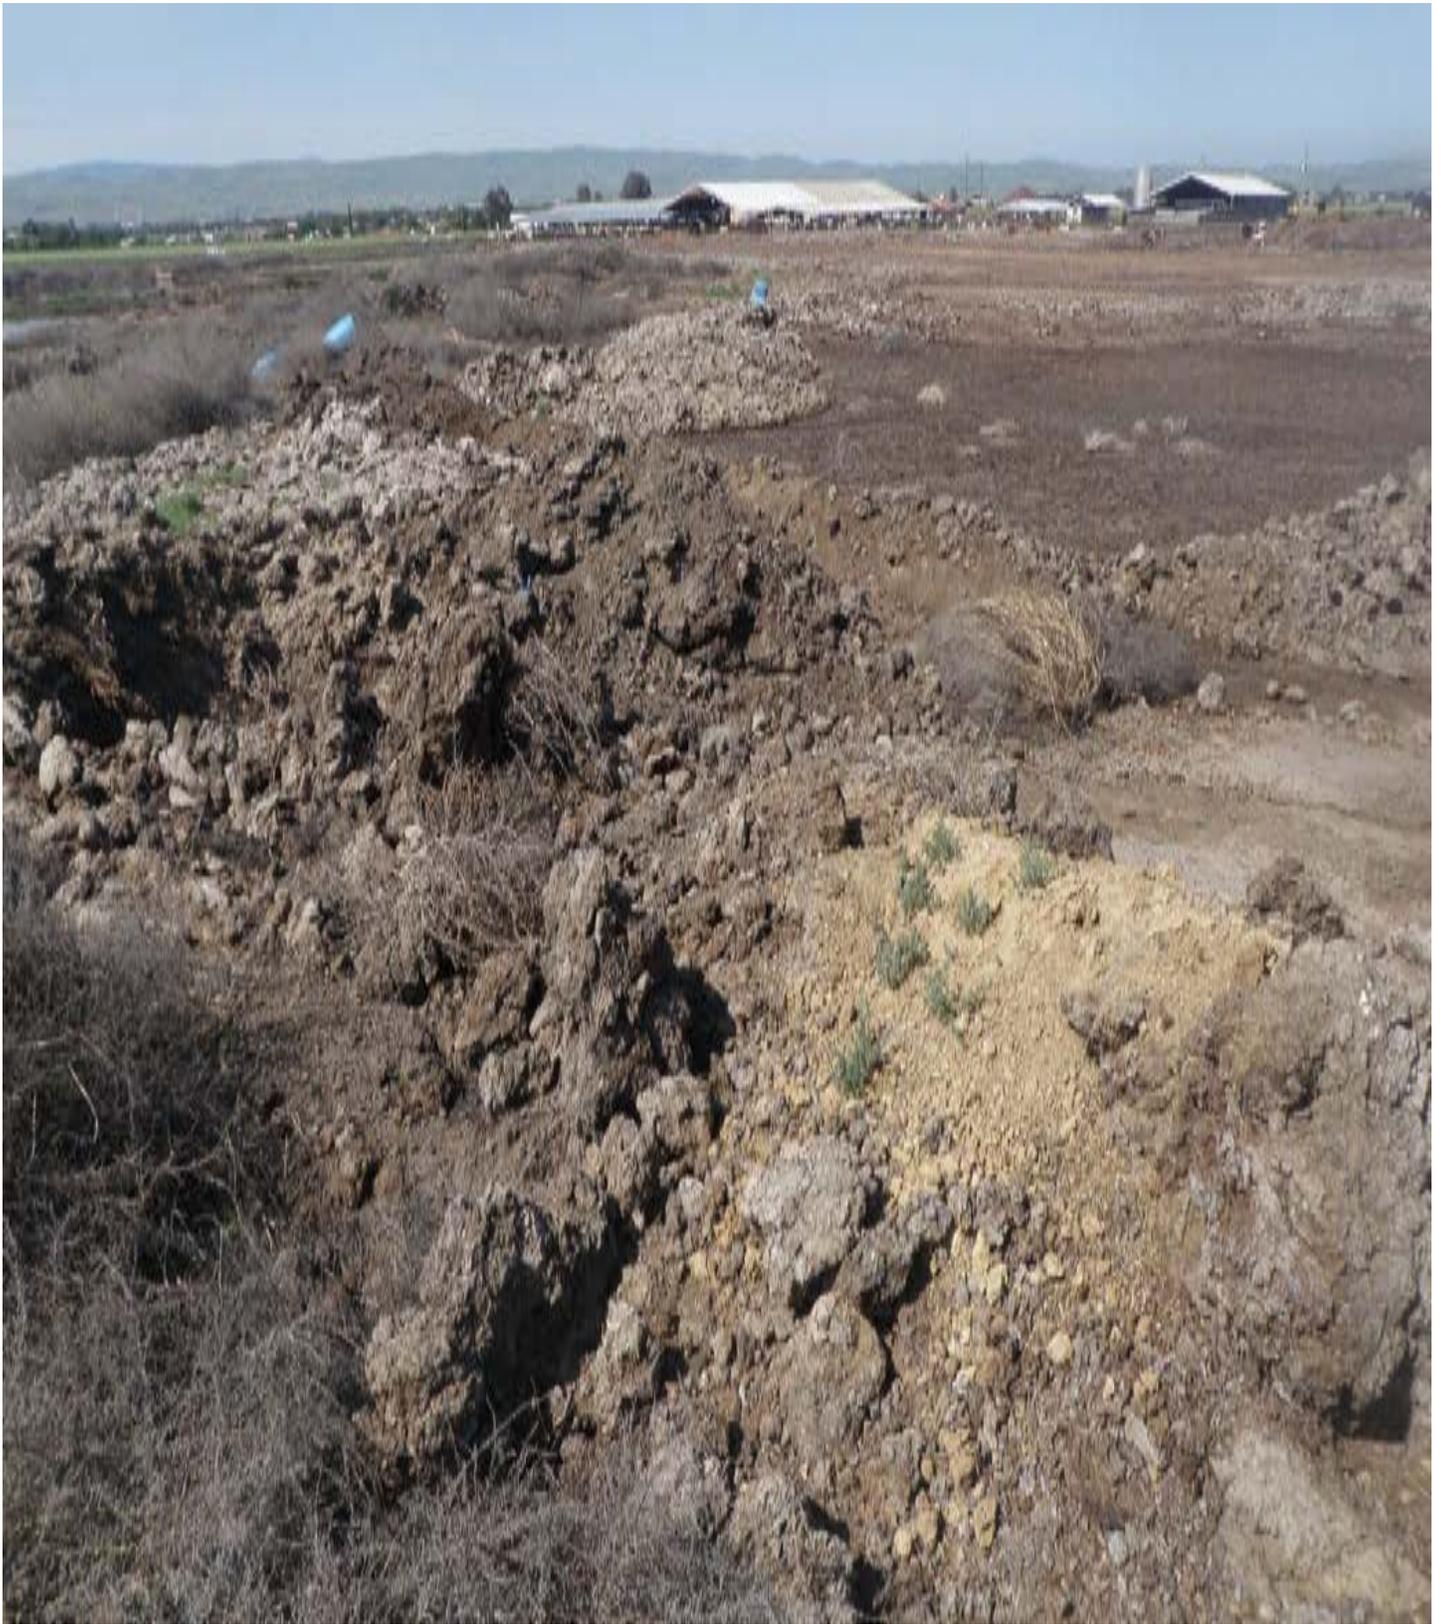
Photo taken from the northeast corner of the production area looking to the southwest; note lack of distinction between manure storage areas. Excessive manure has been allowed to accumulate.

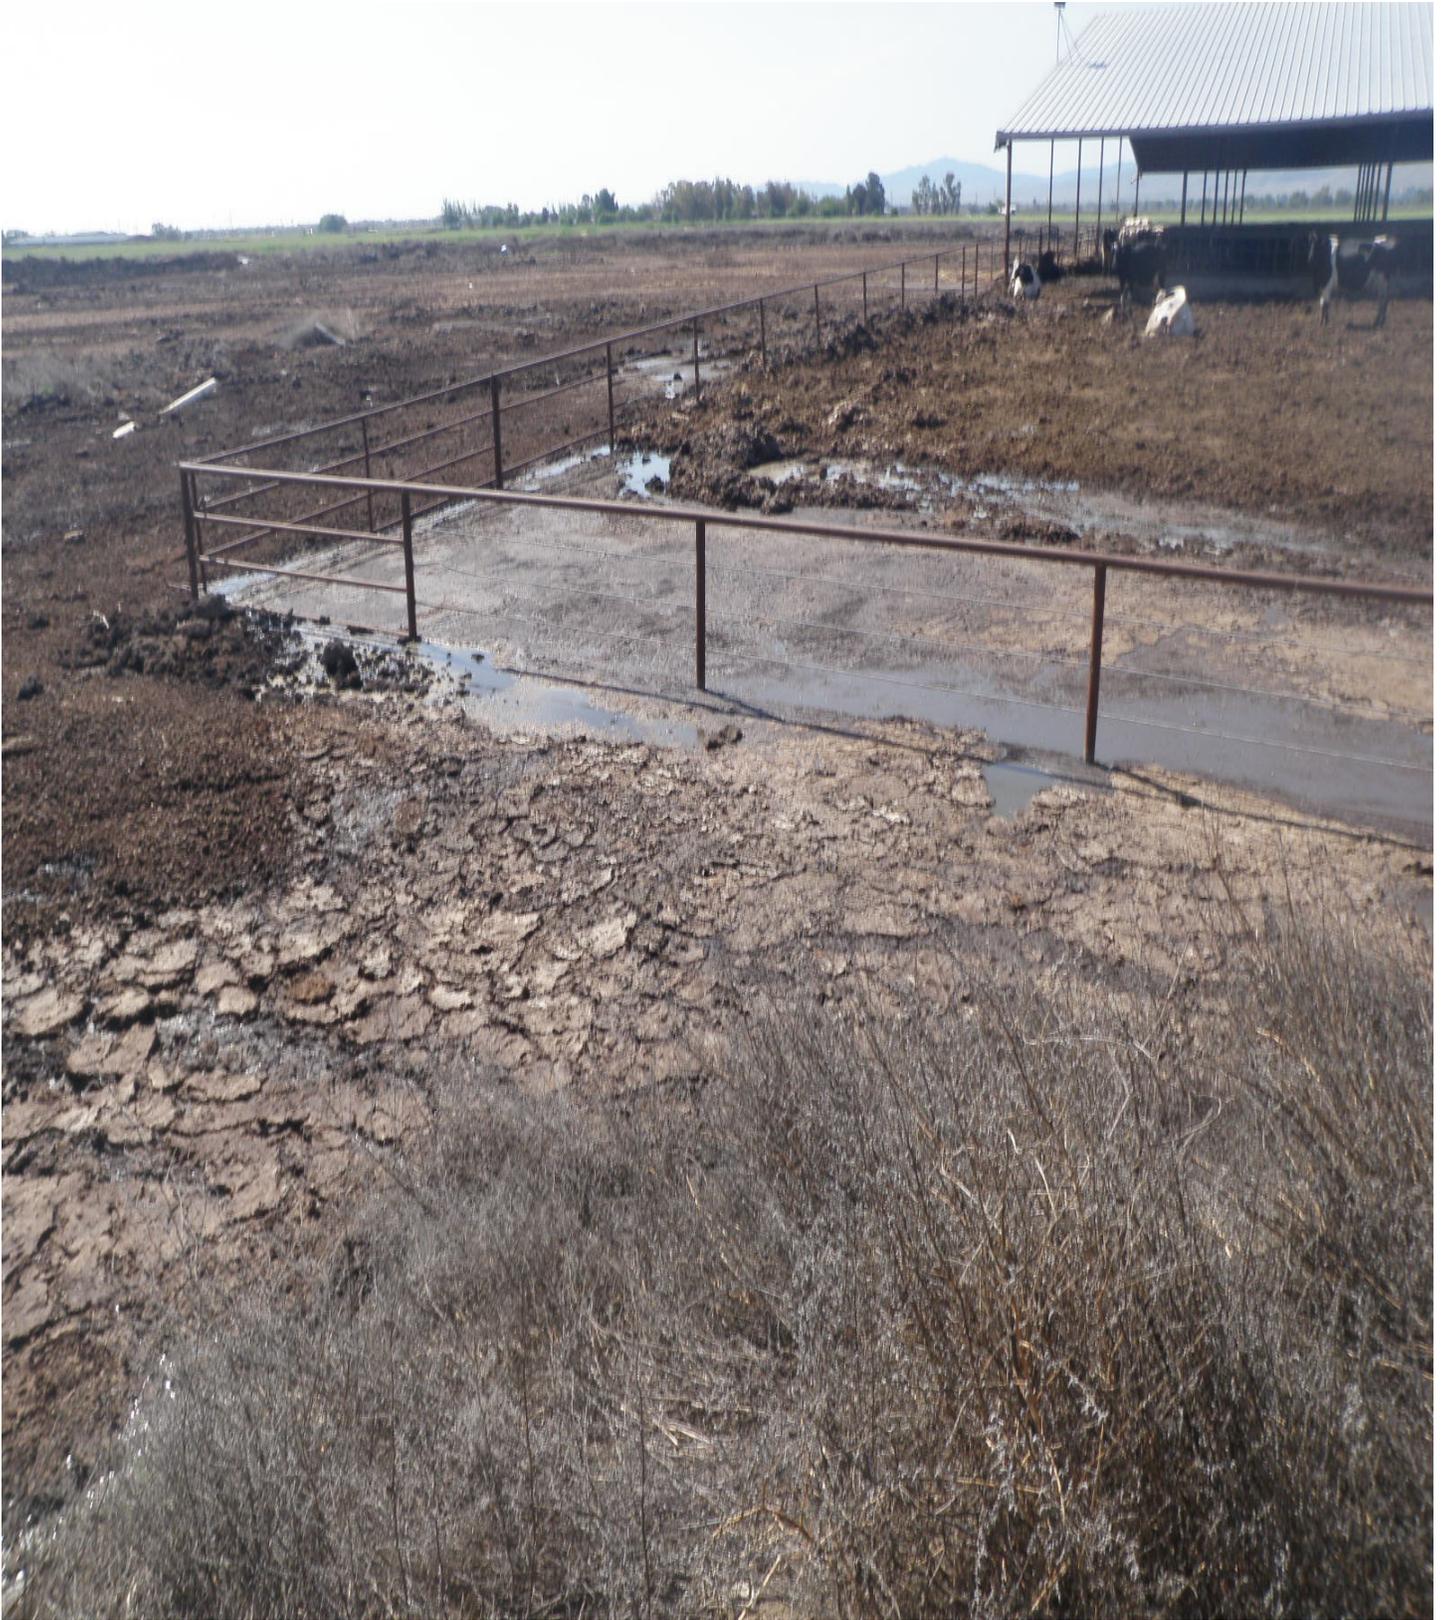
Photo of uncontrolled wastewater creeping into a corral at the Henry Tosta Dairy.

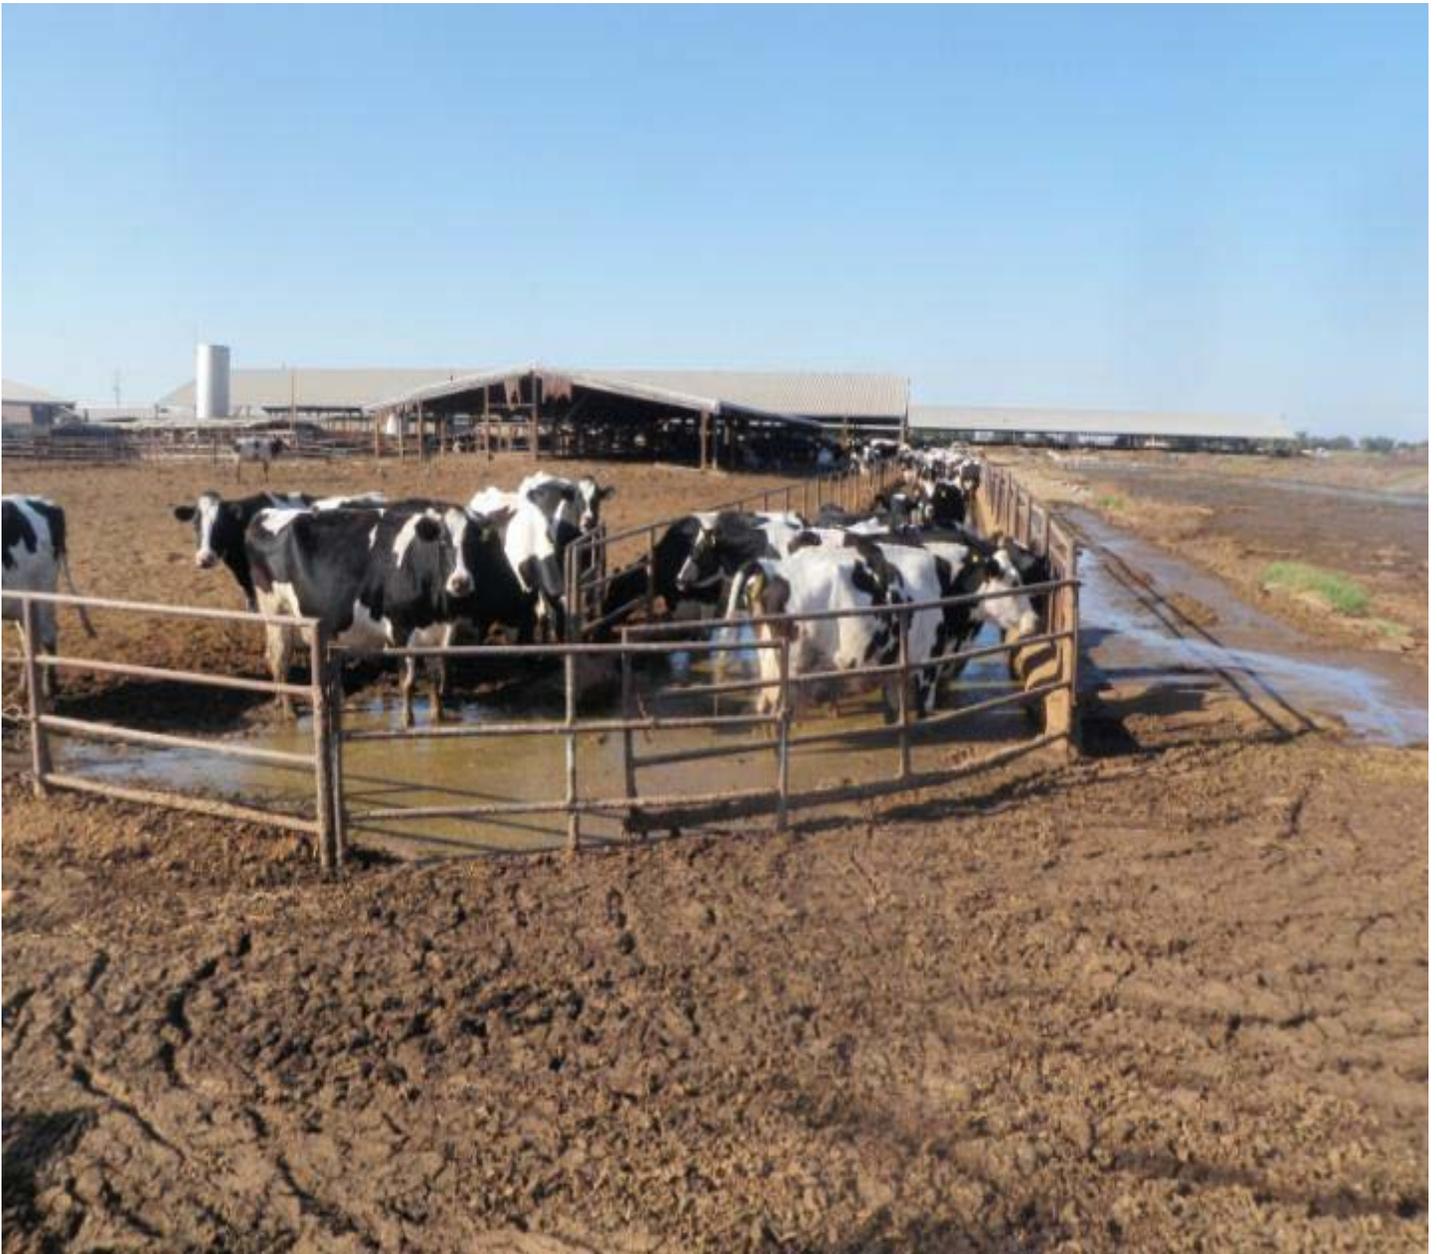
Photo of cows at the Henry Tosta Dairy standing in wastewater and manure slurry that has backflowed from the wastewater pond located to the right of the corral fence.

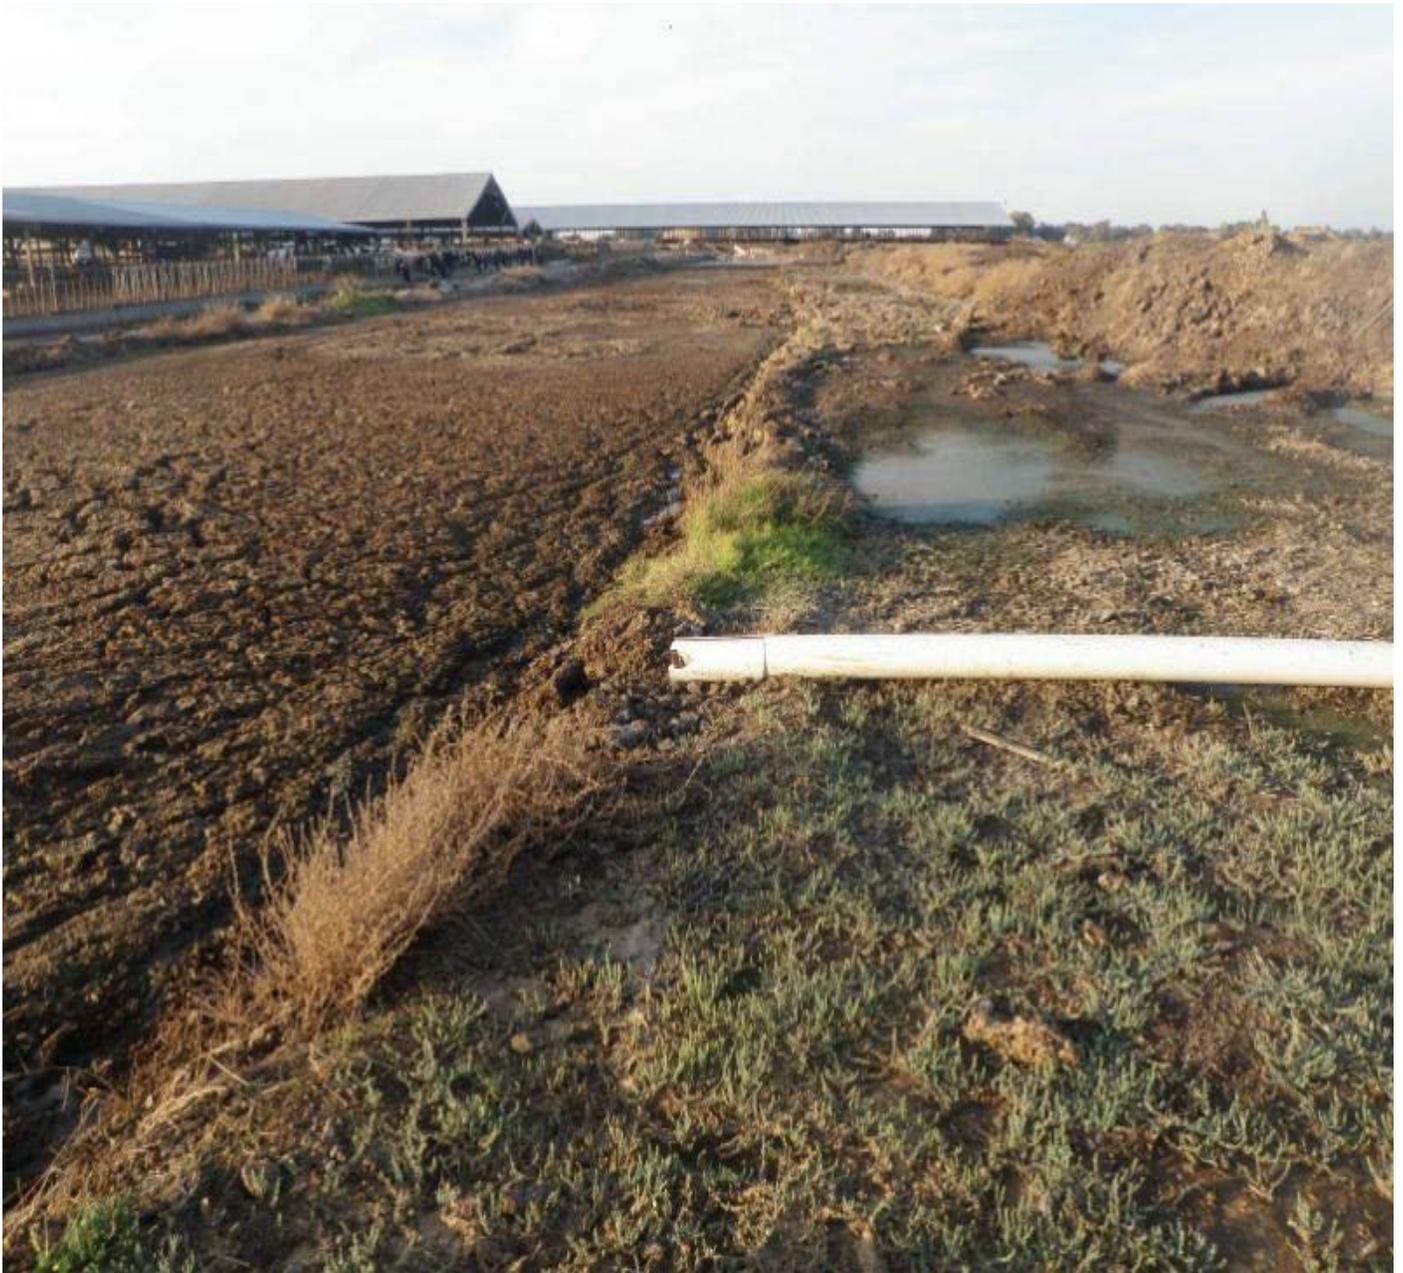
Photo of puddles of wastewater remaining on the lagoon embankments adjacent to the solids settling basin; puddles of wastewater demonstrate the embankments of the solids settling basin had recently over-topped.

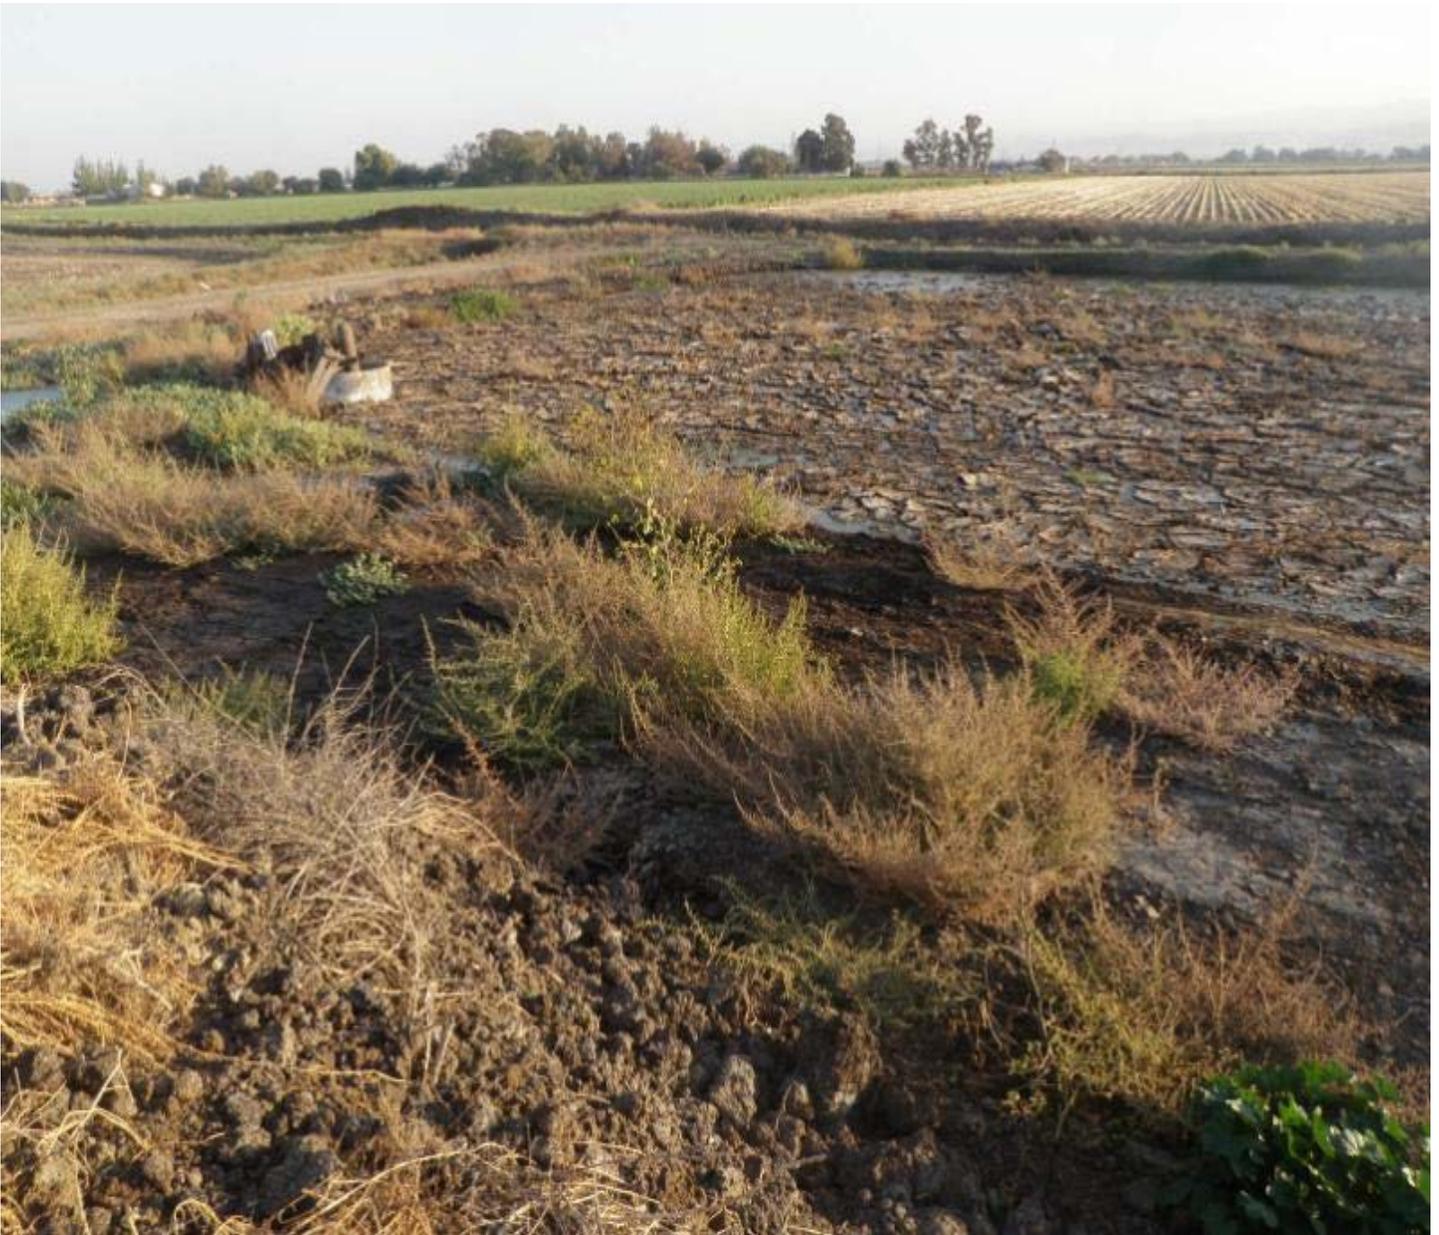
Photo of solids settling basin #2. Note excessive accumulated manure and wastewater contained in the basin; no freeboard was observed.
