**California Forestry Association**

**Wetland/Riparian Policy**

Re: Comments on Proposed Wetland and Riparian Area Protection Plan

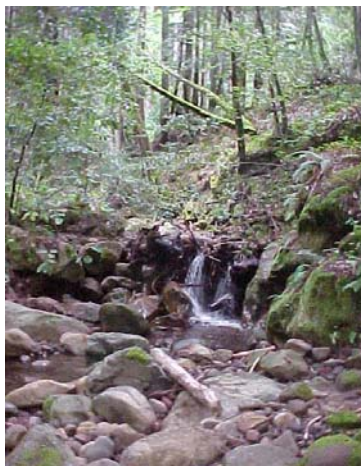
Figure 1. A small watercourse or stream in a forest in California.

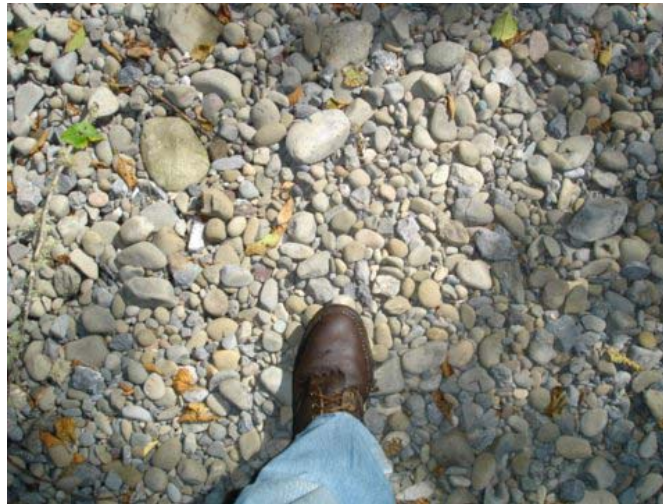
Figure 2. Substrate of a watercourse or stream in a forested watershed on the California coast. Reaches with clean gravel are an important habitat component of many forested streams. A key objective of the water quality related FPRs is to prevent transport of excessive fine sediment (e.g., sand and silt) to watercourse channels.

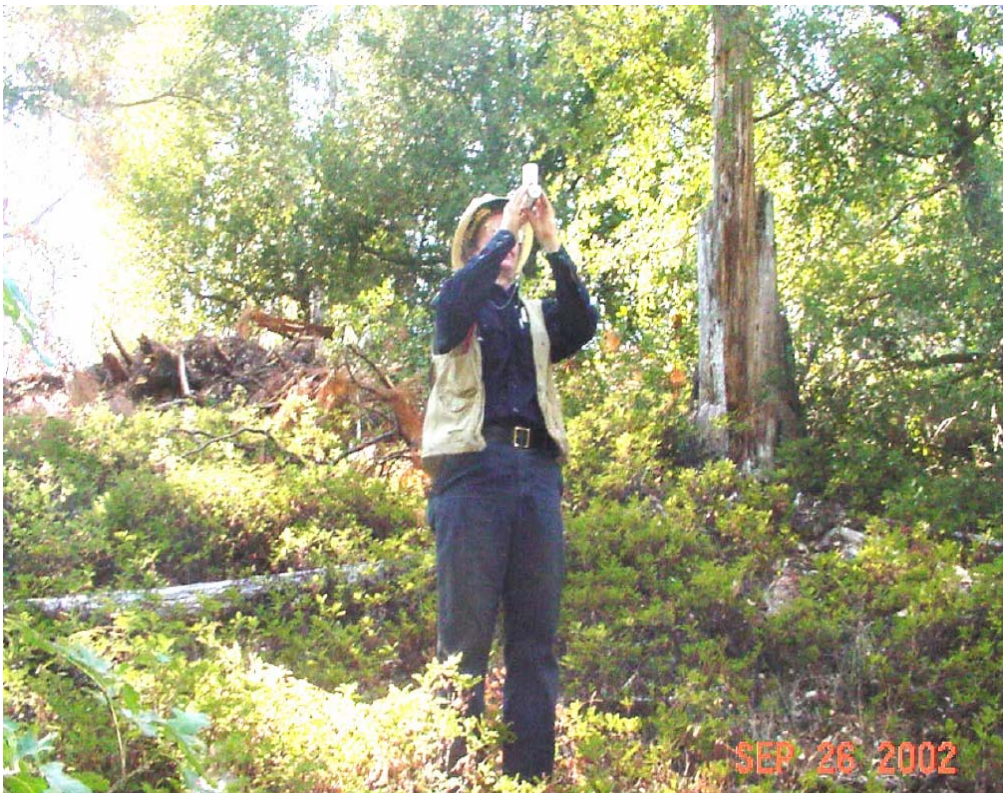
Figure 8. Pete Cafferata, CDF, making canopy cover measurements using a sighting tube.

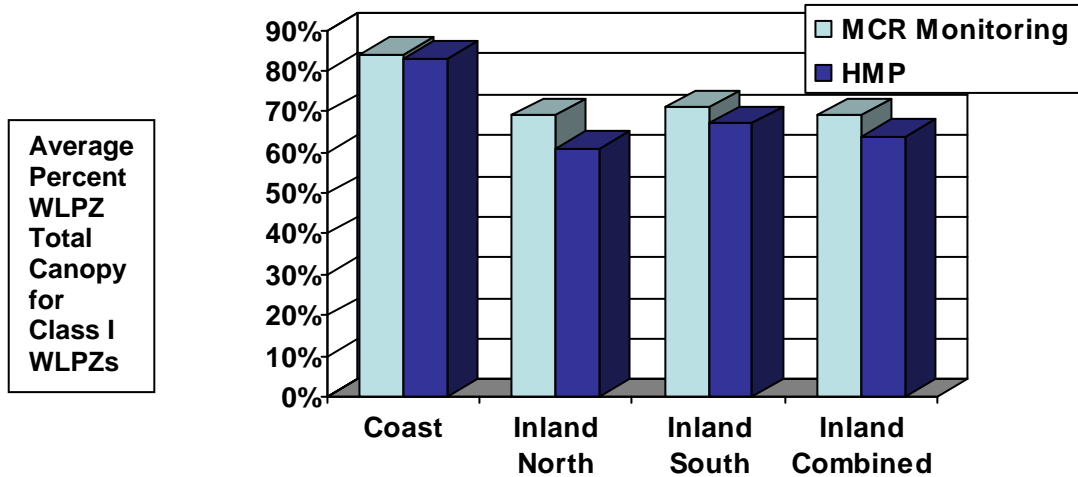
Figure 11. Graphic comparison of MCR (2001-2004) and Hillslope Monitoring Program (1999-2001) results for average percent WLPZ total canopy by Region for Class I watercourses.

Class I WLPZ Comparison	MCR Monitoring (2001-2004) Class I WLPZ percent total canopy	HMP (1999-2001) Class I WLPZ percent total canopy
Coast (Region 1)	84% n = 29	83% n = 27
Inland North (Region 2)	69% n = 18	61% n = 17
Inland South (Region 4)	71% n = 5	67% n = 13
Inland (Regions 2&4 combined)	69% n = 23	64% n = 30

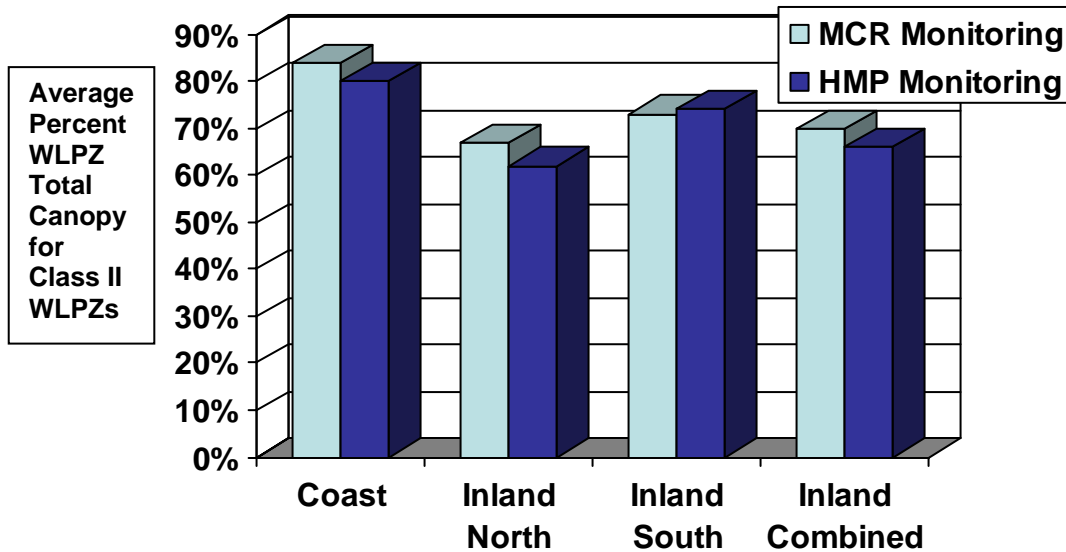
Figure 12. Graphic comparison of MCR (2001-2004) and Hillslope Monitoring Program (1999-2001) results for average percent WLPZ total canopy by Region for Class II watercourses.

<b>Class II WLPZ Comparison</b>	<b>MCR Monitoring (2001-2004) Class II WLPZ percent total canopy</b>	<b>HMP (1999-2001) Class II WLPZ percent total canopy</b>
Coast (Region 1)	84% n = 81	80% n = 109
Inland North (Region 2)	67% n = 31	62% n = 46
Inland South (Region 4)	73% n = 23	74% n = 19
Inland (Regions 2&4 combined)	70% n = 54	66% n = 65

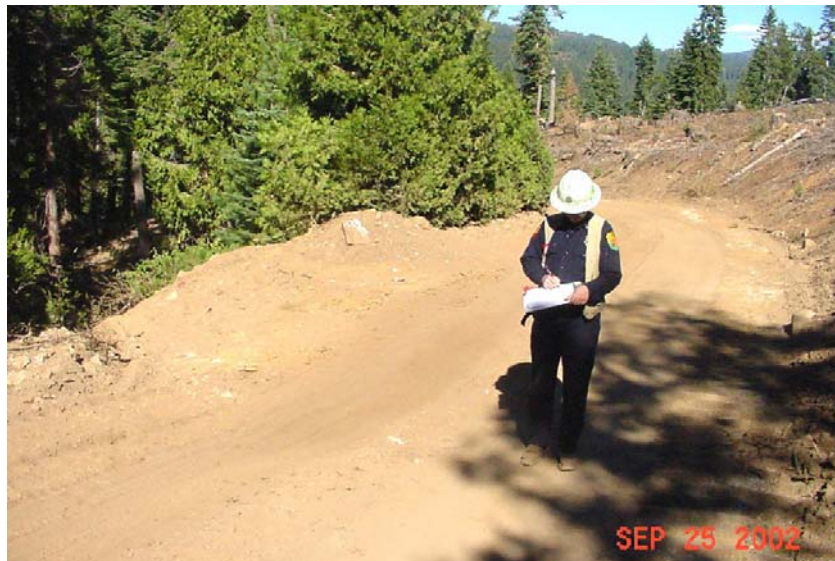
Figure 13. Pete Cafferata, CDF, recording road observations at a rolling dip. Orange box on his right hip is a hip-chain which meters-out string for tracking distances of specific road-related features along a 1000-foot sample segment.

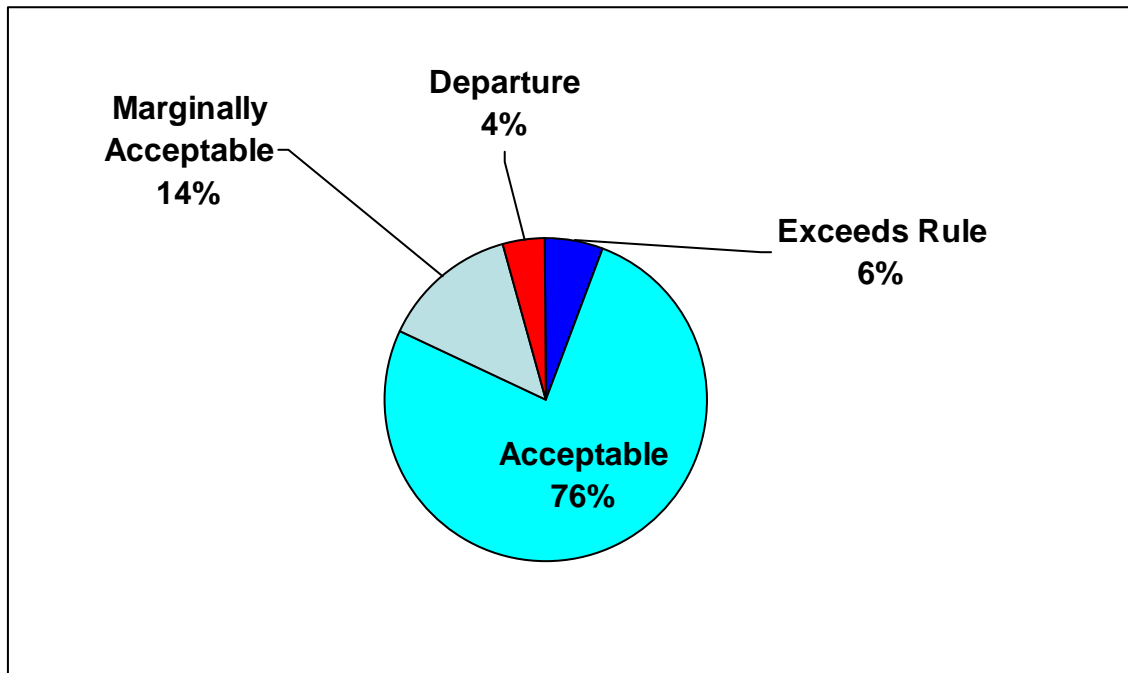
Figure 14. Overall road-related features rated for implementation (n = 1,991).

As shown below in Figure 14, of the 1,991 implementation evaluations, 4% were rated as departures from the FPRs, 14% were rated as marginally acceptable, 76% were rated as acceptable, and 6% were rated as exceeding the FPR requirements (greater than acceptable implementation).

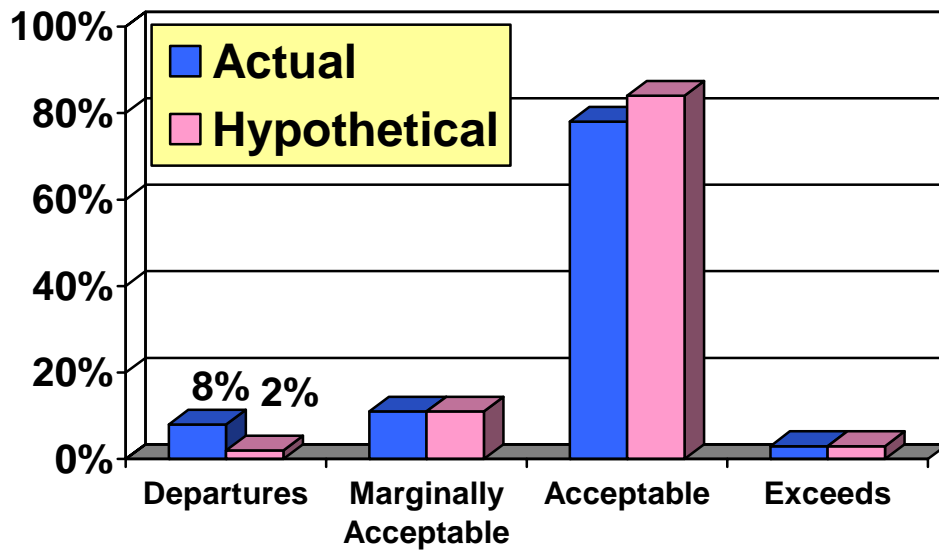
Figure 17. Inland (CDF Regions 2 & 4) hypothetical exercise: What would happen to the departure rate if we found and fixed the worst 6% of all road segments? Answer, the departure rate would hypothetically drop significantly from 8% to 2%.

Assuming that departure rates for the Coast and Inland regions have been consistently evaluated, there are greater opportunities for improved implementation Inland, where the worst 6% of road segments account for three-quarters of the observed departures. Consequently, preventing departures on the worst 6% of the road mileage would hypothetically reduce the inland departure rate from 8% to a much more acceptable 2%, as shown in Figure 17, below.

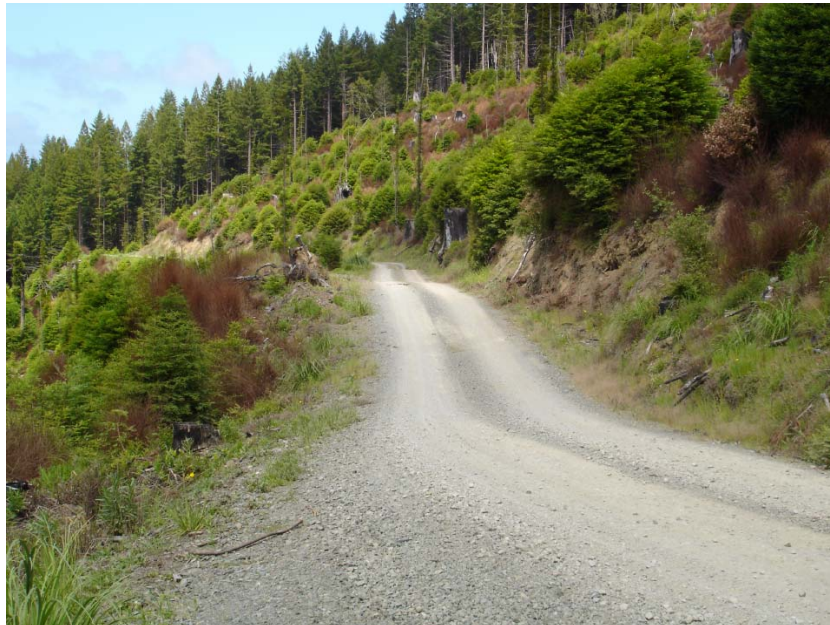
Figure 19. Example of road segment built to drain properly in wet weather. Note the two functional dips and their spacing.

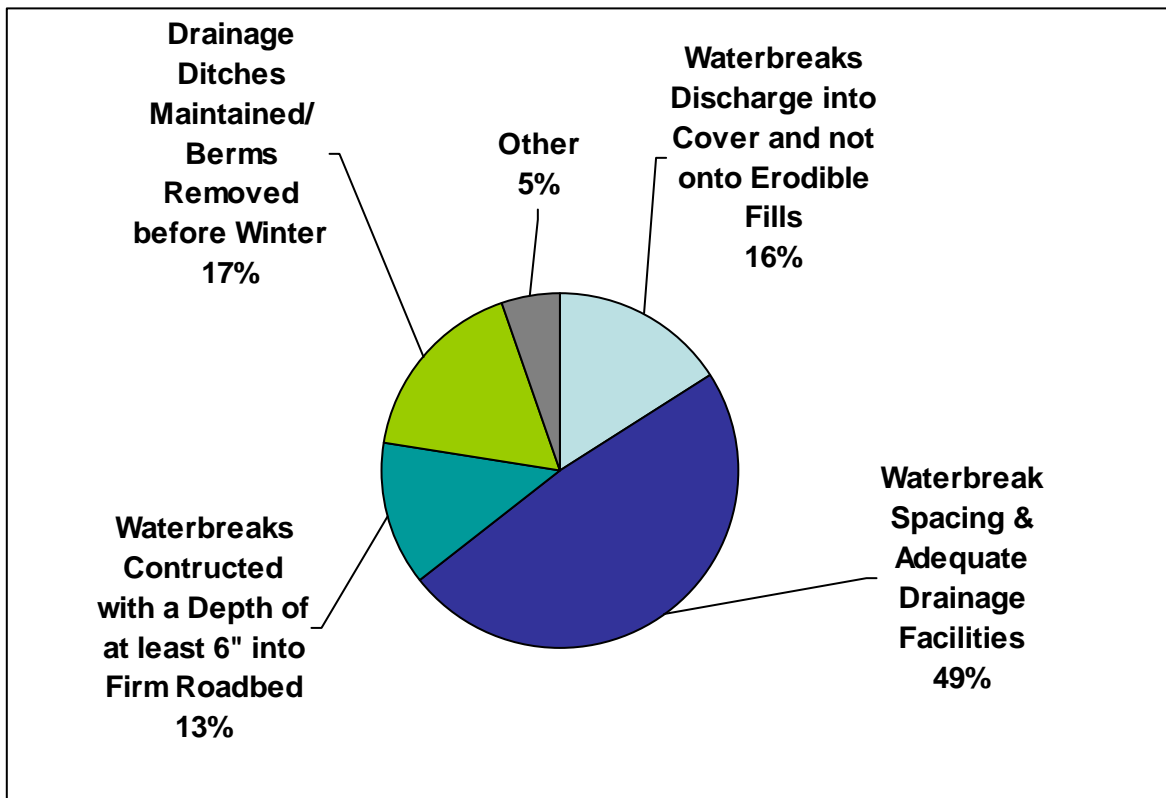
Figure 20. Departures from the road-related FPRs – percentages by category.

When looking at specific types of features related to observed departures from the FPRs, there is very a definite pattern. Overall, 95% of the observed road-related departures involve FPRs directly related to providing proper drainage. Some of the remaining five percent of departures may also be directly or indirectly affected by drainage. Figure 20, shown below, groups the 95% of departures that are definitively related to drainage into five major categories, and a list of these departures by specific FPR is provided at the end of this section.

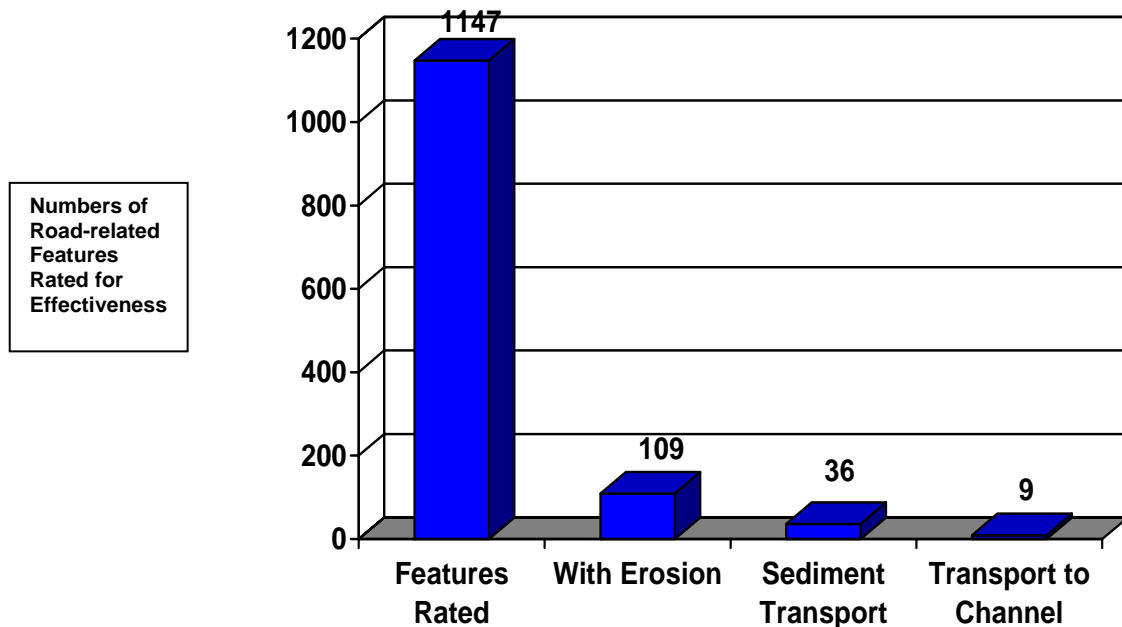
Figure 21. Road-related features rated for effectiveness, comparing the total features rated to the number with evidence of erosion, sediment transport and transport to channel.

As shown in Figure 21, below, evidence of erosion was found on 109 of the 1,147 road-related features rated for effectiveness. Sediment transport was found associated with 36 of the 109 erosion features, and 9 of those 36 features had evidence of sediment transport to a watercourse channel.

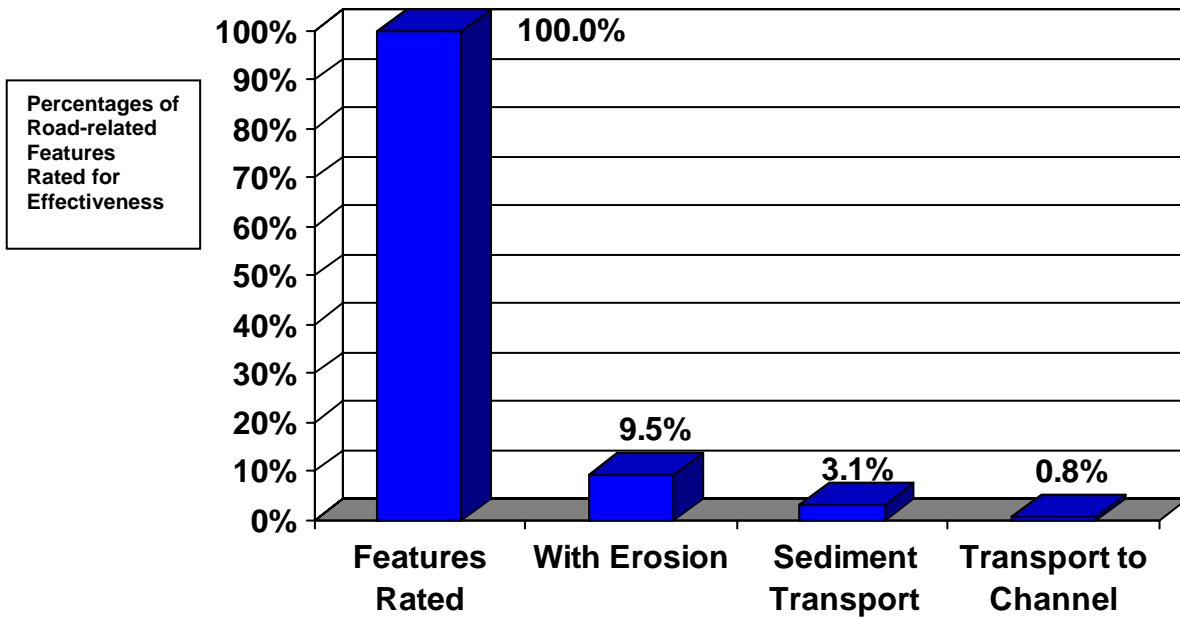
Figure 22. Road-related features rated for effectiveness as percentages, comparing the total features rated to the number with evidence of erosion, sediment transport and transport to channel.

When calculated as a percentage of the total features rated, 9.5% of the road features evaluated for effectiveness had erosion, 3.1% showed signs of sediment transport, and 0.8% showed evidence of sediment transport to a channel, as shown in Figure 22.

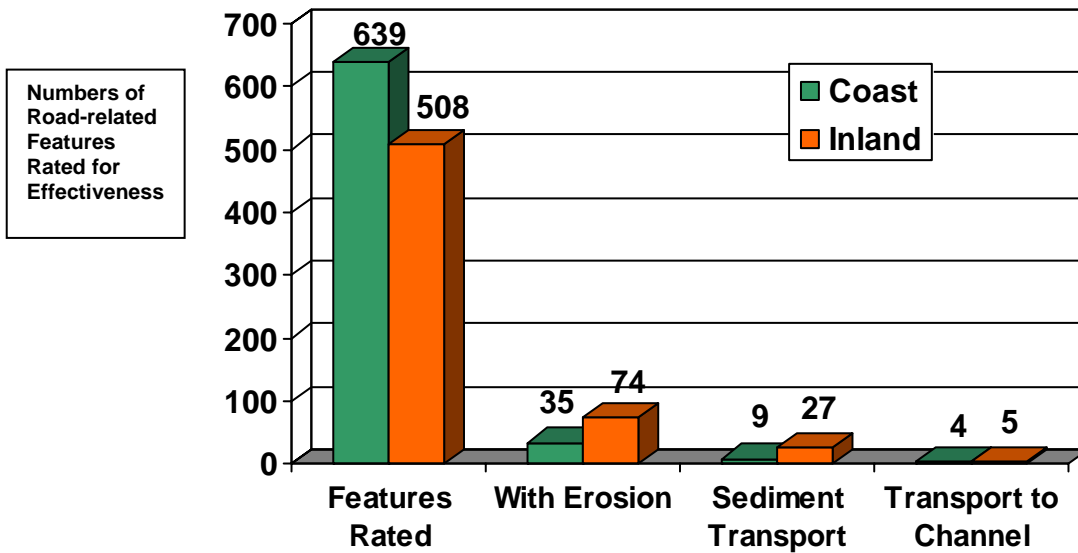
Figure 23. Coast vs. Inland road-related features rated for effectiveness, comparing the total features rated to the number of features with evidence of erosion, sediment transport and transport to channel.

Dividing the data into regions yields 639 road-related features rated for effectiveness on the Coast (CDF Region 1) and 508 Inland (CDF Regions 2 & 4). Of these, 35 and 74 had evidence of erosion, 9 and 27 showed evidence of sediment transport, and 4 and 5 had evidence of transport to a channel for the coast and inland regions, respectively, as shown in Figure 23.

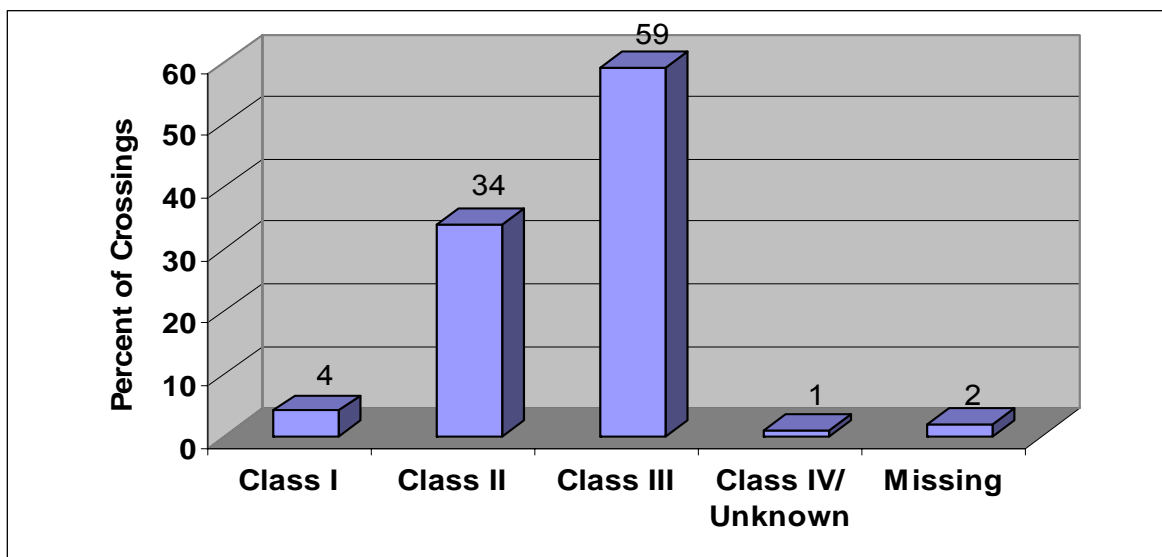
Figure 27. Percentages of the sampled watercourse classes.

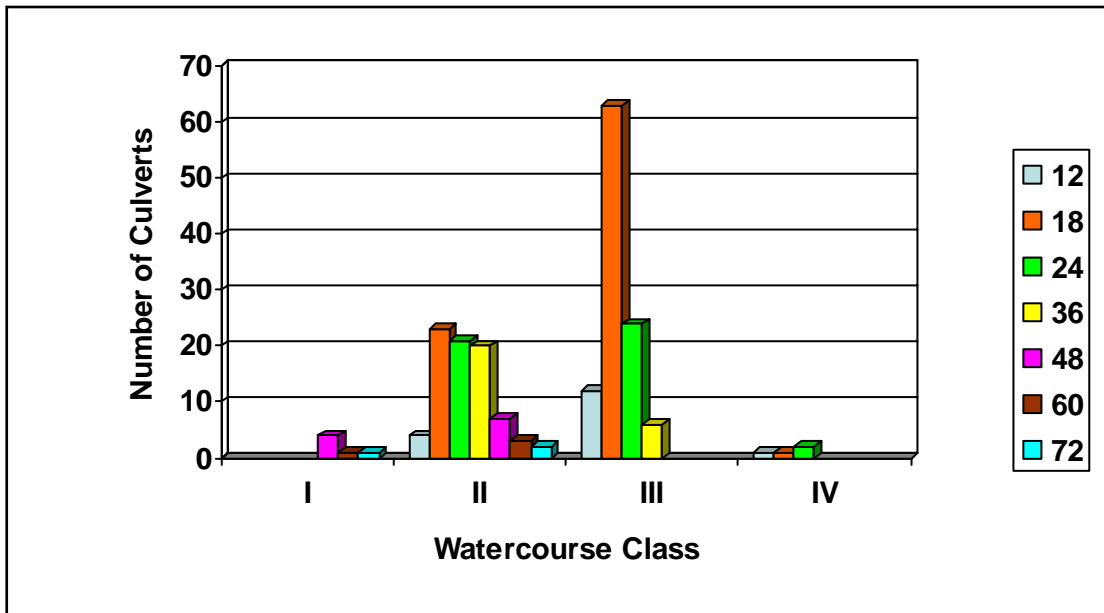
Figure 29. Distribution of culvert diameter categories (inches) by watercourse classes.

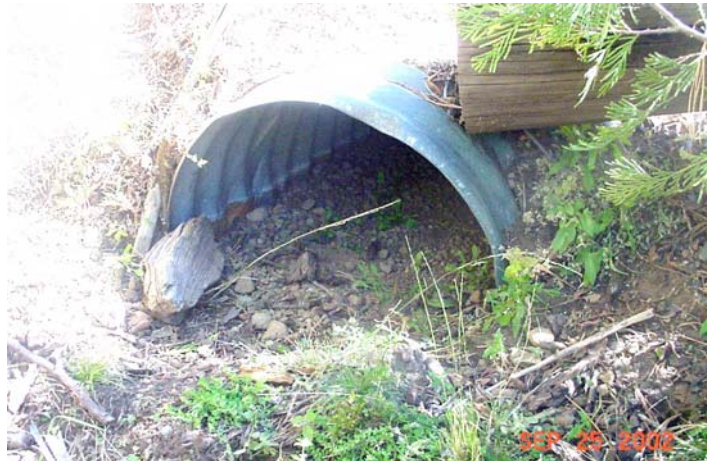
Figure 32. Example of an existing culvert that is partially plugged with sediment on a central Sierra Nevada THP included in the MCR sample.

Watercourse crossing effectiveness was evaluated by applying one of the following four ratings to 27 crossing-related parameters: not applicable (N/A), not a problem (usually “none” or “slight”), a minor problem, or a major problem.<sup>8</sup> Examples of crossings rated for effectiveness are shown in Figures 31 and 32. On nearly 25 percent of the 289 crossings rated for effectiveness, this evaluation was conducted one or more years after the implementation ratings were made. The rest of the crossings with effectiveness ratings were evaluated for implementation and effectiveness at the same, or nearly the same, time. Table 17 shows the percentage of major and minor problems when all crossing types are combined. The percentage of crossings with major and minor problems for different combinations of crossing types, crossing features, and problem types is displayed in Table 18.

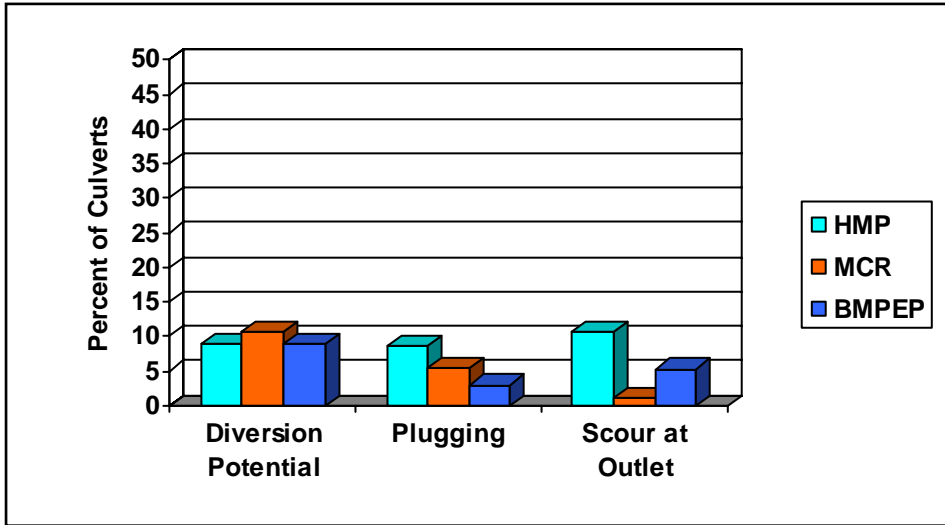
Figure 35. Comparison of three Modified Completion Report (MCR) culvert crossing effectiveness categories to results from the Hillslope Monitoring Program (HMP) and USFS BMP Evaluation Program. Ratings are for major effectiveness categories for the HMP and MCR programs.

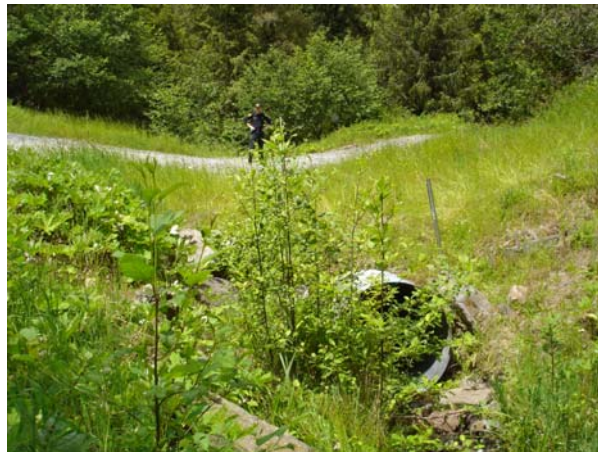
Figure 36. John Munn, CDF, at a culverted watercourse crossing in a forested watershed on the North Coast of California without diversion potential. Munn is standing in the critical dip.
