**California Regional Water Quality Control Board
Colorado River Basin Region 7
SWAMP HABs Program**

**Assessment of Cyanobacteria and Cyanotoxin
Occurrence In Water and Benthic Algal Mats
at the Salton Sea**

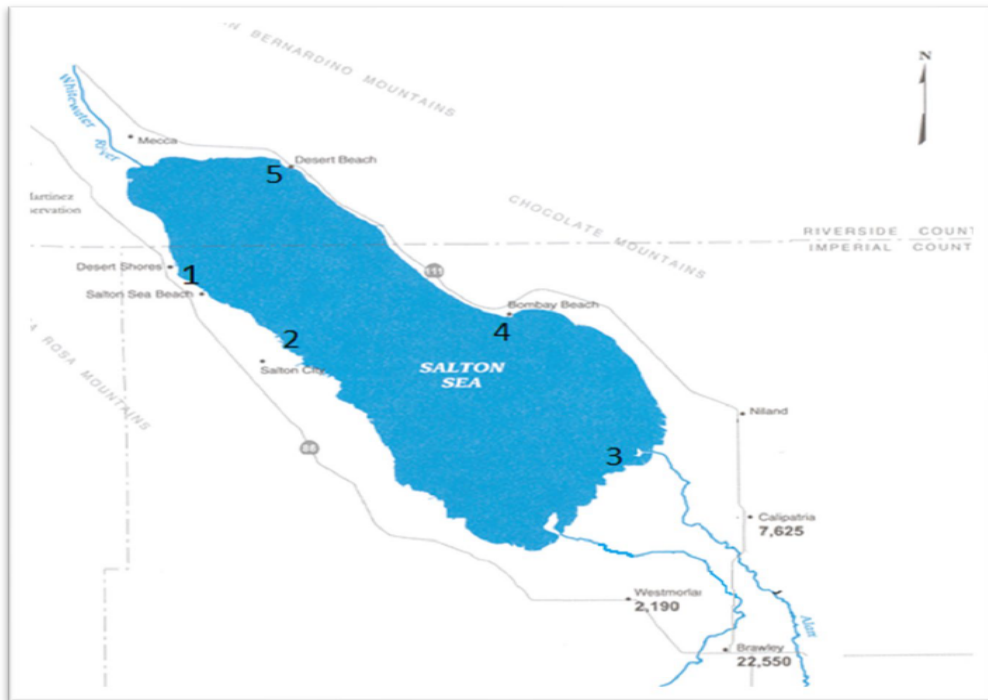
Figure 1: Map of Salton Sea Sampling Sites

Water, algal mat and algal scum grab samples were collected monthly for one year, taken from the shoreline of the Salton Sea at five monitoring sites (Figure 1):

1. Desert Shores
2. West Shores
3. Obsidian Butte
4. Bombay Beach
5. State Recreation Area

Site selection was based upon frequency of public use, site accessibility and historical occurrences of cyanotoxins. There are limited public access points along the perimeter of the sea, and so the most frequently used access points were selected for this assessment. In addition, these sites were known to have detectable levels of cyanotoxins, as discovered during a previous monitoring effort conducted by the Regional Board in 2017-2018.

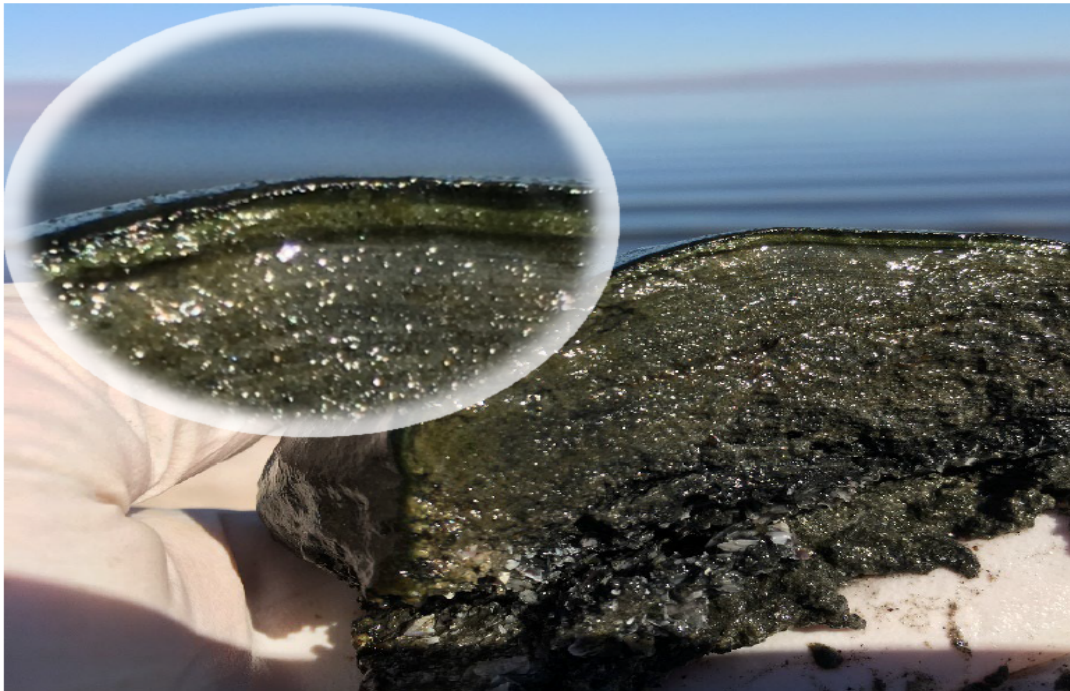
Figure 2: Cross Section of Benthic Sediment with Overlying Algal Mat

Salton Sea algal mat production is prolific, occupying the littoral zone along much of the sea's perimeter. Mats occur in different hues of greens, browns and yellows, varying in thickness up to 7mm, and covering a range of substrates including sediments, gypsum crusts and even fine clay and silts, all of which make sample collections a challenge. Cross-sections of some mats display distinct stratified layers of colored 'bands', which are more visible in thicker mats. Microscopy of the mat material reveals a significant amount of sediment and detritus embedded within the mats, including decaying organic material, barnacle nauplii and *Corixid* body parts.

During collection of algal mats overlying sediments, the mat was at times very thin (<1.0mm), causing more sediment to be collected than algal sample. Soft bristle brushes were found to be incapable of liberating the algal material from the substrate, while a stiffer nylon brush removed both algal material and foreign material, including sediment. Various collection techniques and tools were employed throughout the assessment; however, none were successful in cleanly separating the mat from the underlying substrate. It should be noted that during the latter part of this assessment, the author developed a collection technique that minimizes the amount of sediment collected with the sample. A Standard Operating Procedure (SOP) incorporating that method is under development by the Colorado River Basin Regional Water Quality Control Board.

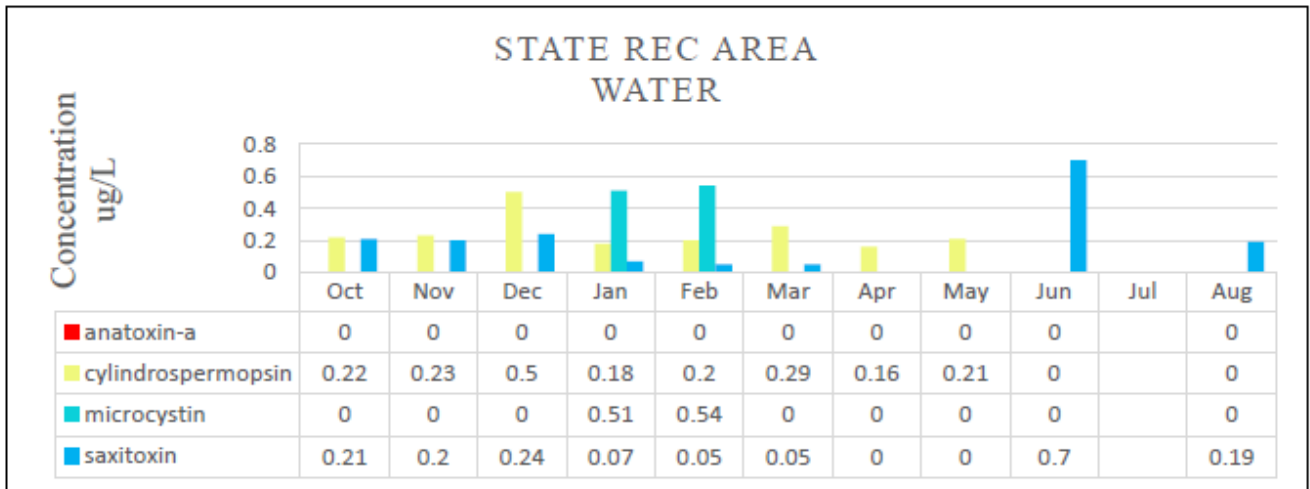
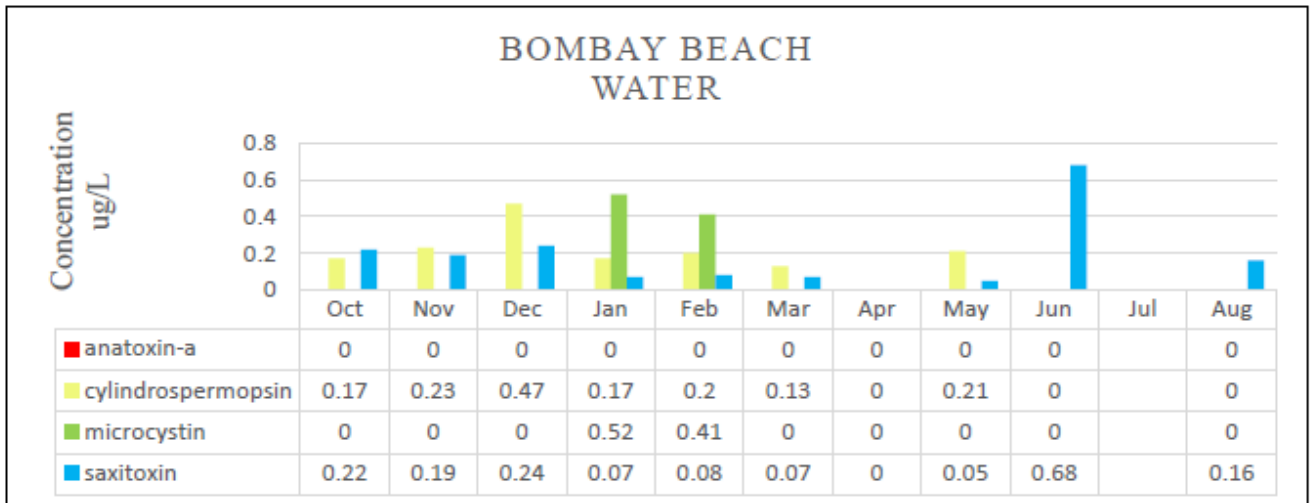
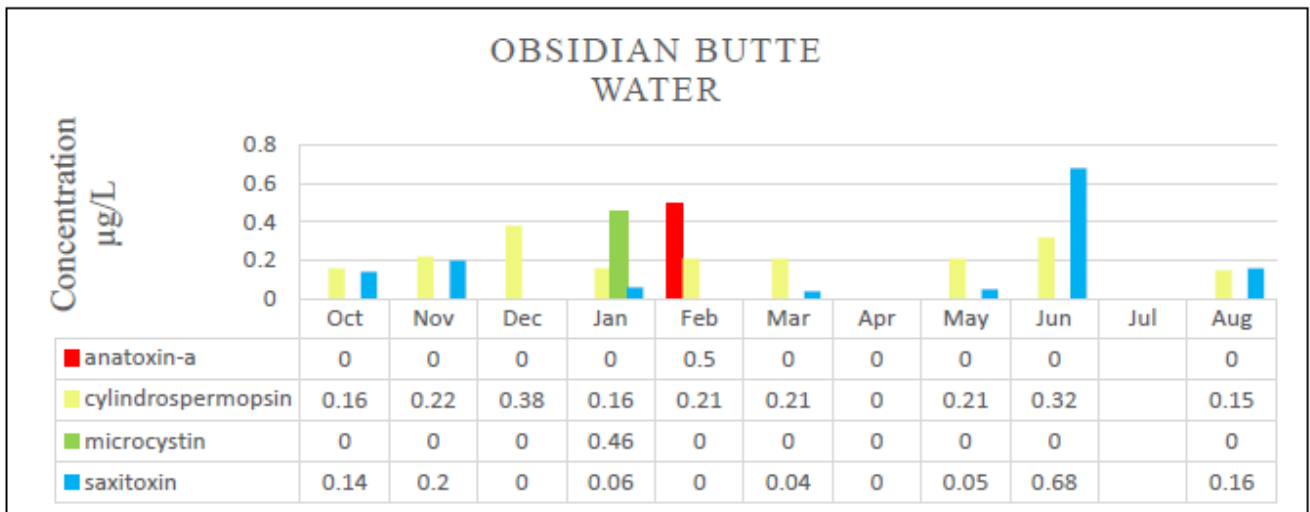
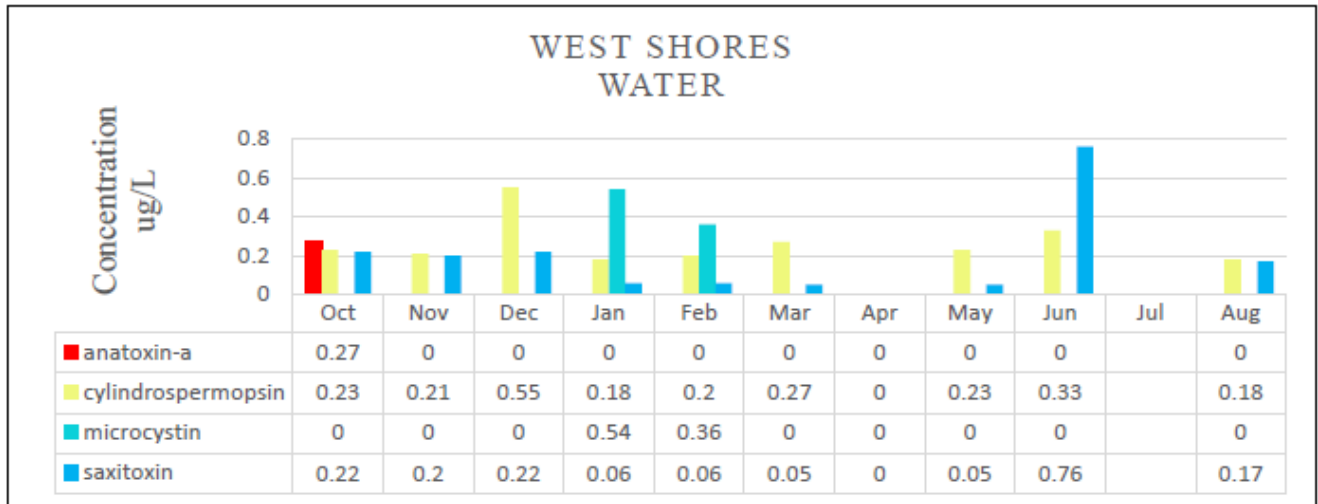
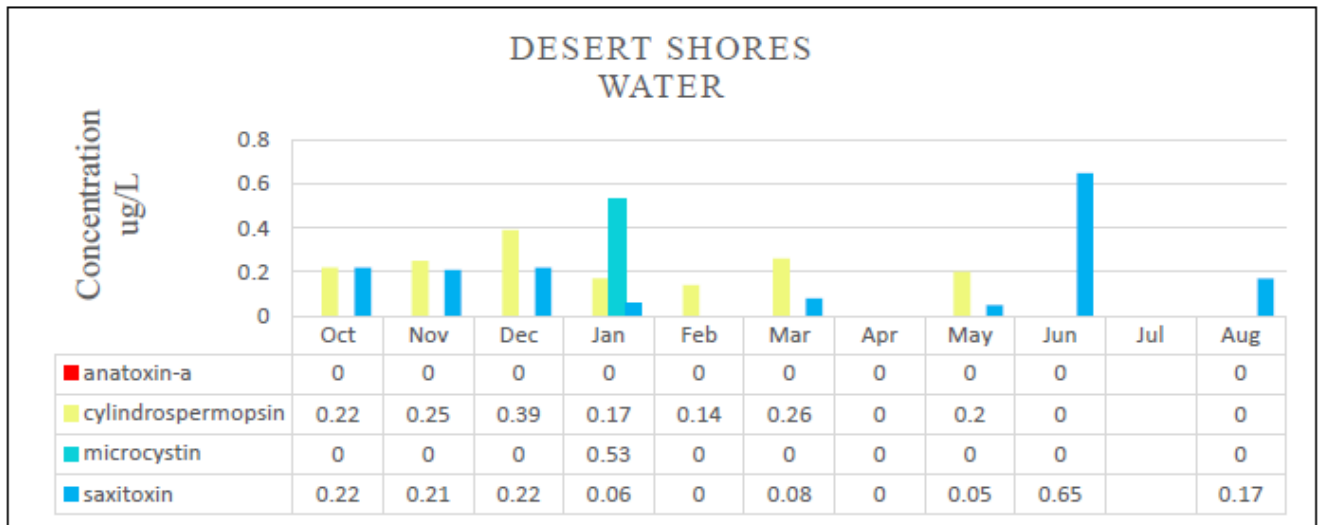
Appendix A: Cyanotoxin Concentrations in Water and Benthic Algal Mats

(Missing values represent samples that could not be collected)
