SWAMP Assessment Report for the Central Coast Region	1997-99
--	---------

**Central Coast Ambient Monitoring Program Hydrologic Unit Report  
for the 1997-99 Pajaro River Watershed Rotation Area**

January 2003

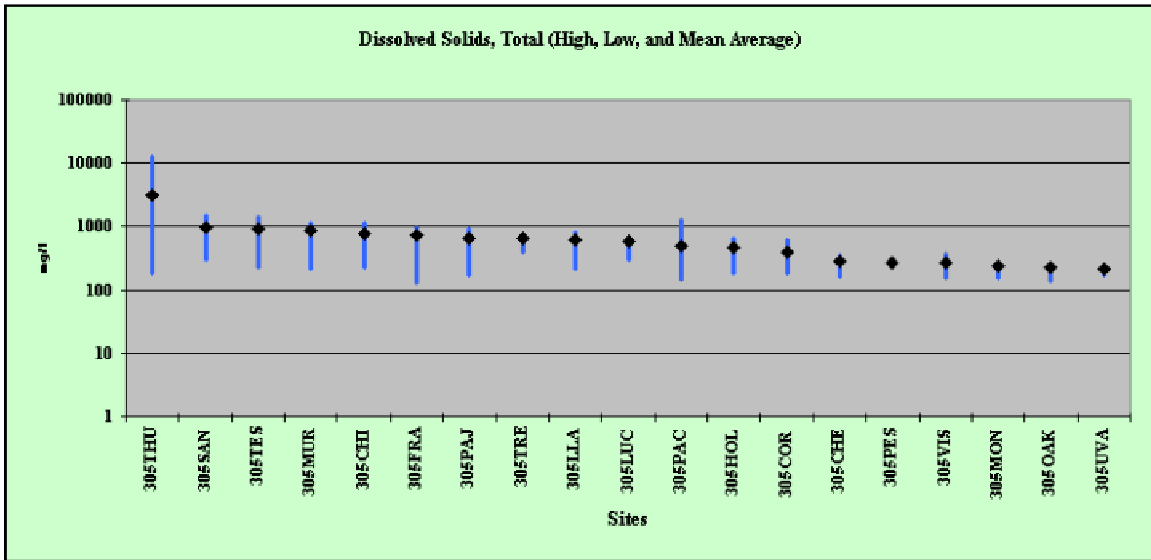
**Figure 4.17 - Mean and Range of total dissolved solids (mg/l) concentrations from samples collected during the Pajaro River Watershed Characterization, 1998.**

Conductivity and TDS levels in surface waters tended to peak in late summer and were at their lowest values during winter. Conductivity at all sites (except 305THU) is shown in [Figure 4.11](#) and 305THU is shown in [Figure 4.12](#). Total dissolved solids at all sites are shown in ([Figure 4.17](#)).

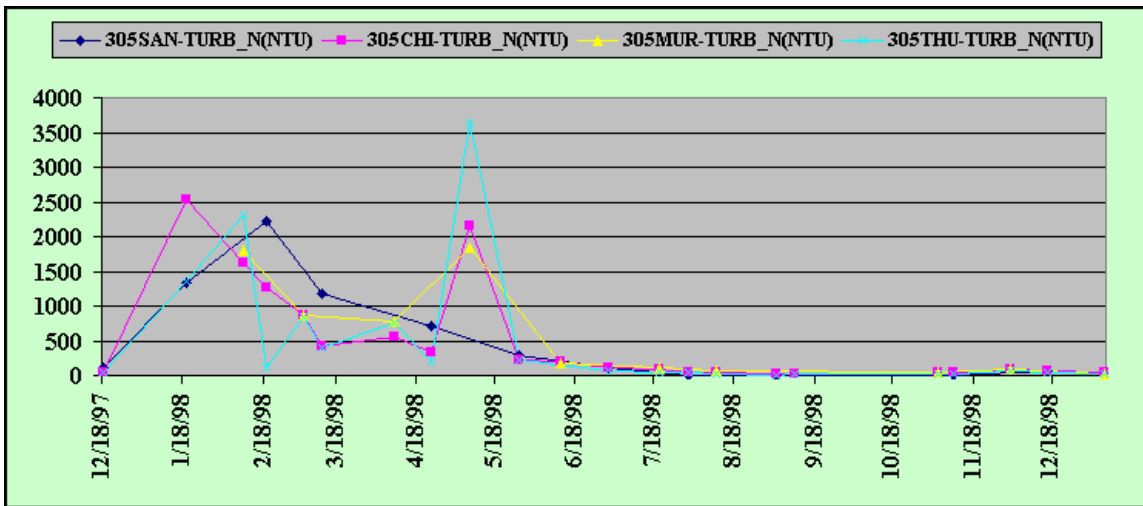
**Figure 4.19 - Mean and Range of turbidity levels observed at sites during the Pajaro River Watershed Characterization, 1998.**

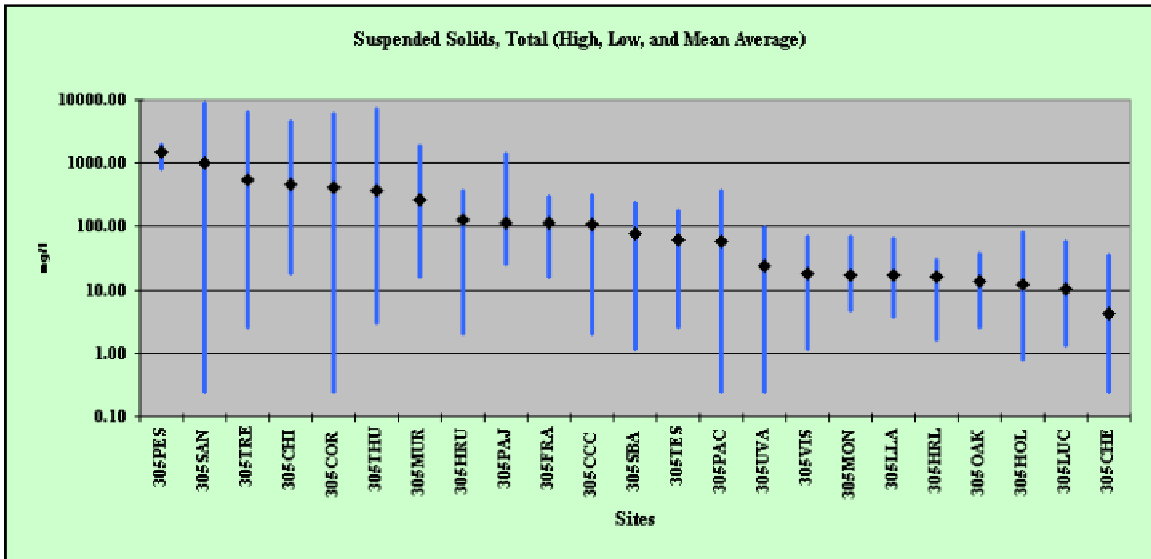
**Figure 4.21** - Total suspended solids (TSS) levels at lower San Benito River Y Road (305SAN) and Tres Pinos Creek (305TRE) sites, Pajaro River Watershed Characterization, 1998.

respectively (Figure 4.20). Peak TSS levels on lower San Benito River were recorded during January, February, and March 1998. The Y Road (305SAN) site had the highest TSS observed, at 8870 mg/L (Figure 4.21). TSS levels in the lower San Benito River appear to show a clear pattern of seasonal variation with winter TSS levels above 1000 mg/L and summer TSS levels below 10 mg/L.

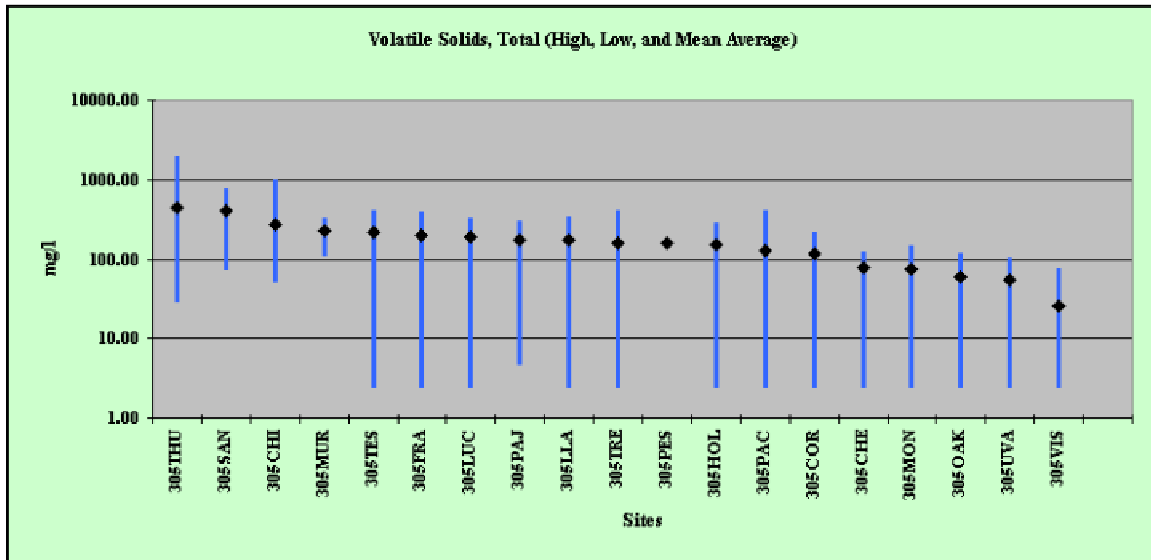
**Figure 4.23** - Total volatile solids (TVS) levels (mg/l) at San Benito River Y Road (305SAN) and Chittenden Gap (305CHI) and Thurwachter Bridge (305THU), Pajaro River Watershed Characterization, 1998.

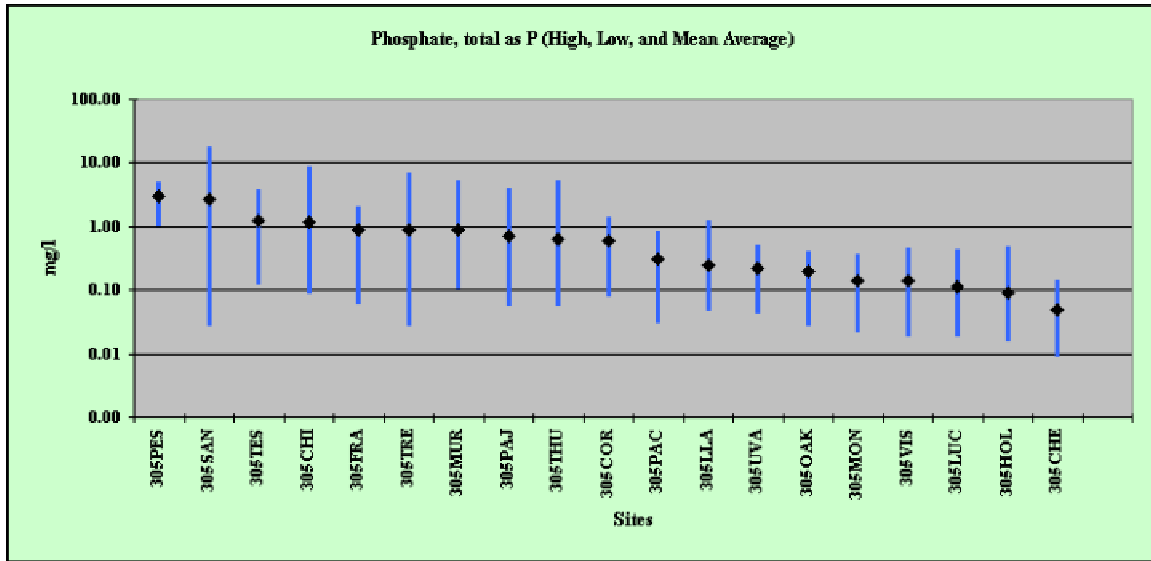
**Figure 4.35** - Total phosphate (as P) concentrations (mg/l) for the San Benito River Y Road (305SAN), Tres Pinos Creek (305TRE), and the Pajaro River at Chittenden Gap (305CHI), Pajaro River Watershed Characterization, 1998.

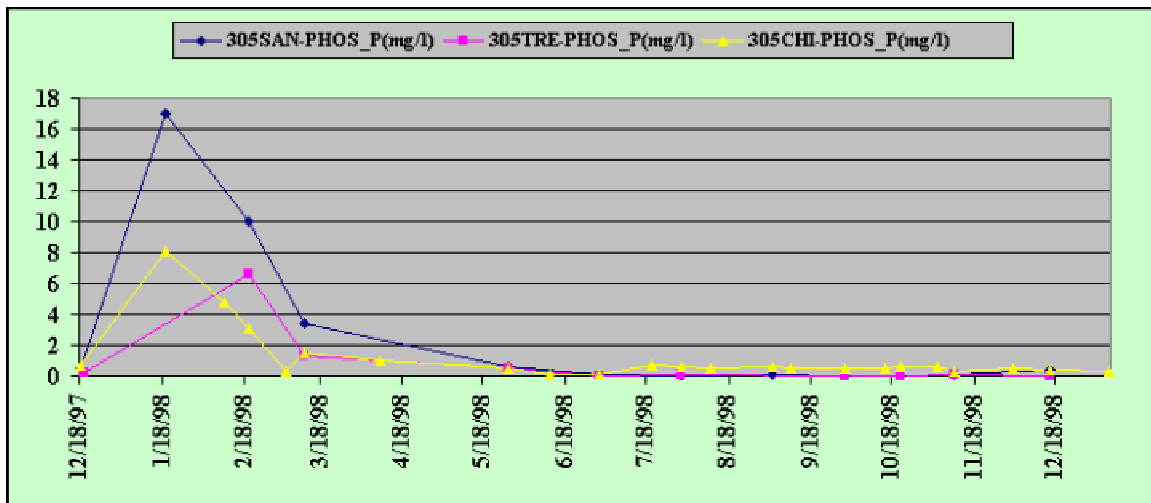
**Figure 4.36** - Total phosphate (as P) concentrations (mg/l) for Tequisquita Slough (305TES), Pajaro River Watershed Characterization, 1998.

Overall, total phosphate levels in the Pajaro River system are elevated, with all sites having peak total phosphate levels that exceed the CCAMP attention level of 0.12 mg /L total phosphate as P. Highest mean total phosphate concentrations were found in the San Benito River and downstream (Figure 4.34). Total phosphate levels peaked during winter, with extremely high values on the San Benito River Y Road (305SAN), Tres Pinos Creek (305TRE), and on the Pajaro River at Chittenden Gap (305CHI), reaching 17.0 mg/L, 6.6 mg/L, and 8.1 mg/L, respectively (Figure 4.35). Tequisquita Slough (305TES) concentrations were somewhat elevated throughout the year (Figure 4.36). Peak total

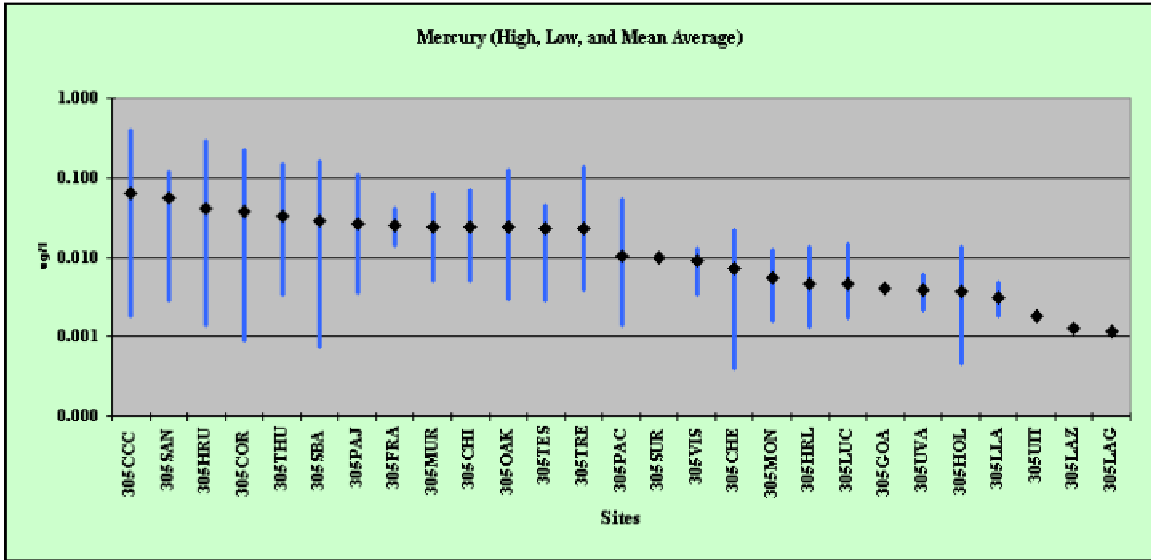
**Figure 4.51** - Mercury concentrations over time at Clear Creek (Clear Creek Road) (305CCC), San Benito River at Y Road (305SAN), San Benito River above Hernandez Reservoir (305HRU), and San Benito River above unnamed tributary (305SBA), Pajaro River Watershed Characterization, 1998.

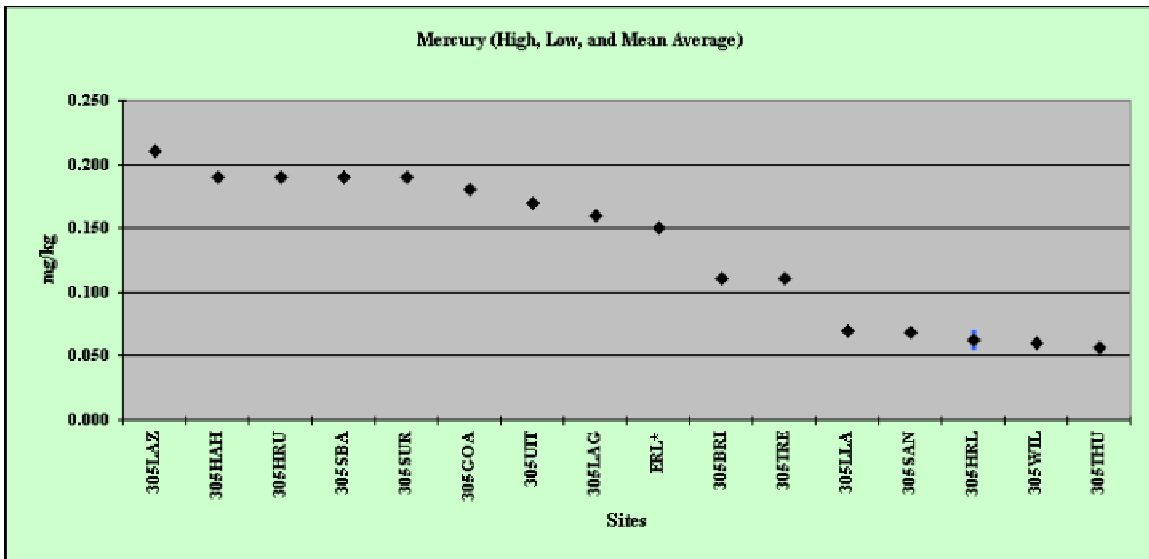
**Map 4.3 – Mean Mercury concentrations in sediment samples collected from sites in the Pajaro River Watershed Characterization, 1998.**

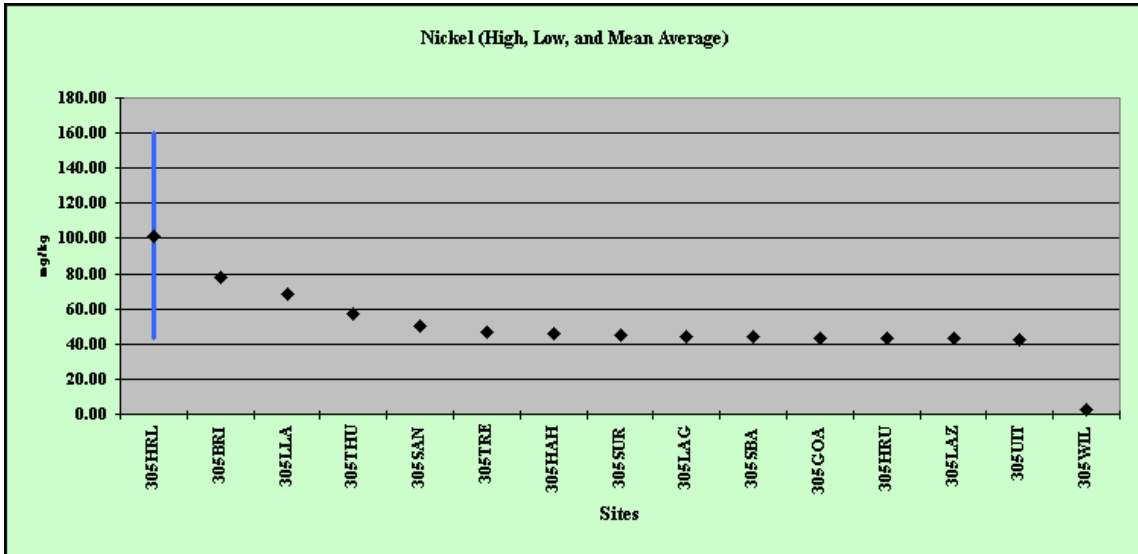
**Map 4.4** – Mean Nickel concentrations in sediment samples collected from sites in the Pajaro River Watershed Characterization, 1998.
