DSC - 2 Delta Flow Criteria Eutrophication Studies

The second part of this presentation describes eutrophication of a storm water pond that was subject to the same type of water chemistry changes and over the same general time period as our studies on the Delta.

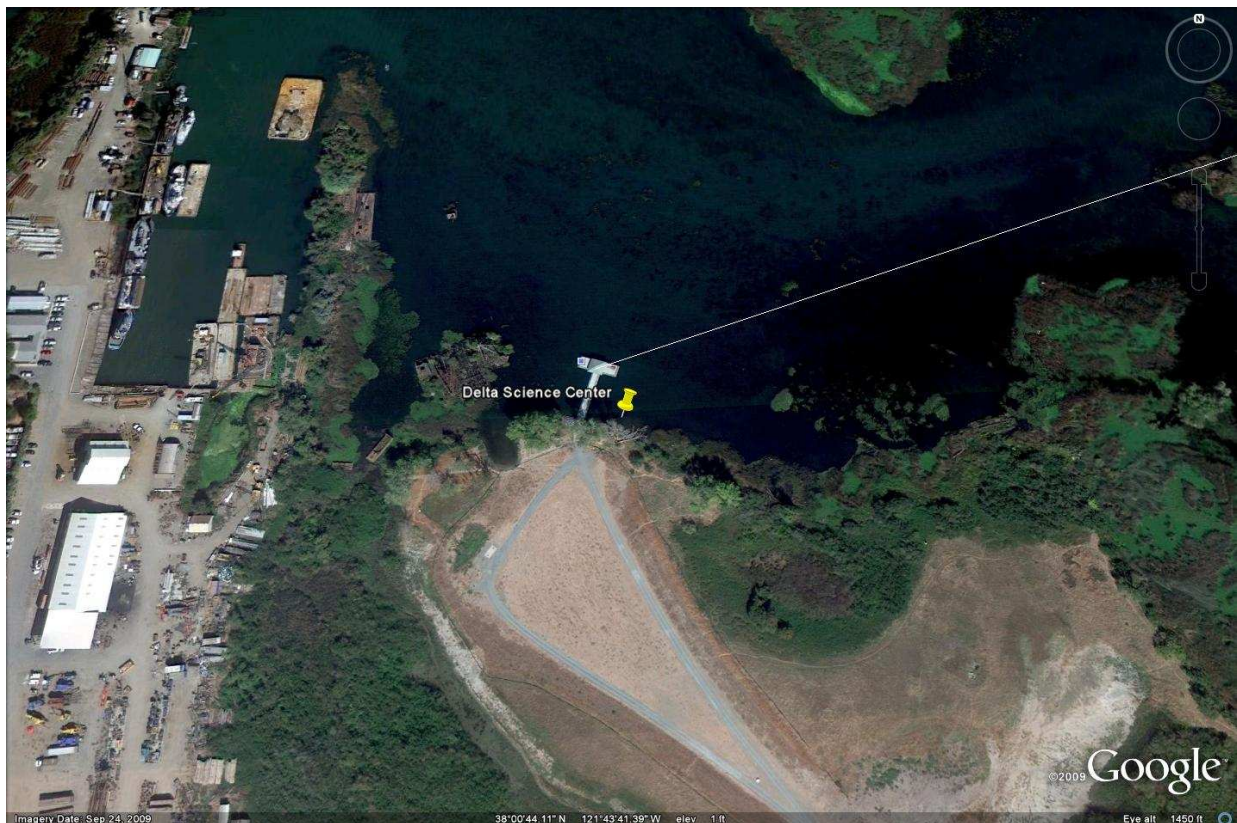
Figure 1, Image of Big Break Regional Shoreline, September, 2009

Figure 1 shows an area near where the pier has been built in the East Bay Regional Park. The park is called the Big Break Regional Shoreline and is located off the end of Big Break Road in Oakley, CA

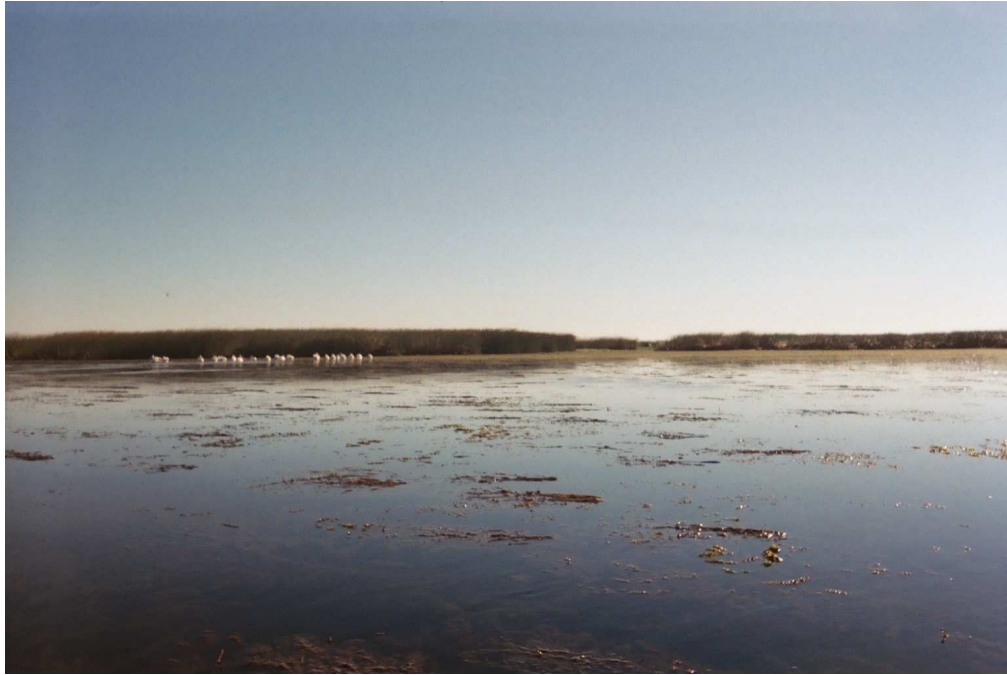
Figure 2, View of Weeds off Big Break Pier, September 2004

You can see in this photo a large flock of pelicans, actively feeding. Weed growth, while abundant, does not cover the surface, nor are there any obvious gas bubbles present. Unfortunately, no analytical data is available for that time.

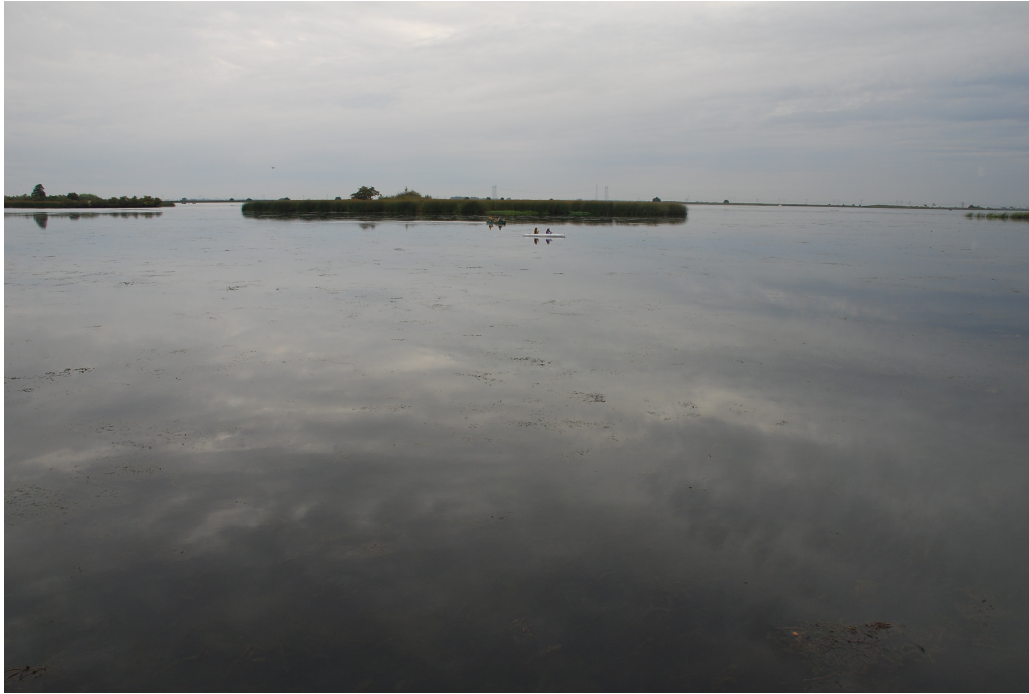
Figure 3, View of Big Break Pier, September 20, 2007

Three years later, in September of 2007, aquatic weeds were present, but again not in great profusion, as shown in Figure 3. Nitrate in the water at this location was approximately 8 mg/l measured as NO_3^- . While no bubbles were observed in the water during this sampling event, dissolved oxygen at the surface had risen to approximately 100% of saturation by 9:30 in the morning. Obviously something was happening to the water chemistry. Soon after these photos and data were taken, it clouded over and started to rain. Further data on water quality at that time are given in Table 1.

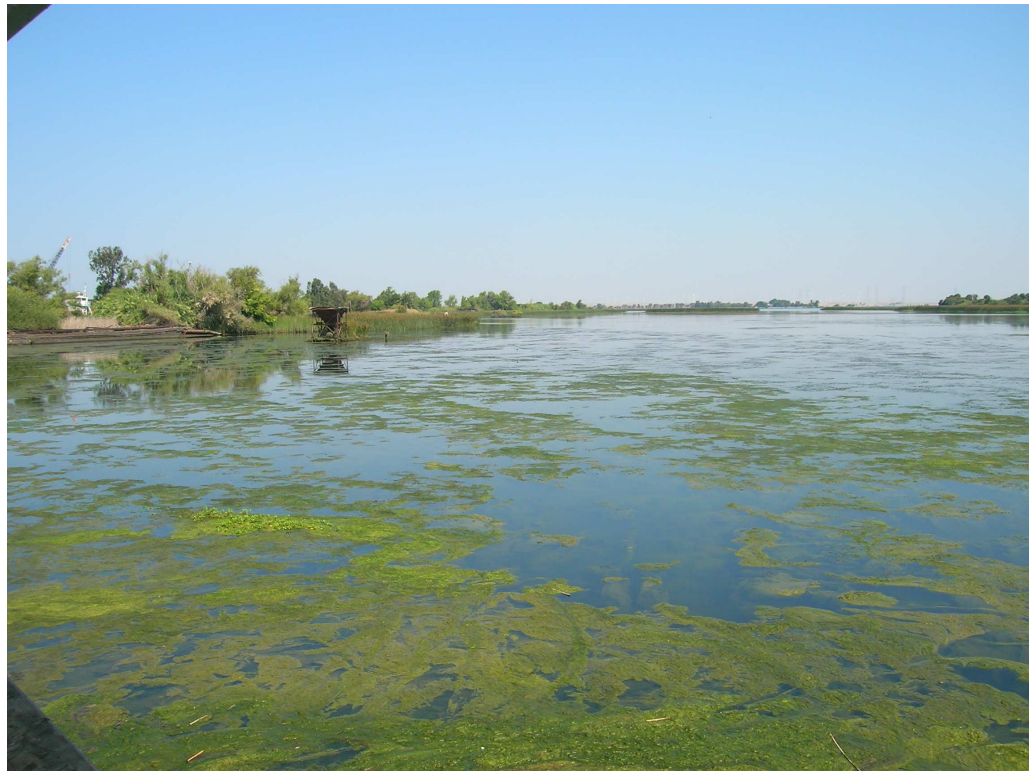
Figure 4, View from Big Break Pier, August 10, 2009

Things had changed substantially by the summer of 2009, as shown in Figure 4. Weed growth was intense and widespread. In addition, by late afternoon each day, bubbles could be observed in the weed beds, as shown closer up in Figure 5.

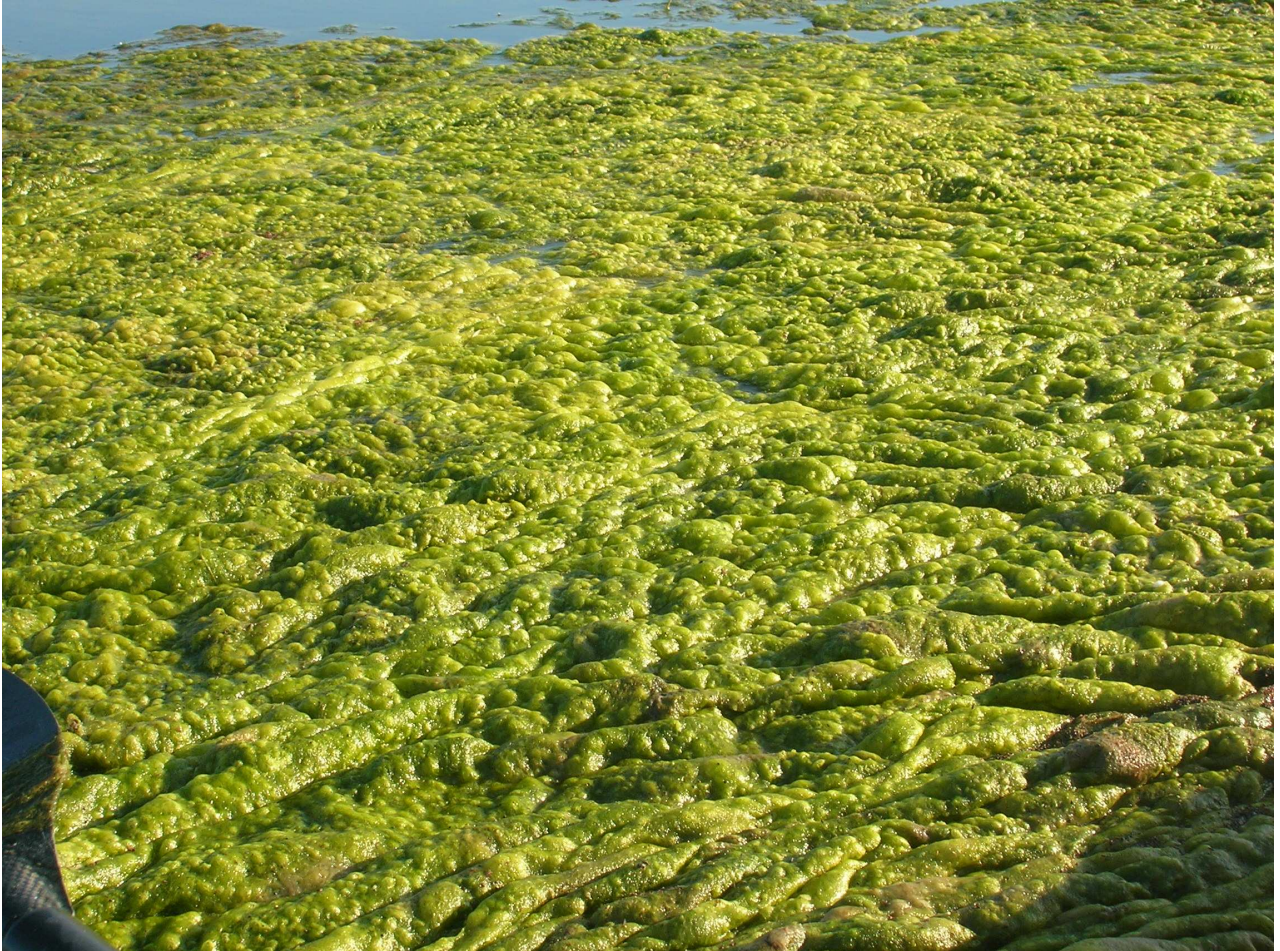
Figure 5, Close-up View of Weeds, 8/15/09

We had clues that something serious was happening from parallel work being conducted in Marsh Creek, which discharges into the eastern end of Big Break. Sampling work carried out on August 15, 2009 at the Big Breaks site showed huge variations in dissolved oxygen and pH from day to night, shown in Table 2. With oxygen levels swinging from 6mg/l up to 15 mg/l (well above saturation) and pH rising to above 9.0, serious damage certainly can be expected for many aquatic organisms.

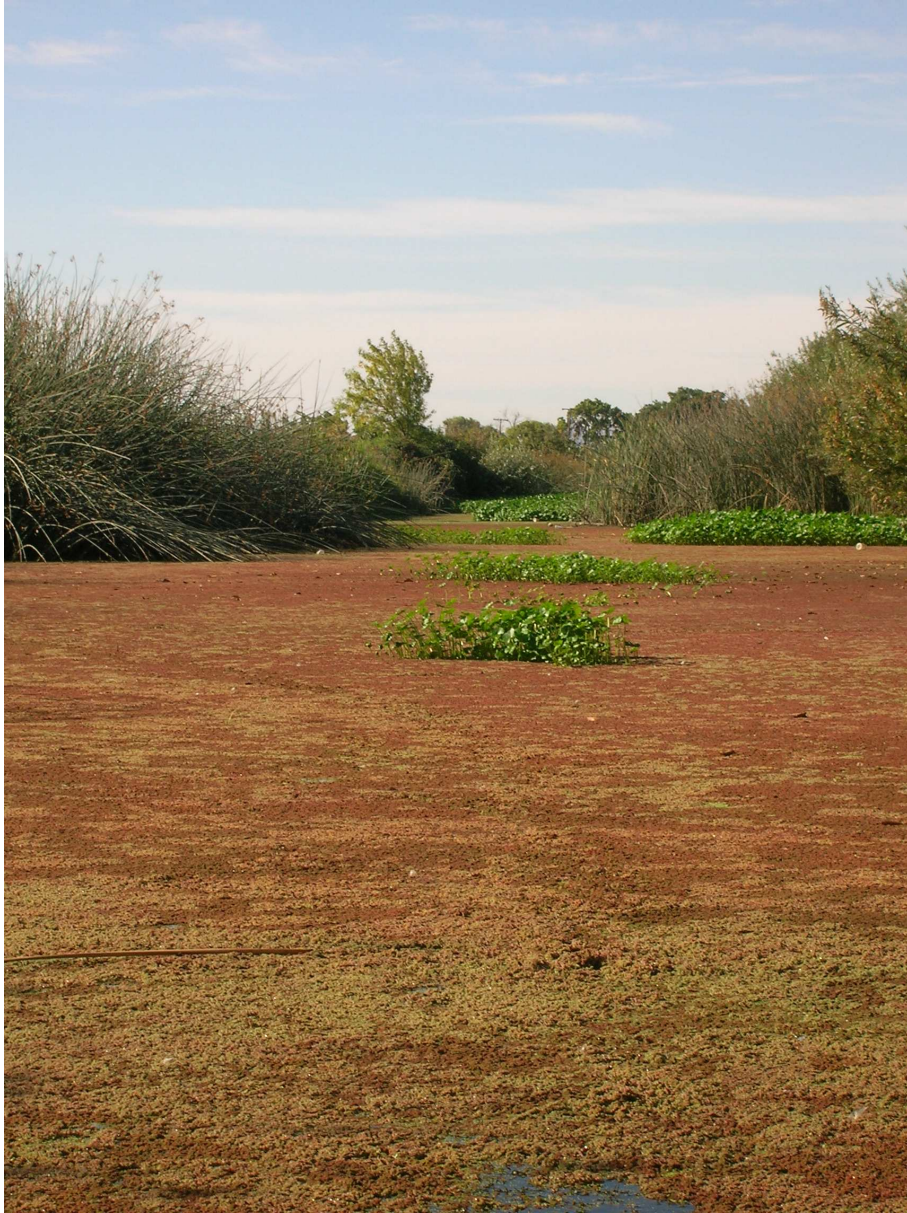
Figure 6, Mouth of Marsh Creek, 9/11/09

The impact of severe eutrophication can be seen even more vividly in Figure 6, taken at the mouth of Marsh Creek in September of 2009. Weed growth at that time was so thick that it was impossible to paddle a kayak through it.

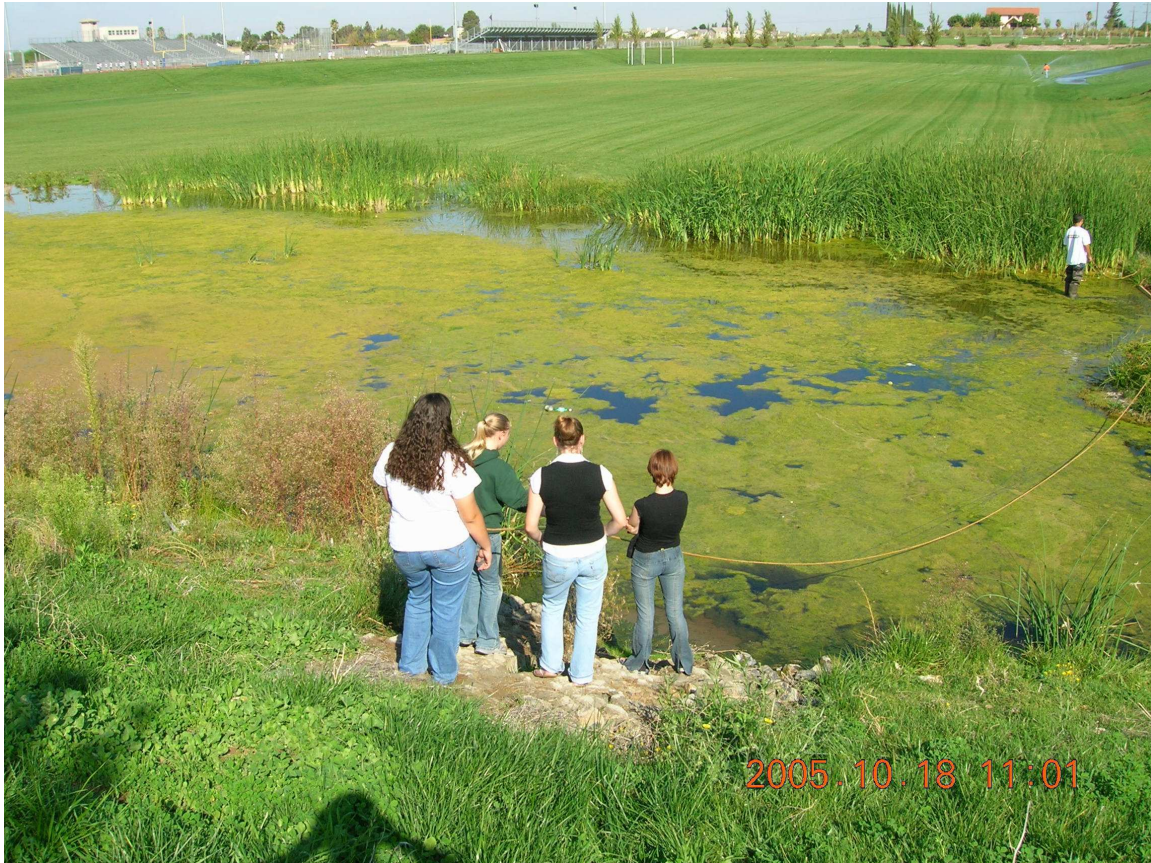
Figure 7, Pond at Freedom High School, November 10, 2005

Figure seven, above, shows that pond in late 2005, approximately one year after construction. Notice filamentous algae nearly covering the water surface and vegetation beginning to encroach from both sides. At that time, typical benthic invertebrates including damselflies and dragonflies still could be found, especially in the areas with vegetation. In addition, thousands of mosquito fish, which had been introduced for mosquito control, were thriving.

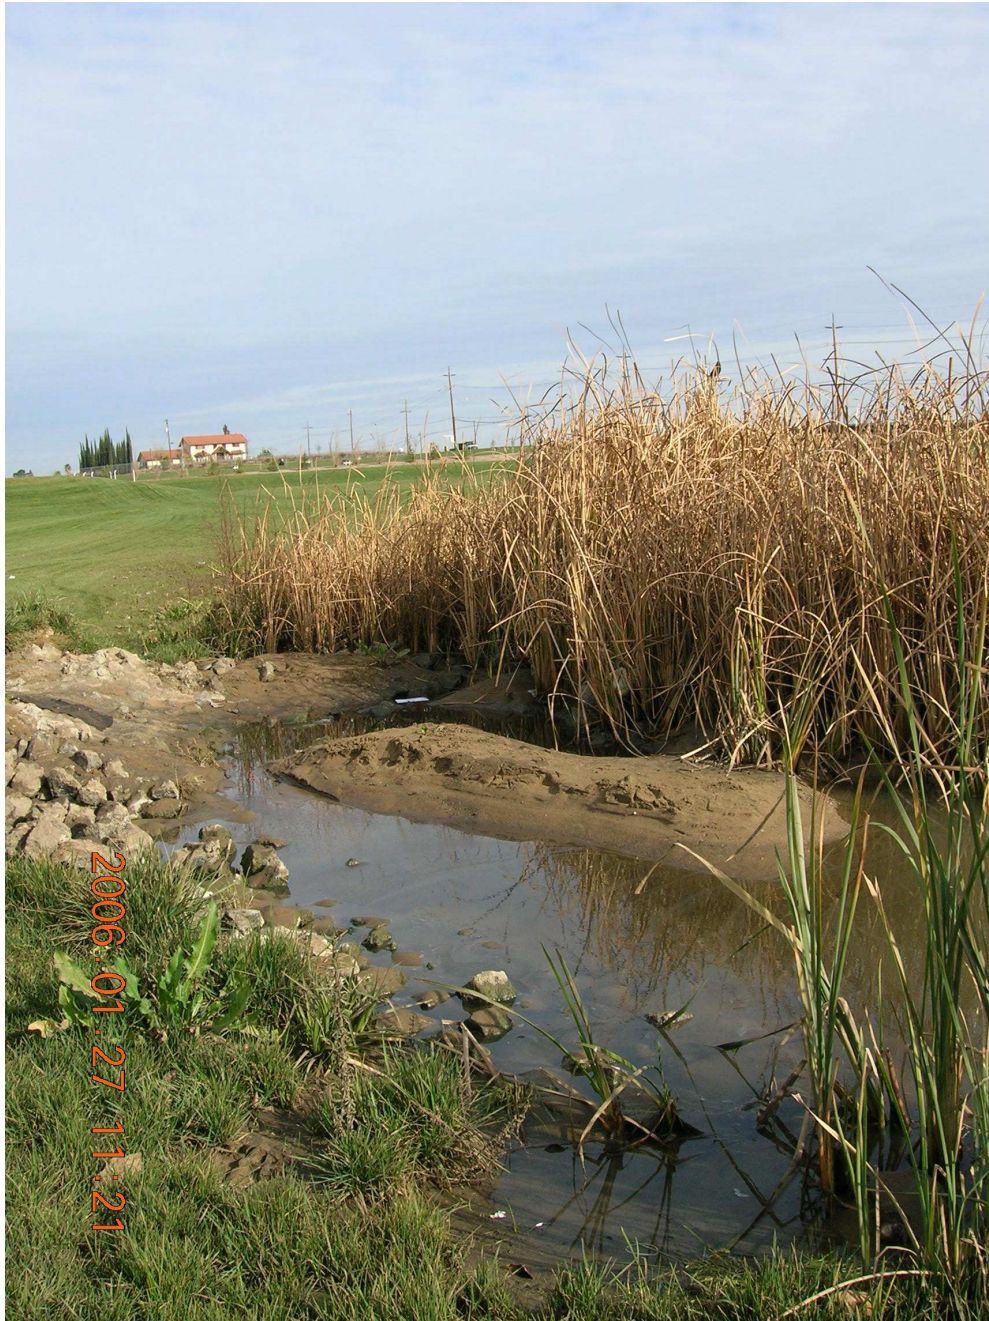
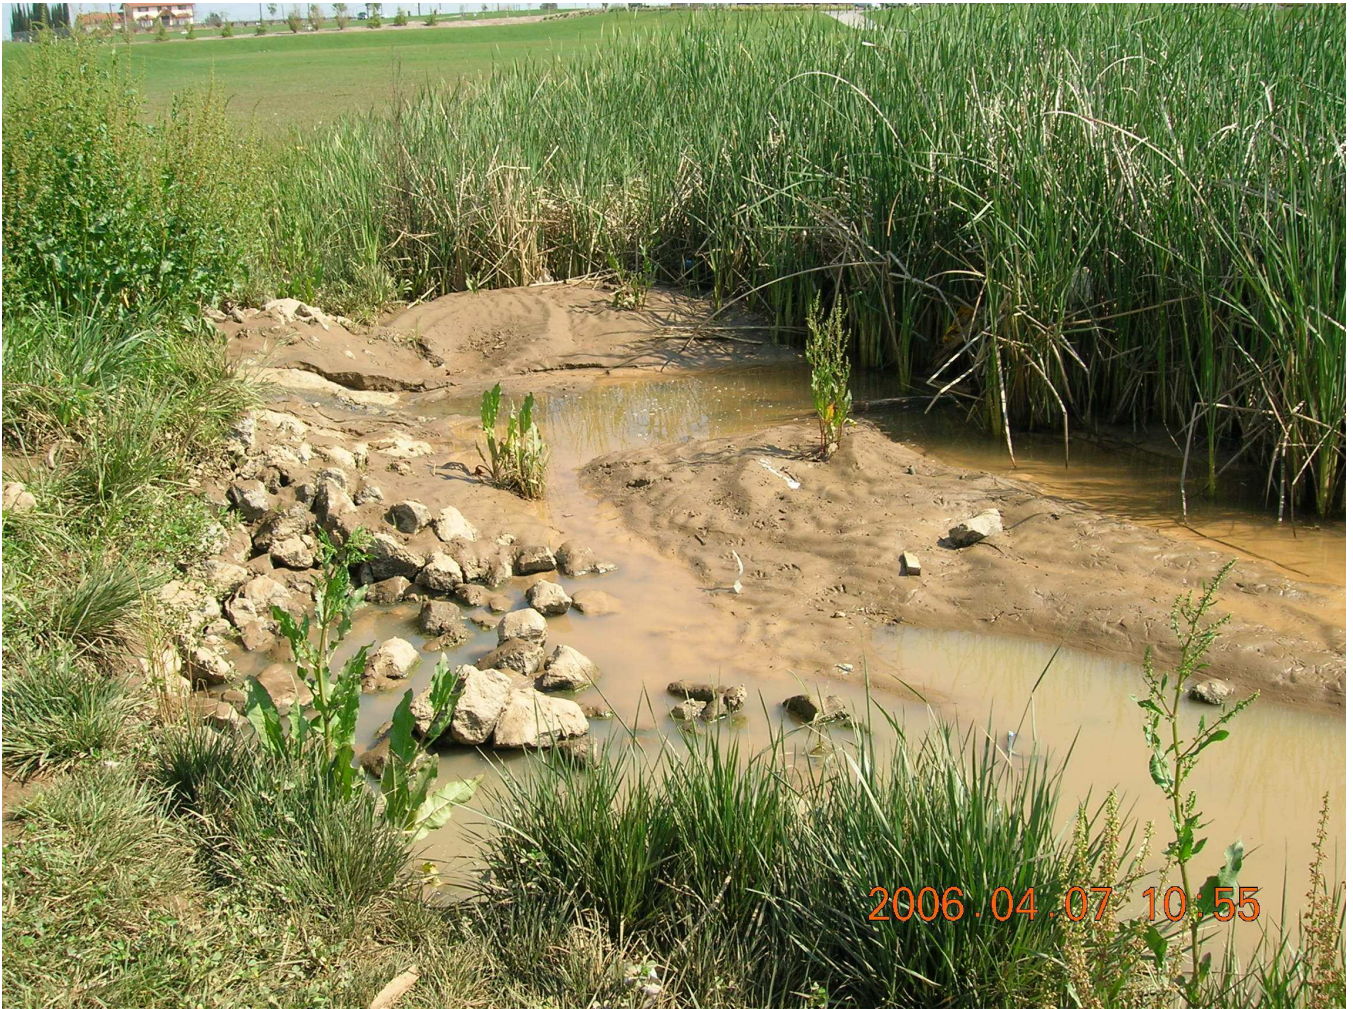
During the following year, there was very active residential construction in the surrounding neighborhoods. In addition, there were several periods of heavy rain during the winter and spring. Figures 8 and 9 show newly deposited sediment at the inlet to the pond.

Water samples taken at the time of the above photos showed up to 4 mg/l to 8 mg/l nitrates, low dissolved oxygen, and turbidity in excess of 500 NTU. In addition, typical aquatic invertebrates that might be expected in this pond environment were totally absent.

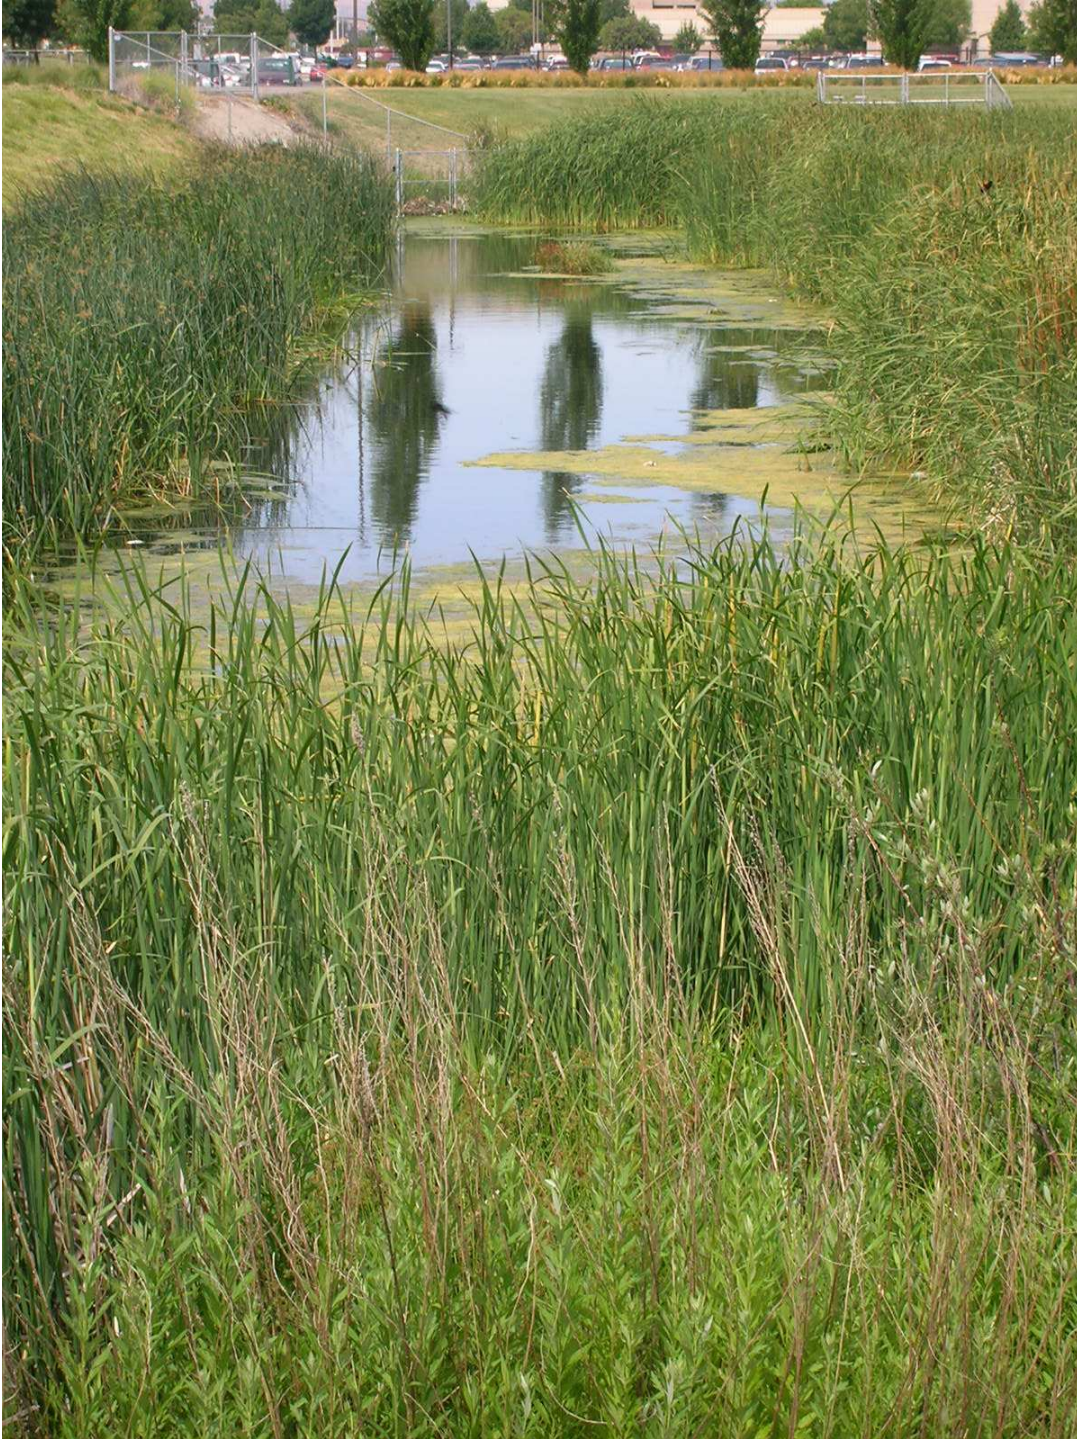
Figure 10, Inlet to Freedom Pond in April 2007.

This is what the pond looked like in June of 2007. Notice that cattails are closing in from both sides and filamentous algae is starting to cover the remaining surface. Nitrate concentrations in the pond water at this time were found in excess of 20 mg/l. During this time period, one could almost watch the changes in vegetation in real time.

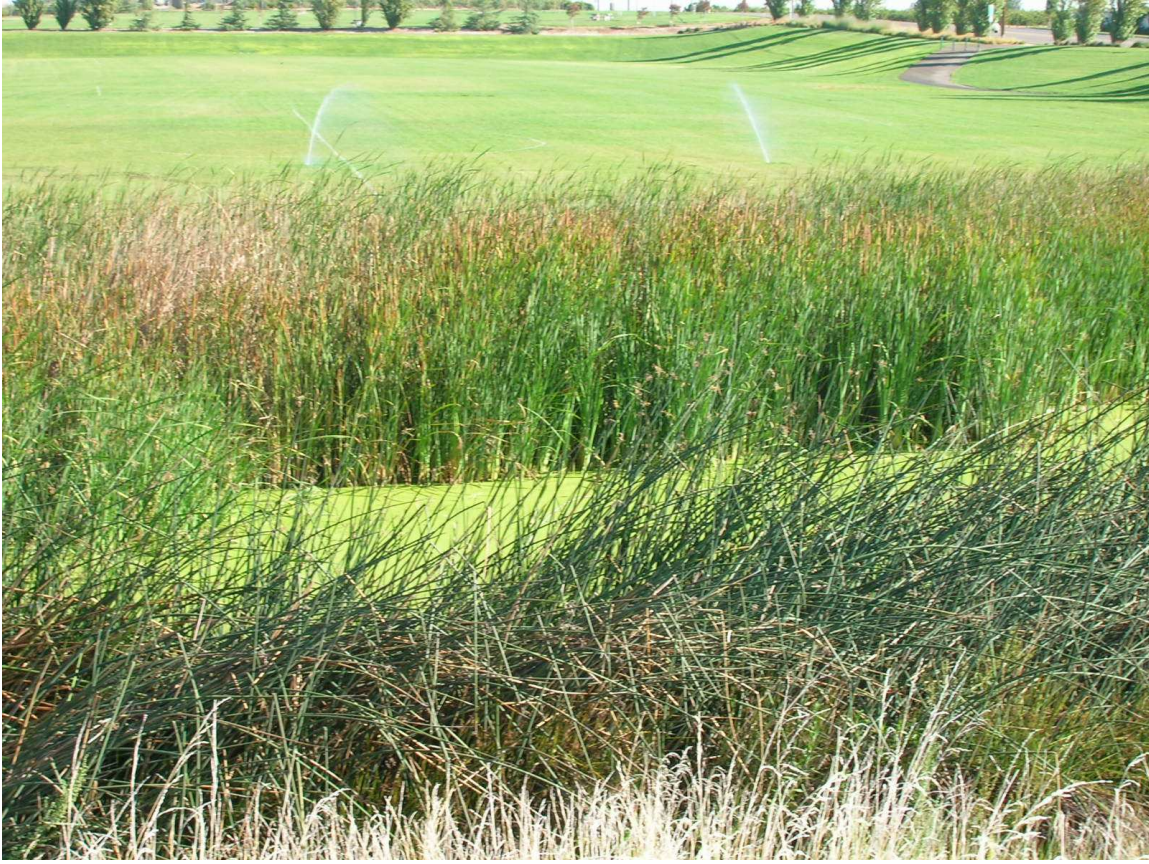
Figure 11, Freedom Pond in August 2008.

In August of 2008, only a narrow strip of open water, covered with floating algae is observable. By that time, the water in the pond had begun to smell, and the bottom was covered with black organic material.

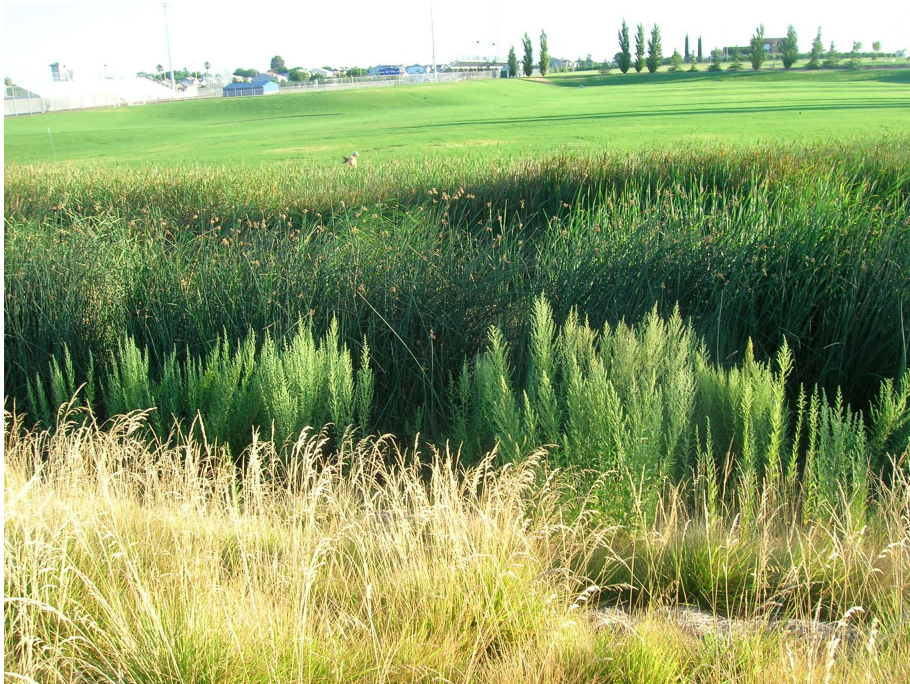
Figure 12, Freedom Pond in July 2009

By July of 2009, the pond had essentially filled with sediment and vegetation. The process of eutrophication from open water to meadow had been completed in only about five years. In more natural circumstances, this sort of conversion takes decades at a minimum to perhaps a thousand years or more.
