Subject: Notice of Violation No. R9-2014-0024, City of San Diego Construction Management Program, NPDES Order Nos. R9-2013-0001 and R9-2007-0001, Municipal Storm Water Permits

**NOTICE OF VIOLATION
No. R9-2014-0024**

Facility: Torrey Hills Unit 19
Inspection Date: 09/20/2013

Facility: Estates at Costa del Mar
Inspection Date: 1/7/2014

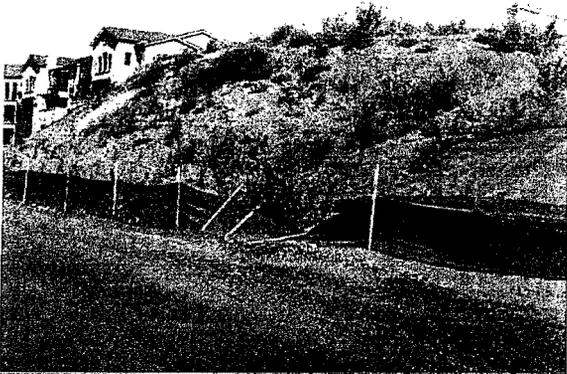
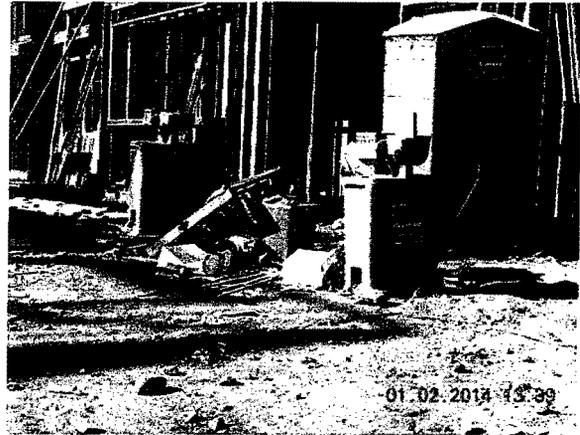
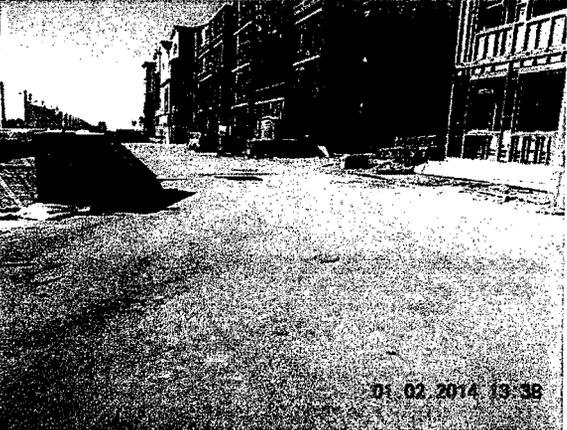
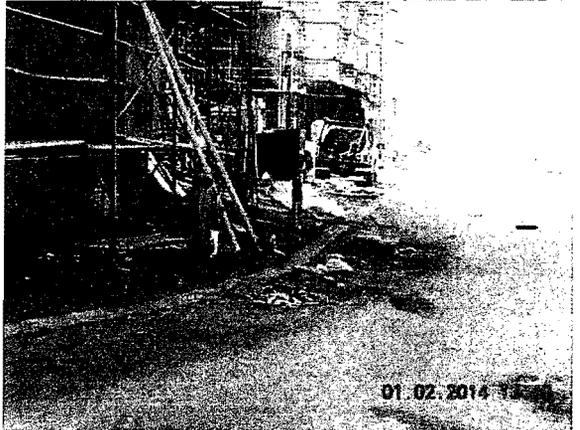
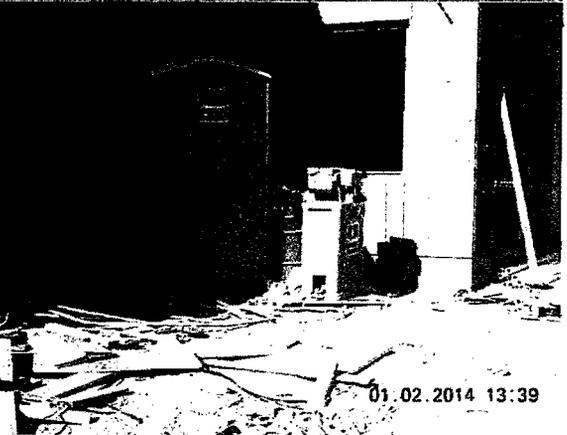
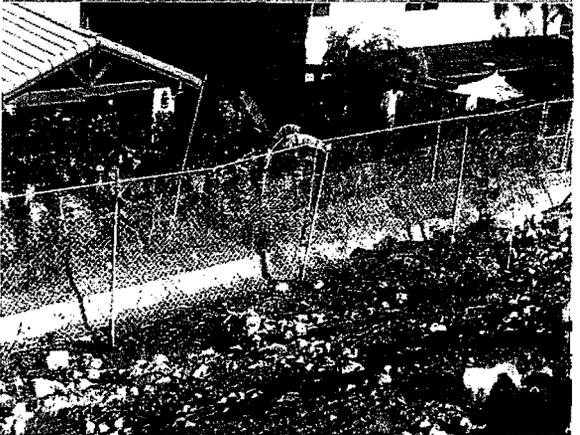
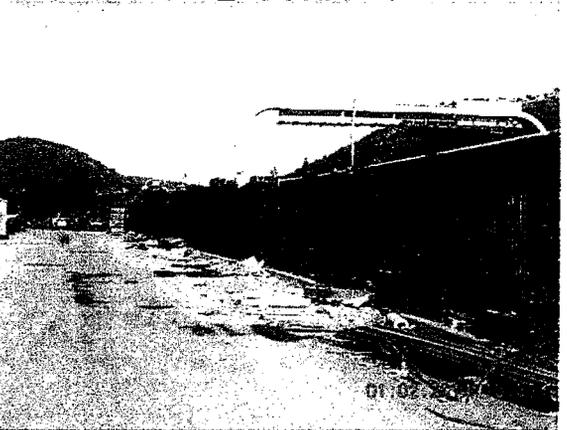
ITEM	Inspection Observation and Corrective Actions Summary	Assigned to	Date Completed
2	2. Inactive slopes require erosion and sediment control BMPs.		
Response:			
12	12. Replace missing or damaged silt fence as needed.		
Response:			
17	17. Sweep tracking as needed. Visually Inspect daily.		
Response:			
18	18. Properly dispose of construction debris/trash.		
Response:			
22	22. Dumpsters need to be covered and the end of each workday and prior/during a rain event.		
Response:			
0			
Response:			
0			
Response:			
0			
Response:
