STATE WATER RESOURCES CONTROL BOARD
DIVISION OF WATER RIGHTS

**NORTH COAST WATERSHED
RESERVOIR INVESTIGATION**

Reservoir ID UN000139

Date of Inspection: October 16, 2013

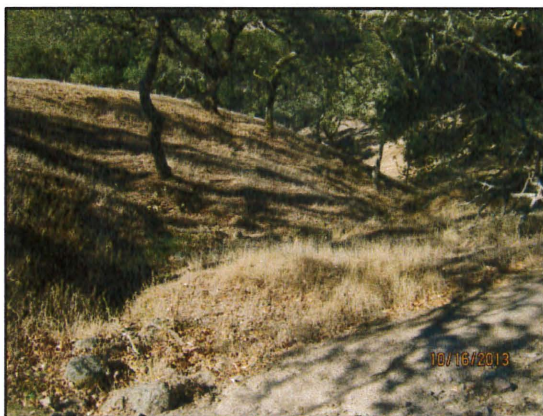
Figure 4: Defined channel as seen looking west from the cattle crossing in Figure 3.

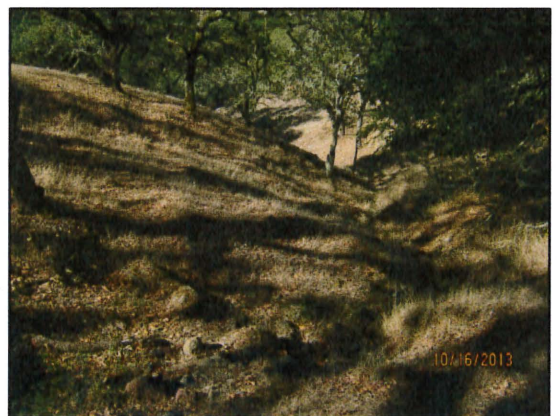
Figure 5: Defined channel as seen looking west downstream of Figure 4.

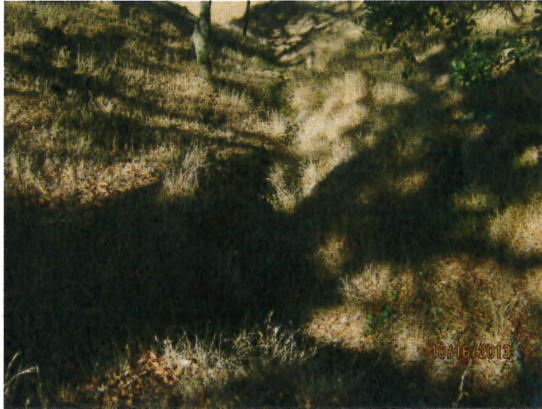
Figure 6: Defined channel as seen looking west downstream of Figure 5..

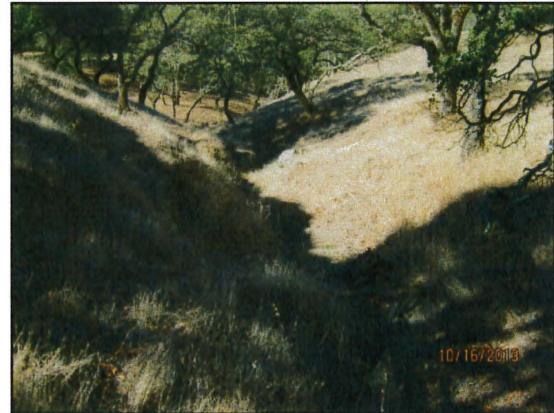
Figure 7: Defined channel as seen looking west downstream of Figure 6.

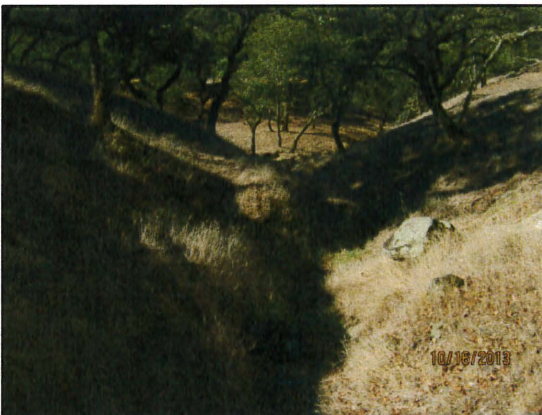
Figure 8: Defined channel as seen looking west downstream of Figure 7. Unnamed Stream seen in the background.

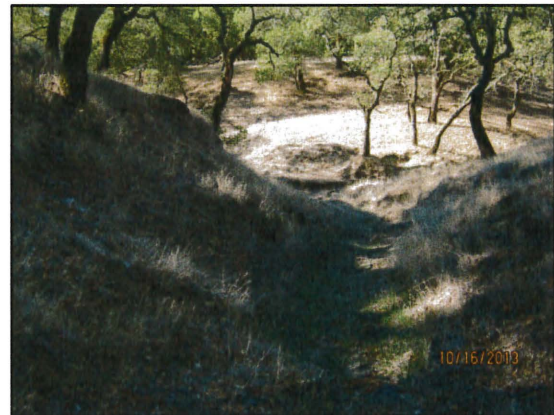
Figure 9: Defined channel as seen looking west. In the center of the photo the channel drains to the Unnamed Stream which flows from the northwest to the southeast.

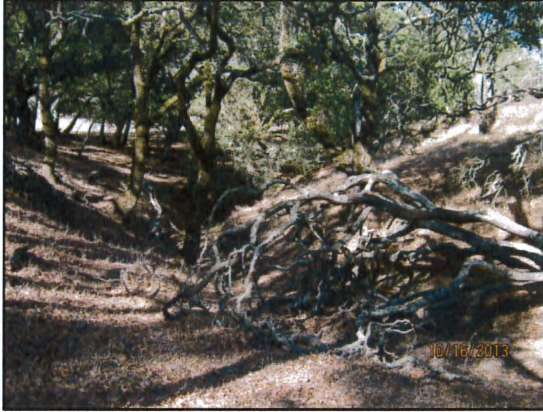
Figure 12: Looking upstream, northeast, along the Unnamed Stream approximately two hundred feet above the confluence.

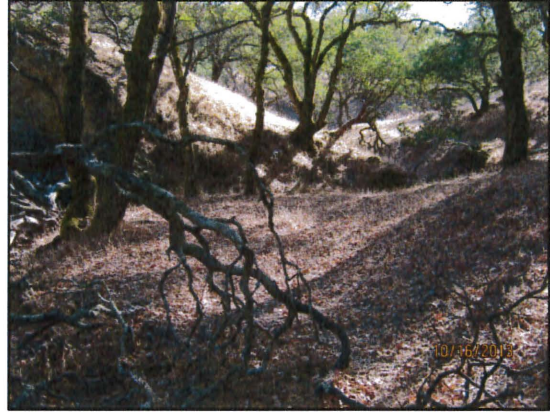
Figure 13: Unnamed Stream as seen looking southeast above the confluence.

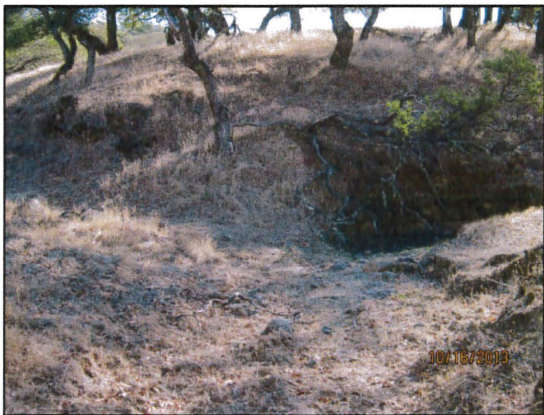
Figure 16: Unnamed Stream as seen looking southeast at the confluence with the defined channel.

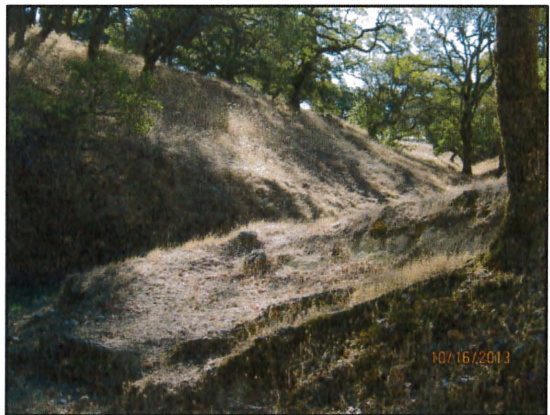
Figure 17: Unnamed Stream as seen looking south at the confluence.

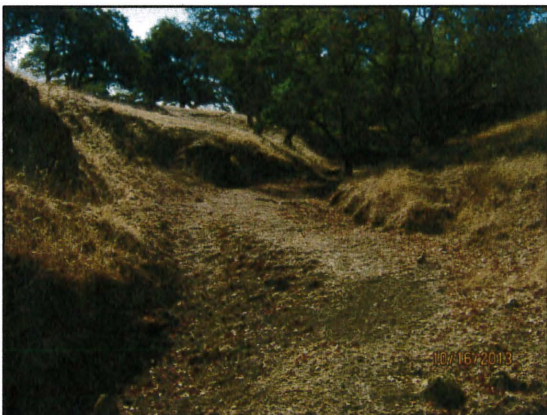
Figure 20: Unnamed Stream as seen looking southeast downstream of Figure 19. Cattle trail along the channel and up the hill as seen to the left of the photo center.

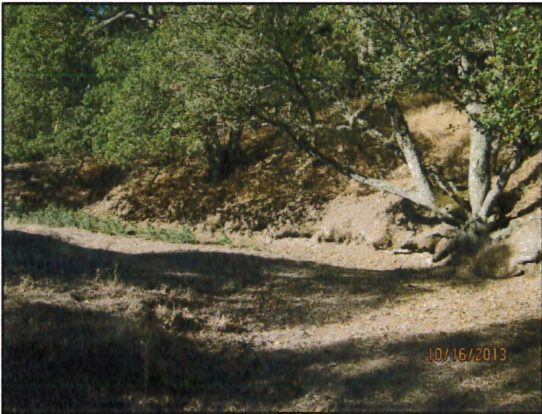
Figure 26: Unnamed Stream as seen looking southwest at a bend in the channel downstream of Figure 25.

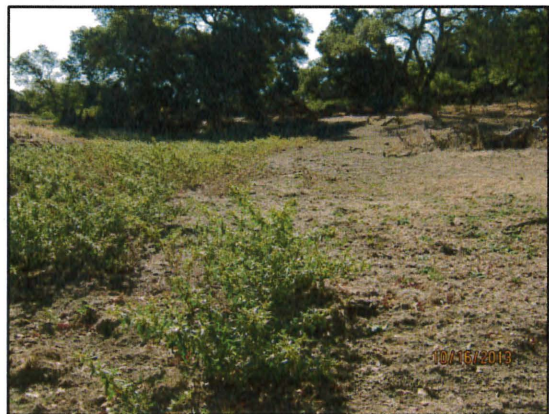
Figure 29: Unnamed Stream as seen looking southeast. Reservoir in the distant left corner of the photo.

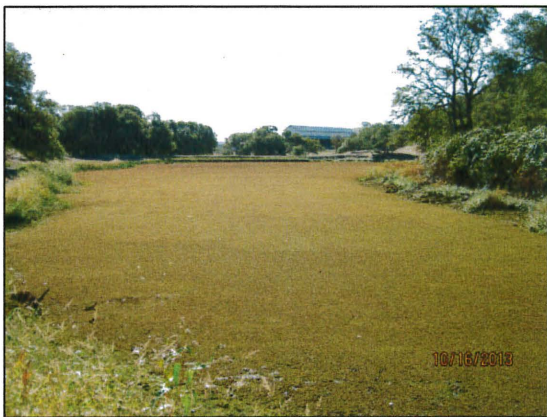
Figure 32: Reservoir as seen looking south from the northeastern bank of the reservoir.

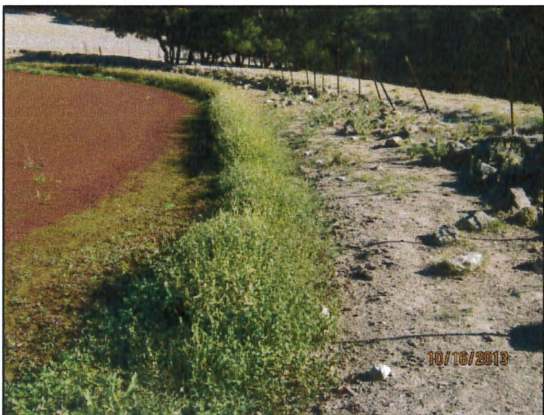
Figure 36: Southern point of the reservoir looking northeast along the dam.

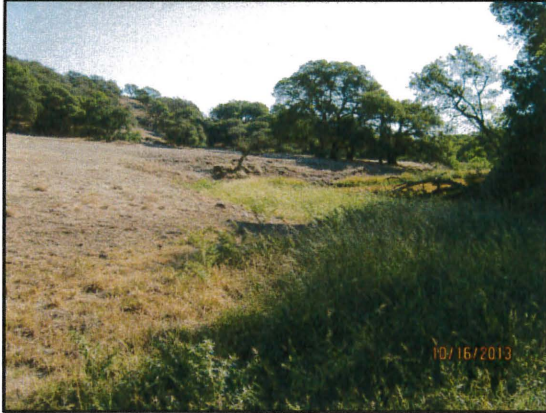
Figure 40: High waterline at the northern end of the reservoir as seen from the Unnamed Stream.

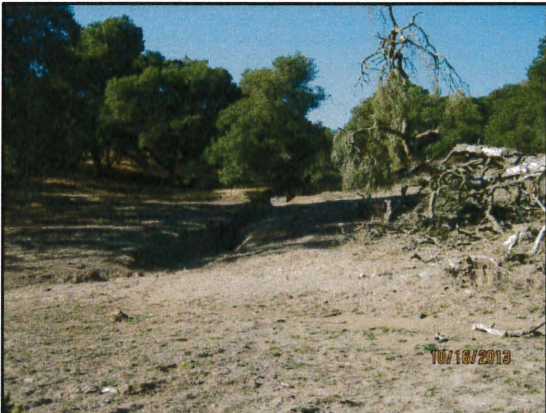
Figure 42: A second defined channel to the west tributary to the Unnamed Stream near the reservoir high waterline.

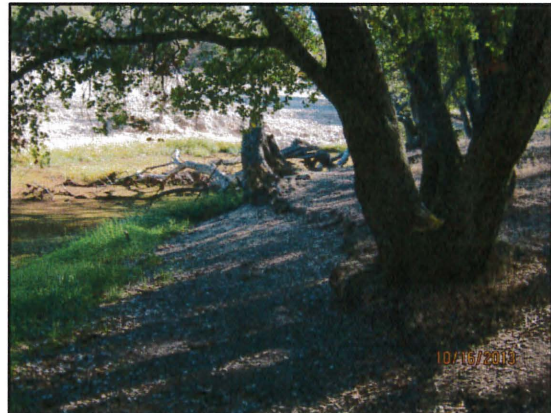
Figure 43: High waterline along the northwestern bank of the reservoir.

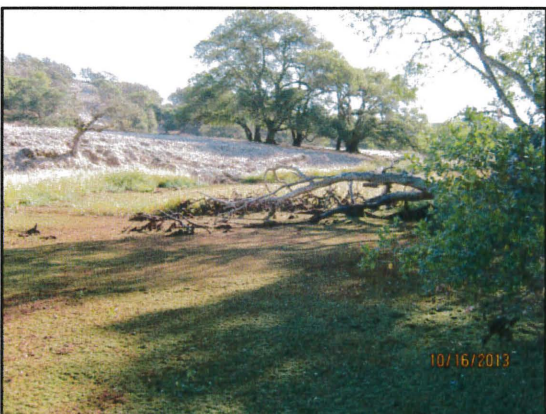
Figure 44: From the northwestern bank looking east across the reservoir.

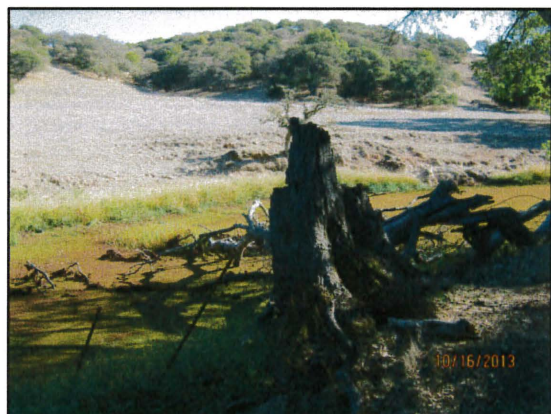
Figure 45: From the western bank looking at cattle pastures on the east side of the reservoir.

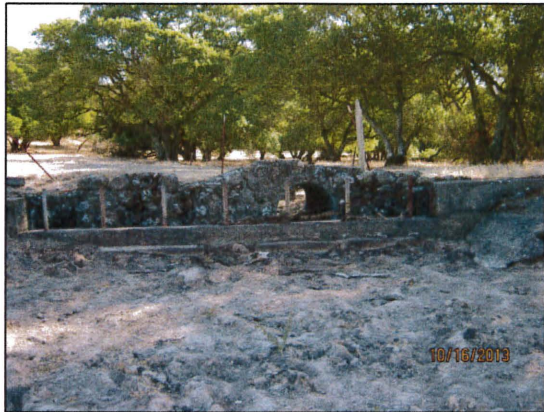
Figure 46: Spillway at the northern end of the earthen dam. Cement wall in front of the spillway pipe is backfilled with sediment.

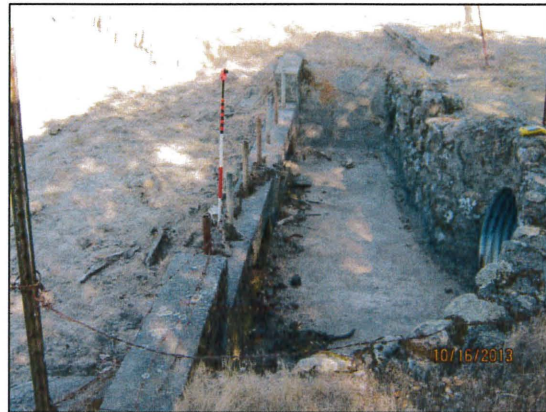
Figure 47: Cemented area between the cement wall and the spillway.

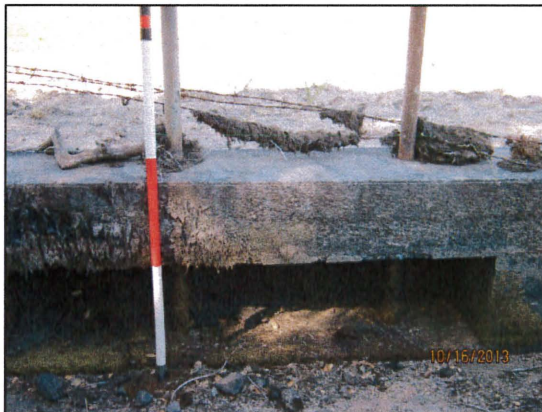
Figure 48: Screened holes in the cement wall now covered by sediment. Dried reservoir surface cover tangled in the wires above the cement wall.

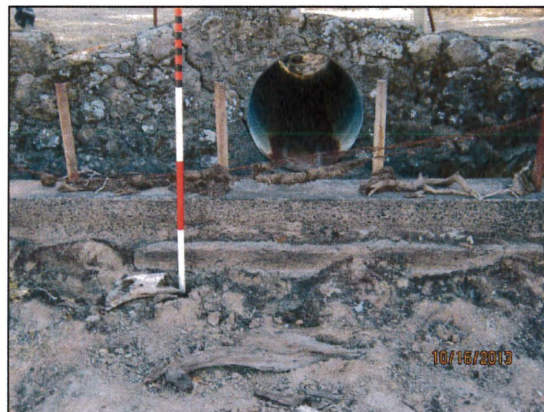
Figure 49: Survey rod in front of the cement wall for perspective.

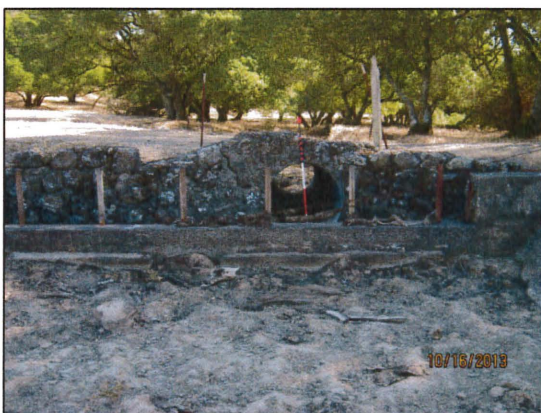
Figure 50: Reservoir spillway and cement wall.

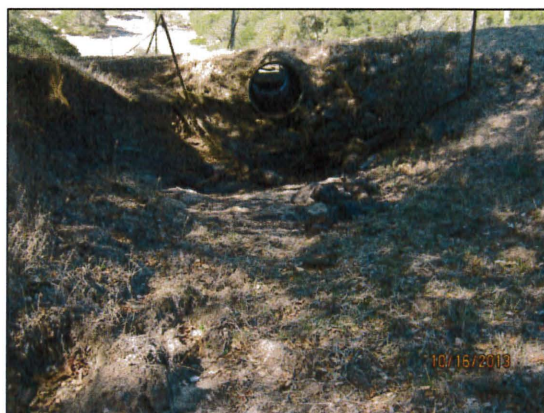
Figure 51: The spillway outlet as seen from the downstream channel.

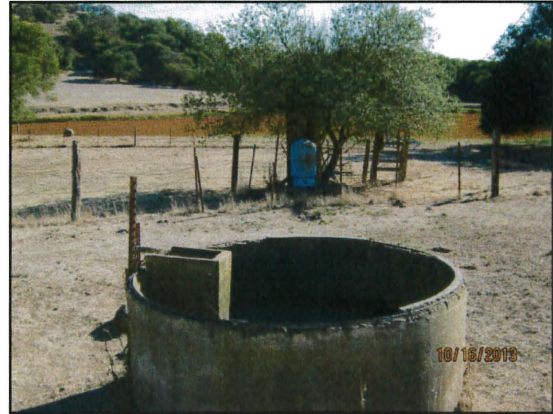
Figure 53: Cattle trough and water well as shown looking east with the reservoir in the background.

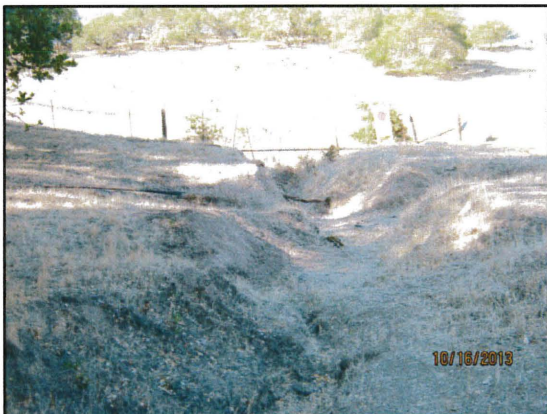
Figure 56: Third defined channel to the south of the water well as seen looking southwest.

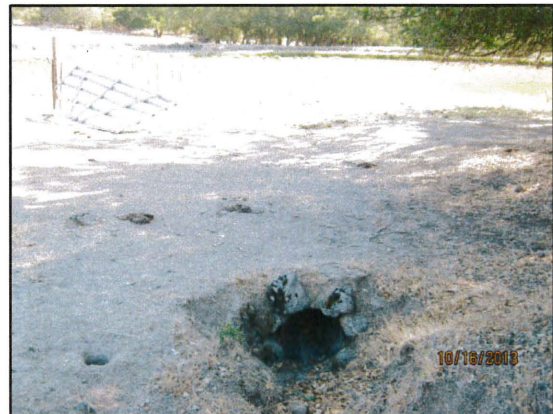
Figure 57: Third defined channel is directed through a culvert under the access road as seen looking northeast towards the reservoir.

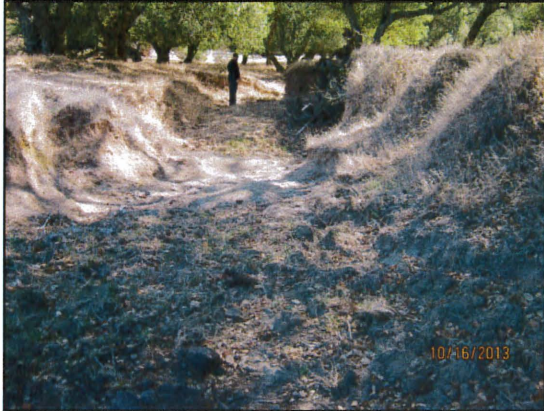
Figure 58: Channel downstream of the spillway as seen from dam directly over the spillway. Channel flows east then curves south to the Unnamed Stream below the dam.

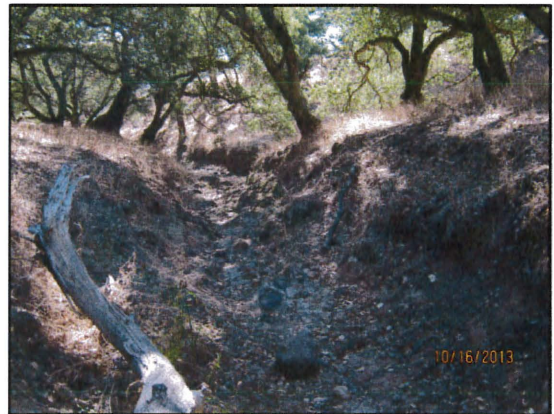
Figure 61: Defined spillway channel looking south.

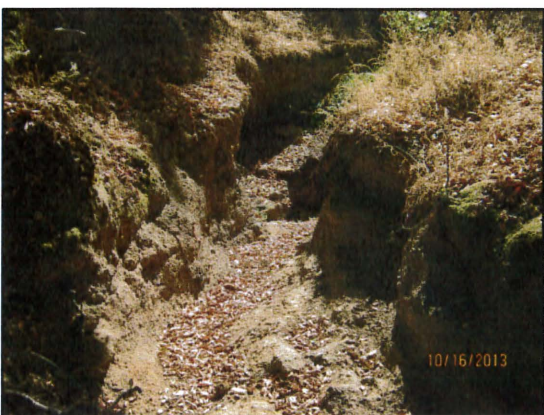
Figure 62: Defined spillway channel looking south.

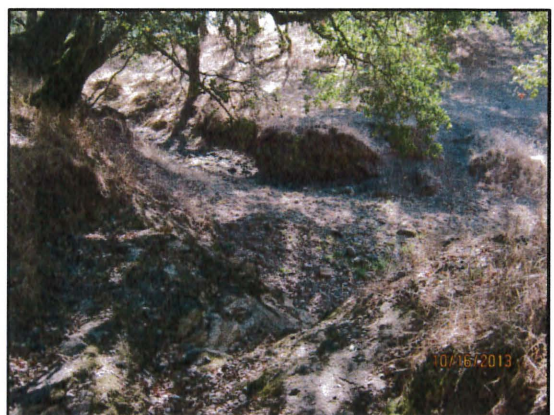
Figure 63: Defined spillway channel at the Unnamed Stream. Unnamed Stream below the dam flows southeast to the property line.

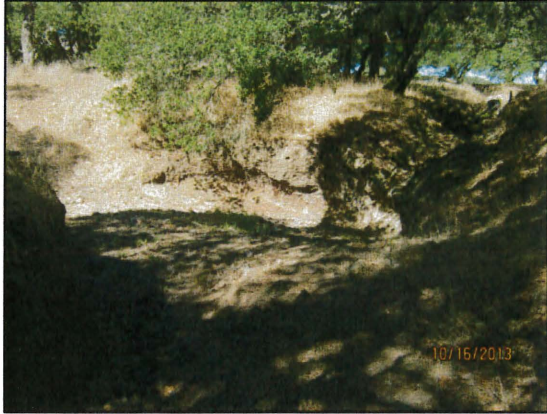
Figure 76: Unnamed Stream looking northwest as it bends to the west. Confluence with the defined spillway channel to the right of the photo.

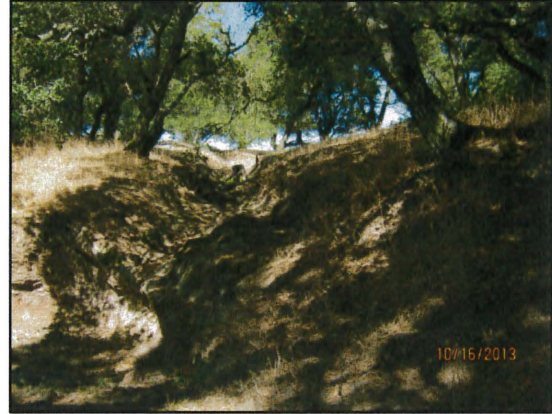
Figure 77: From the Unnamed Stream looking north up the defined reservoir spillway channel.

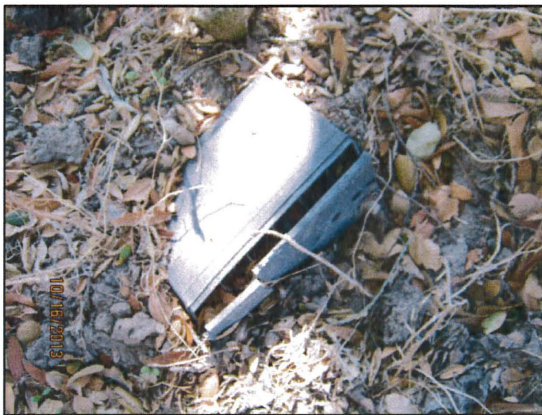
Figure 84: Battery in the Unnamed Stream near the base of the dam.

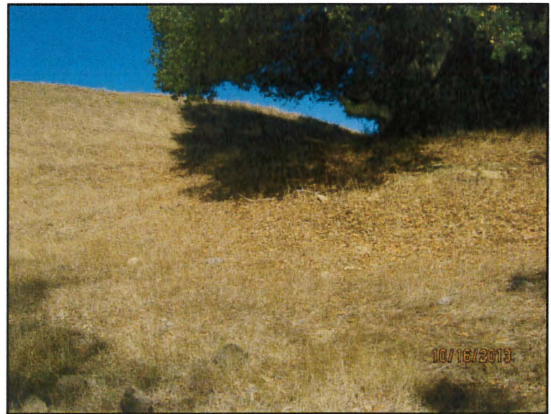
Figure 87: Earthen dam as seen looking north from the Unnamed Stream.

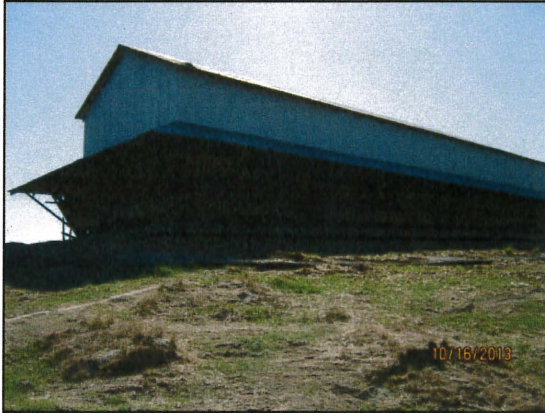
Figure 88: There are two hay facilities approximately 1,000 feet to the north of the Highway.

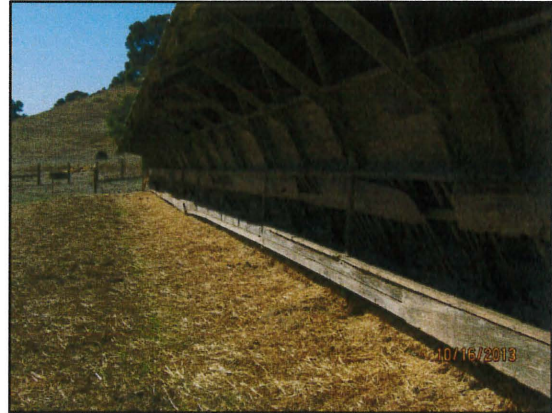
Figure 89: Close up of one of the facilities. Hay was scattered around the facility and stored inside as well.

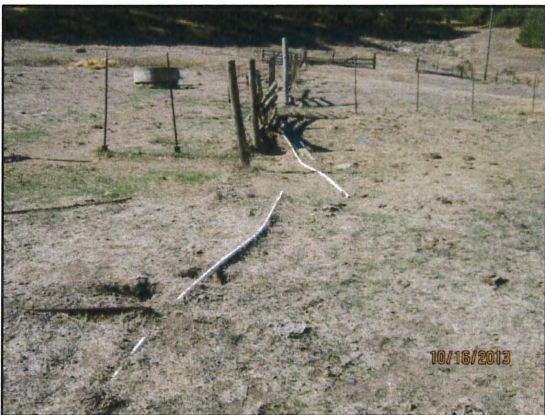
Figure 90: PVC piping running along the fence line as seen looking east.

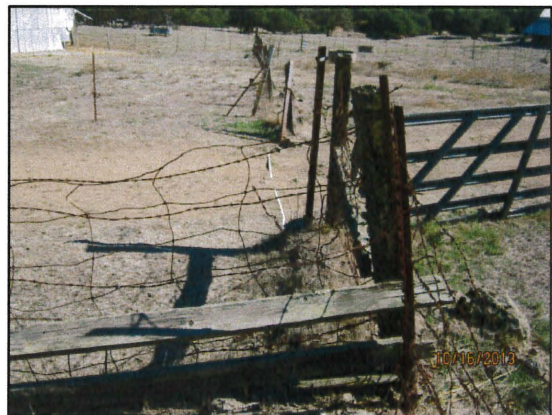
Figure 91: PVC pipe running along the fence line as seen looking east. Hay facilities and water troughs pictured in the background.

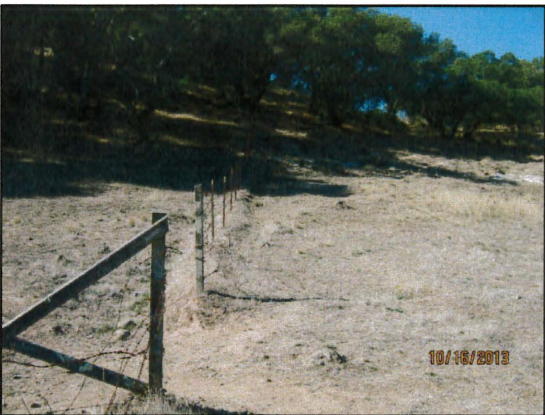
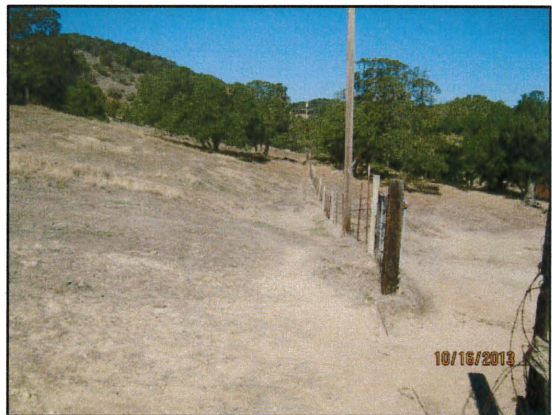
Figure 92: The PVC pipe is buried along the fence line running north to the water well.

Figure 93: The PVC pipe is buried along the fence line running north to the water well.
