STATE WATER RESOURCES CONTROL BOARD
DIVISION OF WATER RIGHTS

**NORTH COAST WATERSHED
RESERVOIR INVESTIGATION**

Reservoir ID UN000139

Date of Inspection: October 16, 2013

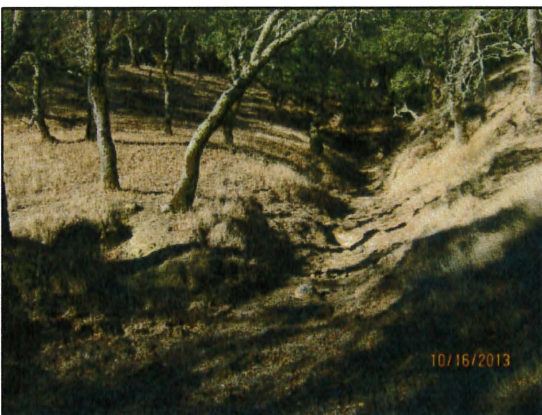
Figure 10: At the confluence looking upstream, northwest, along the Unnamed Stream.

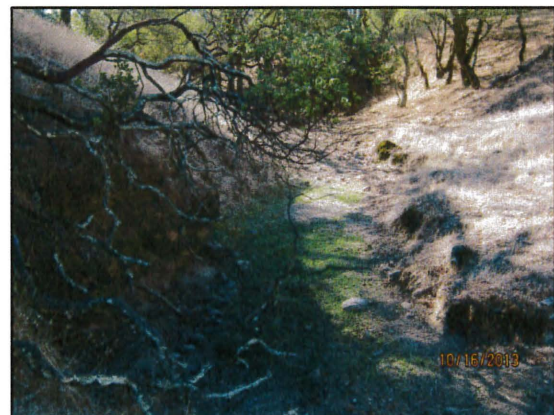
Figure 11: At the confluence looking downstream, southeast, along the Unnamed Stream.

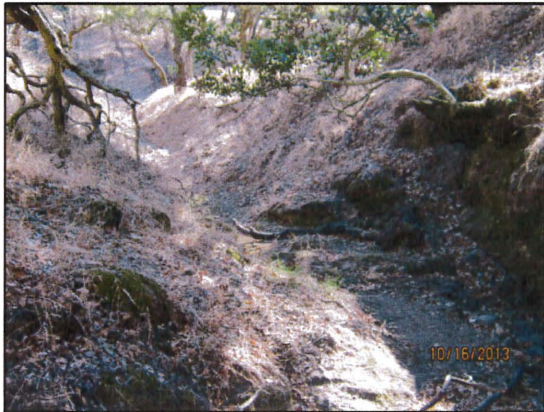
Figure 14: Unnamed Stream as seen looking southeast downstream of Figure 13.

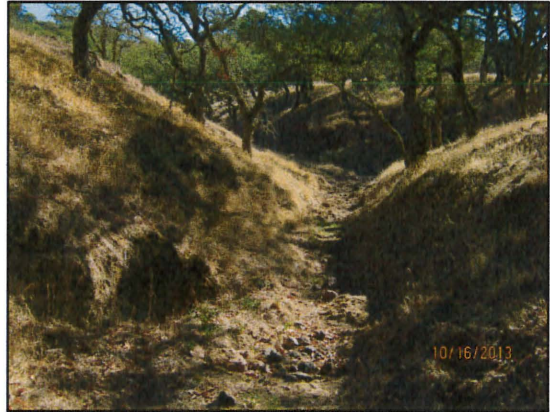
Figure 15: Unnamed Stream as seen looking southeast downstream of Figure 14.

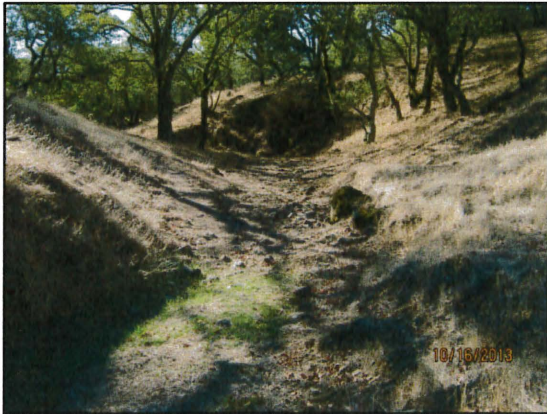
Figure 18: Unnamed Stream as seen looking south downstream of Figure 19.

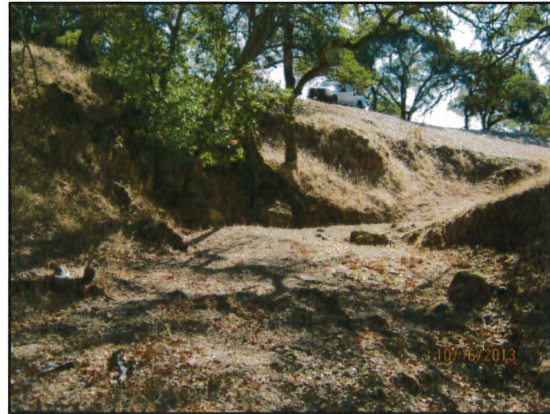
Figure 19: Unnamed Stream as seen looking south downstream of Figure 18.

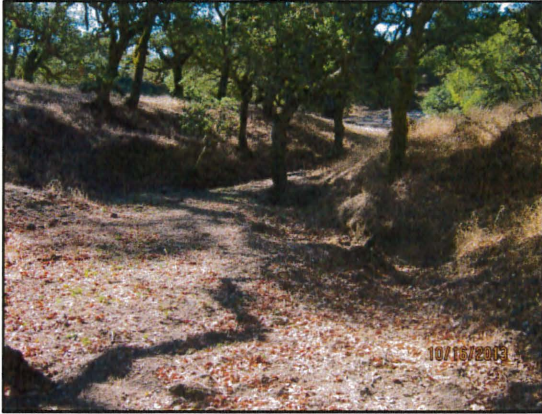
Figure 24: Unnamed Stream as seen looking southeast downstream of Figure 23.

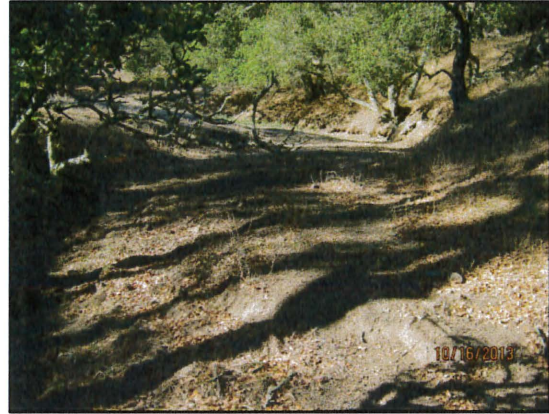
Figure 25: Unnamed Stream as seen looking southwest downstream of Figure 24.

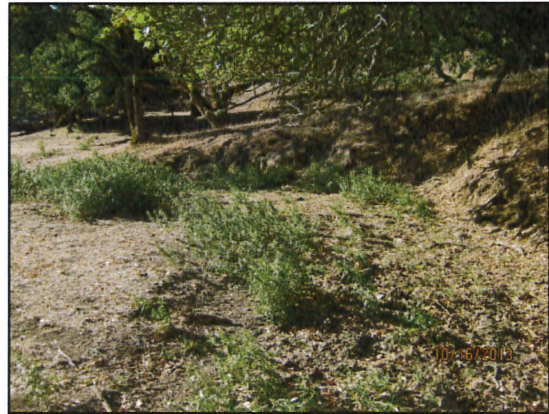
Figure 27: Unnamed Stream as seen looking south downstream of Figure 26.

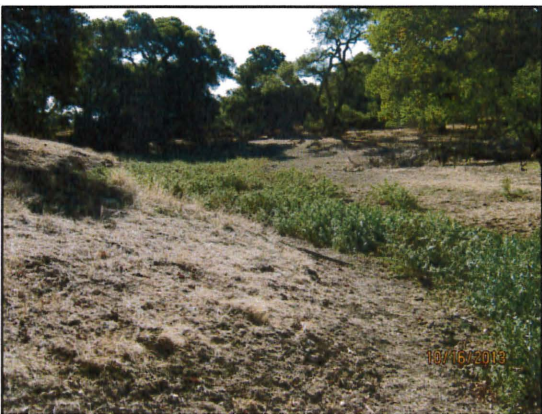
Figure 28: Unnamed Stream as seen looking south downstream of Figure 27.

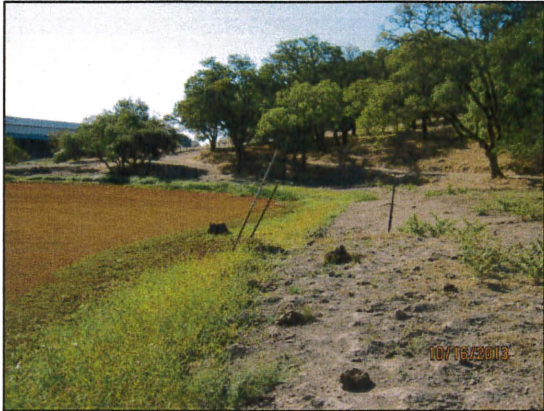
Figure 34: Western side of the reservoir as seen looking south.

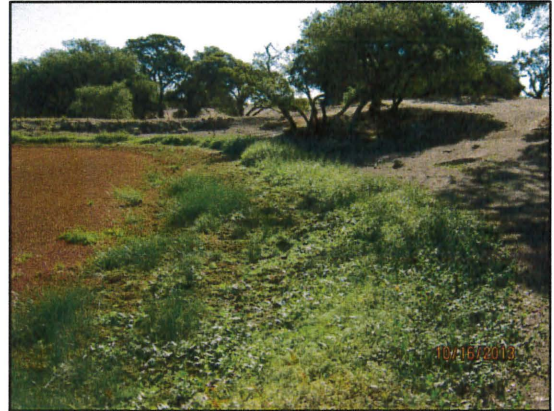
Figure 35: Western side of the reservoir as seen looking south.

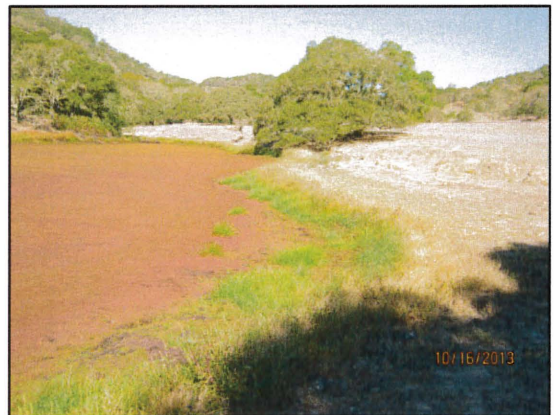
Figure 37: Eastern bank of the reservoir looking northwest as seen from spillway.

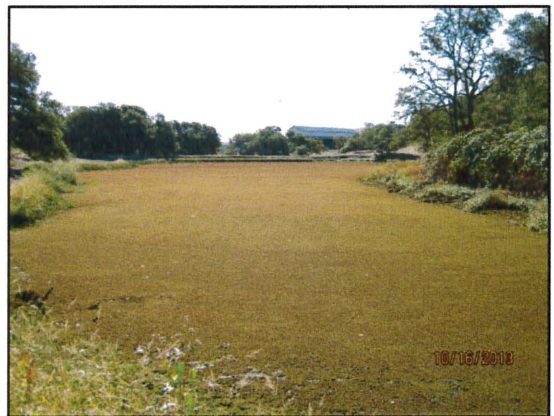
Figure 39: From the northeasterly bank looking south across the reservoir.

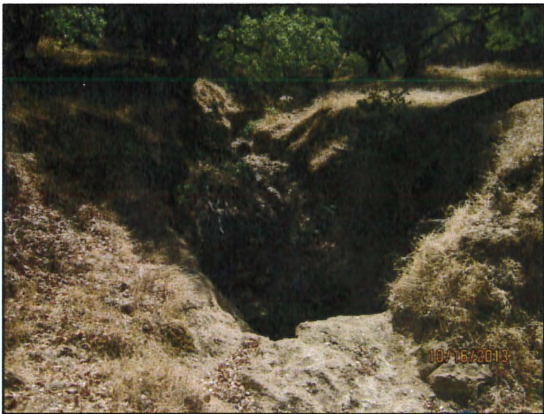
Figure 60: Defined spillway channel looking southeast.
